# Katawa Reserve Flying Fox

Re: Flying Fox – Kaitawa Reserve

# **Annual Inspection**

Kaitawa Reserve

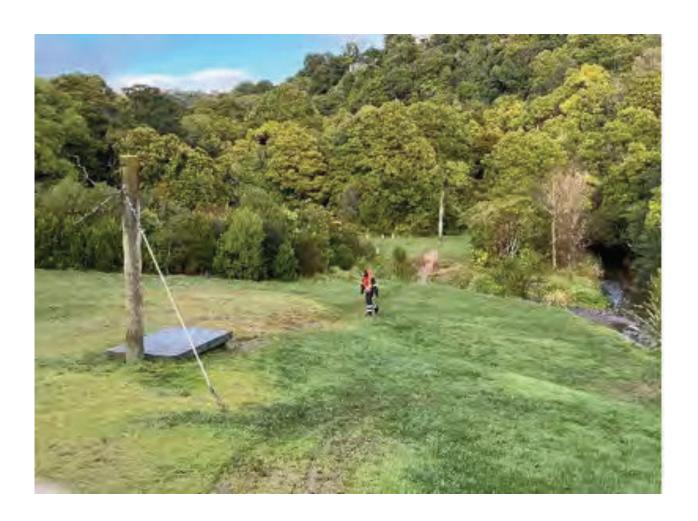
The flying fox is located in Kaitawa Reserve to one side of the reserve and estimated to be over 30 years in age. The flying fox is situated on the slope of the reserve and traverses over a creek with rocks located on either side. The end of the run finishes at the creek bed on a slope. To take the seat to the start of the flying fox one has to cross over the stream. There is no impact surface along the run which is over 1m in height from the seat at several places.

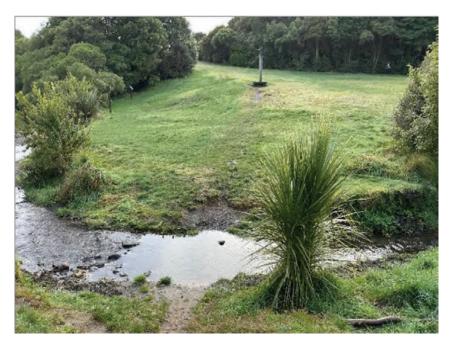
- The cable traverses over a creek at the end of the run which has rocks located on the bank and within it resulting in a hard object within the falling space. There is no impact properties in the event of a fall, which could result in a head injury if falling into the creek bed.
- To take the trolley back to the start, a child has to pull the trolley over the creek.
- The cable is fraying and needs to be replaced.
- The seat is not secure on the chain and needs to be secured.

Rocks within creek bed and on creek edge

- Seek legal advice with regard to Duty of Care under the Occupiers Liability Act, or
- Remove the flying fox in its current location and replace with a compliant flying fox in another part of the reserve where impact properties can be addressed.
