FACILITY MANAGEMENT

PAEKAKARIKI SKATEPARK

CONDITION ASSESSMENT - SKATE SURFACE

MACLEAN SKATEPARK

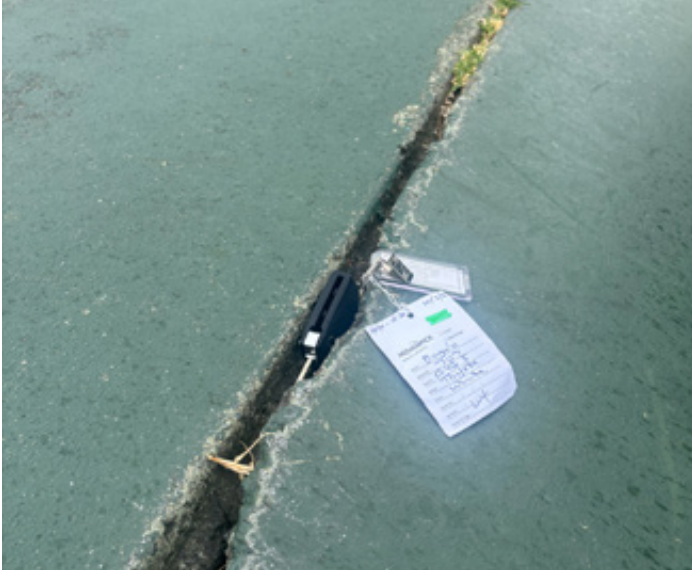
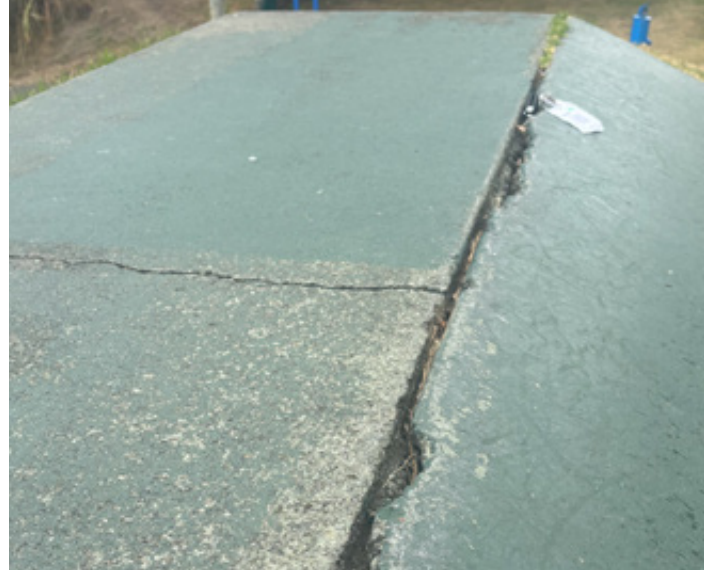
01. WIDE CONSTRUCTION JOINTS + CHIPPING:

Some construction joints within the skatepark are of poor quality and are widening. Wide joints and saw cuts create a hazard for small scooter and skateboard riders as their wheels can become trapped causing the rider to fall unexpectedly creating a safety hazard. Further, wide joints are at risk of widening further and creating holes within the concrete surface.

RISK RATING: HIGH

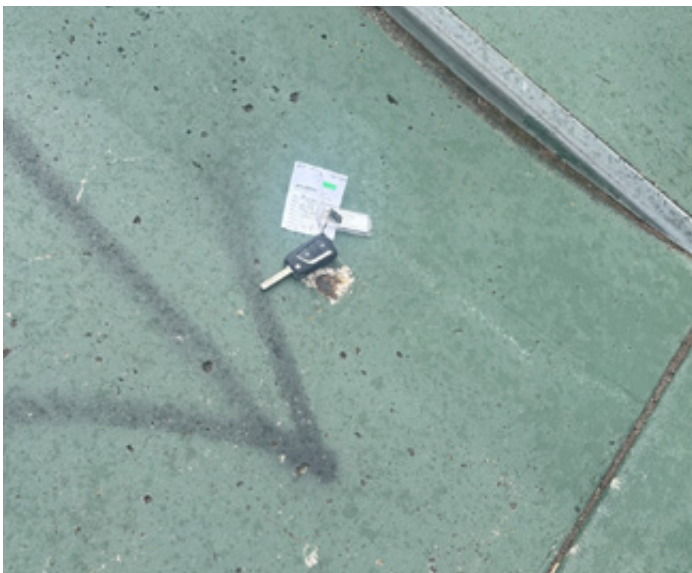
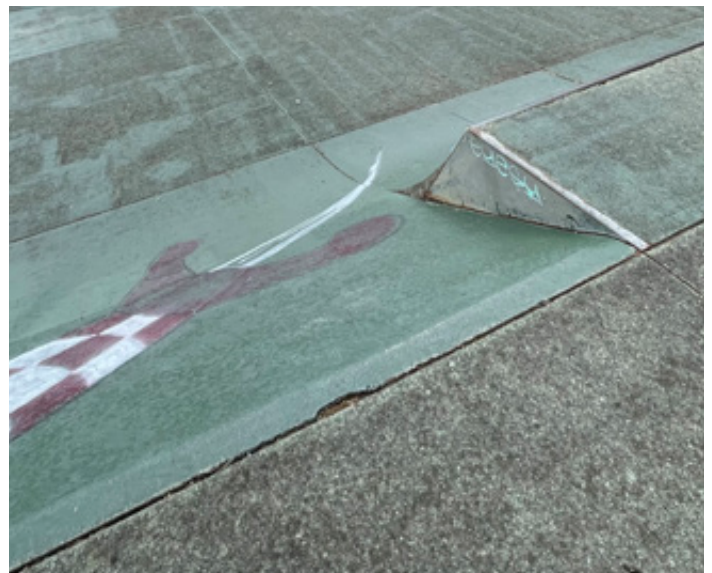
02. CHIPPING:

Chipping has formed along some concrete joints and on obstacles. If left unattended chips will continue to develop, creating a greater hazard. These chipped areas are hazardous to riders as they can catch small wheels causing users to fall creating a safety hazard.

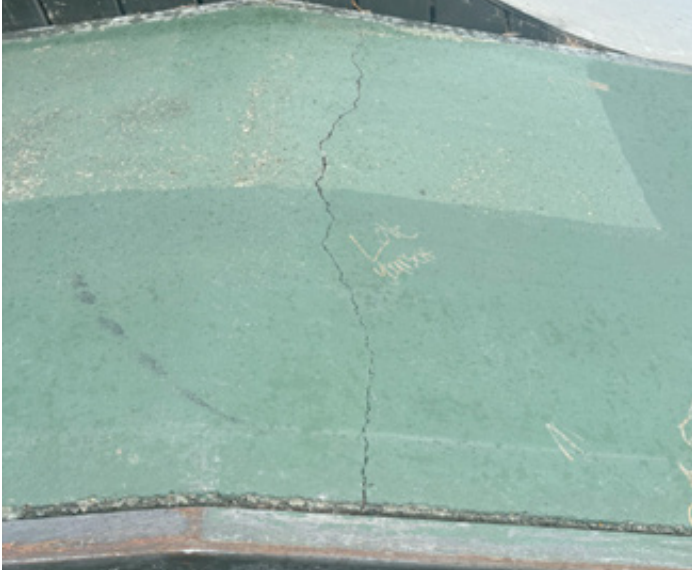
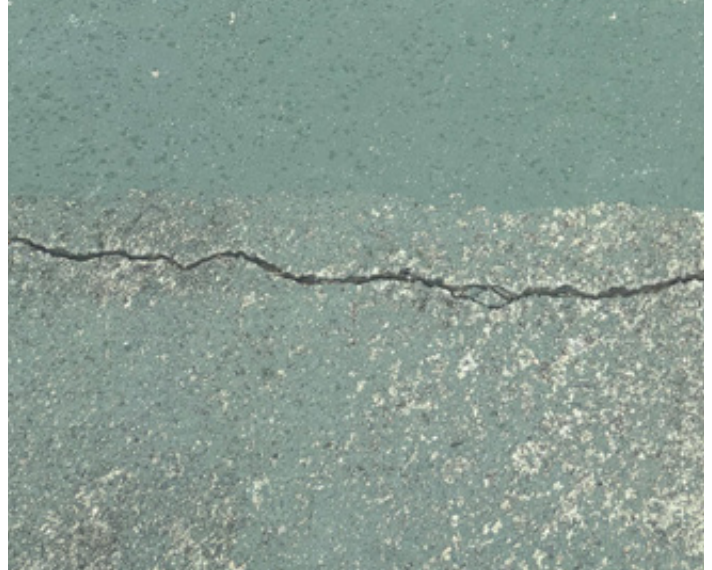
03. FINE CRACKING:

Hairline and minor cracking is evident through the sections of the skatepark. Cracks like these currently pose a low risk, however if left unattended can turn into larger cracks and increase the chance of concrete chipping posing a higher risk to riders.

RISK RATING: LOW

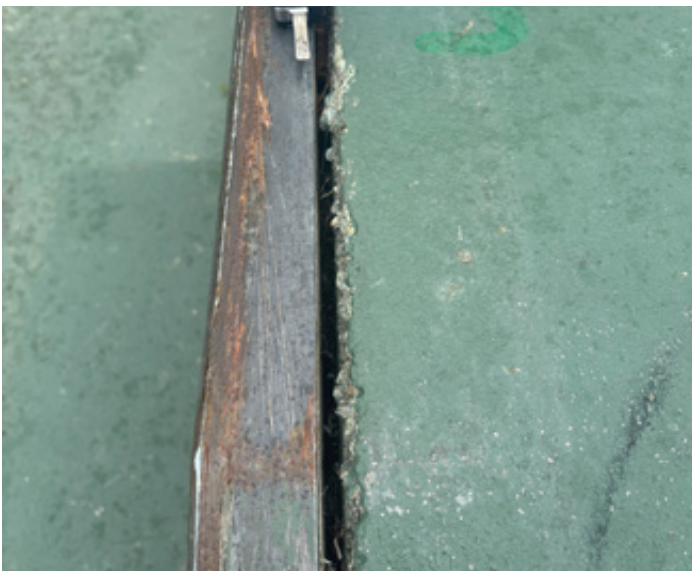
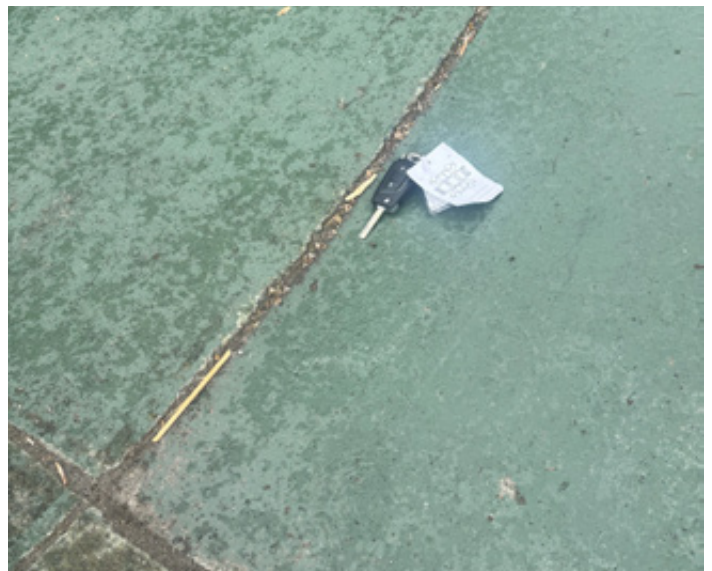
04. CONSTRUCTION JOINTS AND COPING GAPS:

Some gaps are widening within construction joints and also steel coping joints with obstacles. If left unattended gaps will continue to develop, creating a greater hazard. These gaps are hazardous to riders as they can catch small wheels causing users to fall creating a safety hazard.

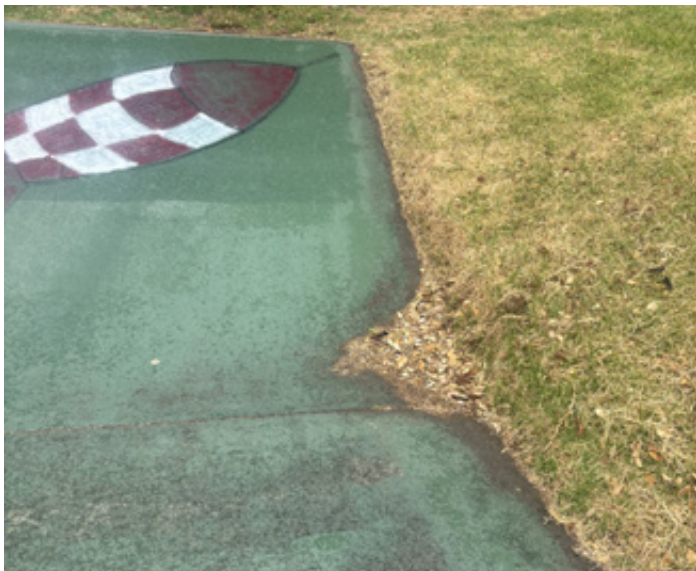
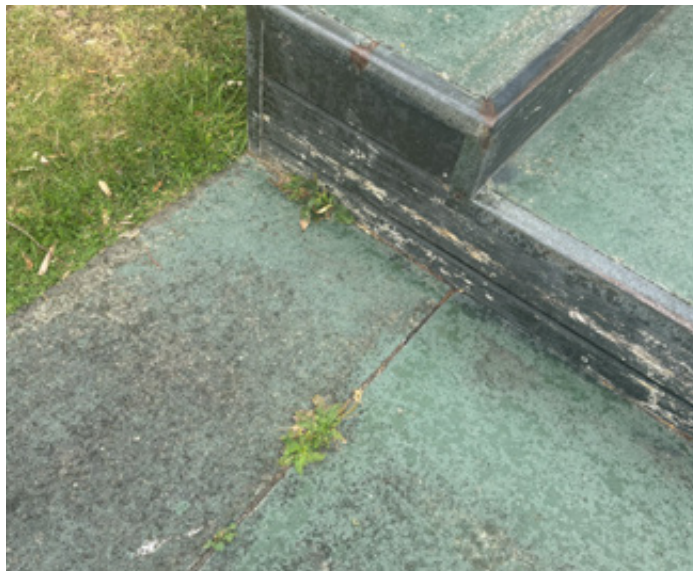
05. LANDSCAPING AND EROSION:

Some areas of landscape surrounding the skatepark have started to erode onto the skatepark surface. This should be maintained as small stones and dirt can create safety hazards for small wheels to get stuck.

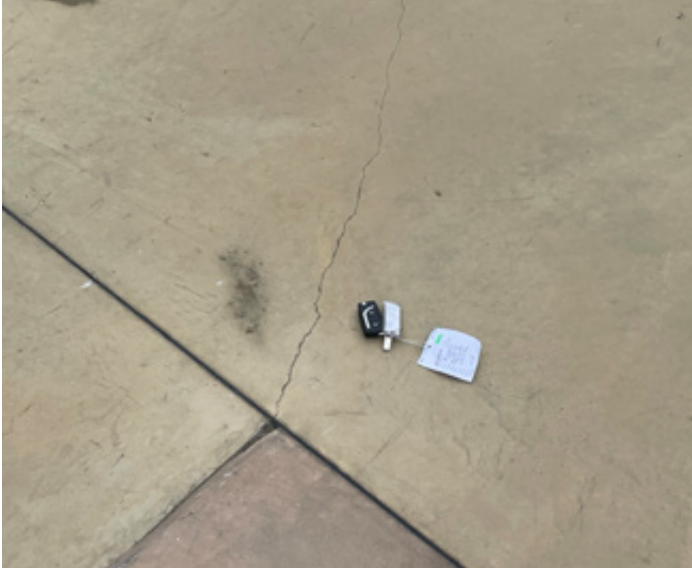
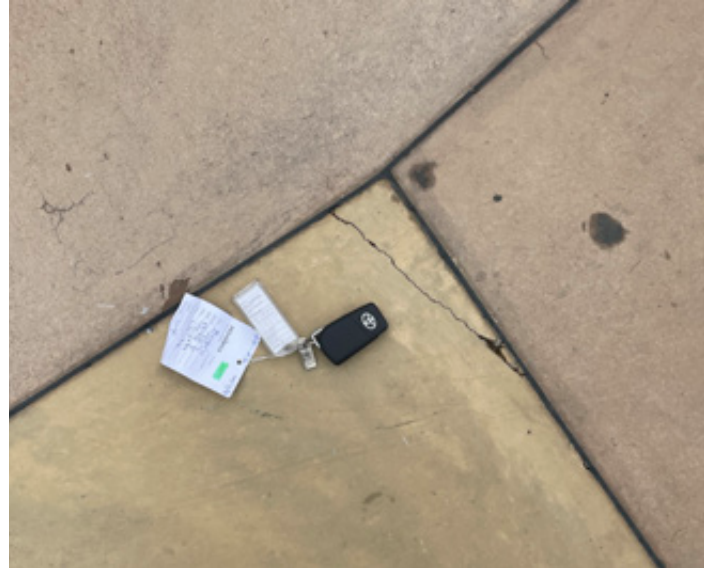
01. FINE TO MEDIUM CRACKING:

Hairline cracking is evident through some areas of the skatepark. Cracks like these currently pose a low risk, however if left unattended can turn into larger cracks and increase the chance of concrete chipping posing a higher risk to riders.

RISK RATING: LOW

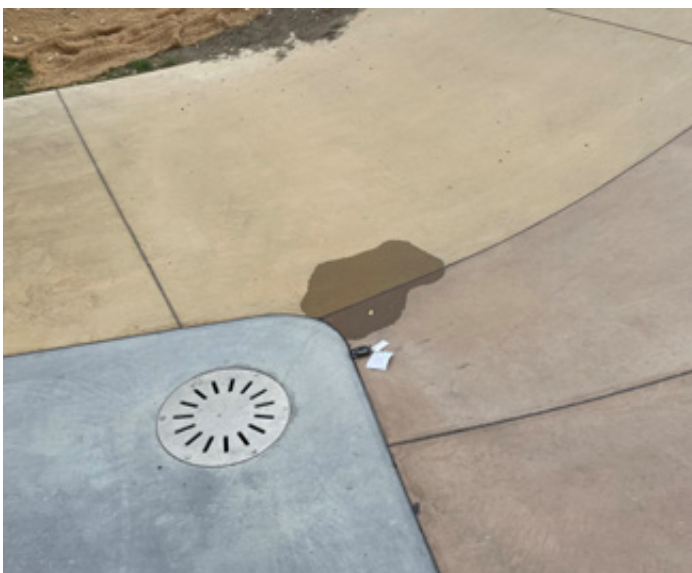
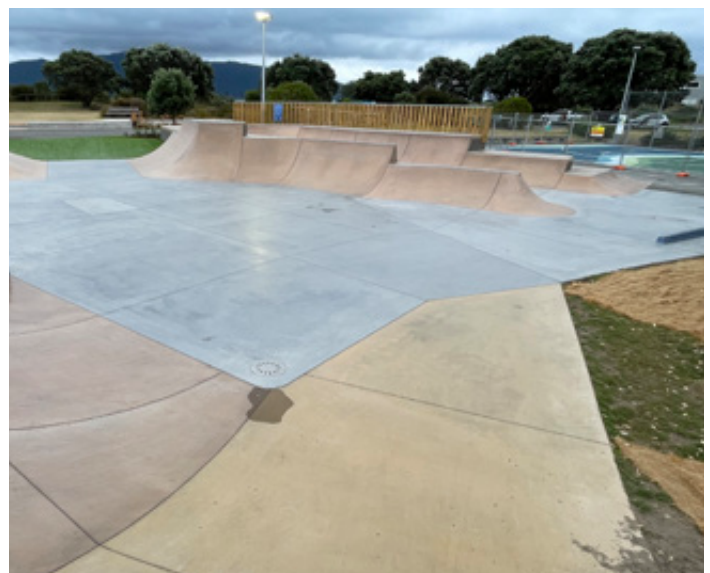
02. POOLING:

An area of pooling is occurring where the grading and drainage does not drain towards the drainage pit. This water has nowhere to go and will take a long time to evaporate. Wet patches on the concrete can become a safety hazard whereby water creates a slip hazard in a high speed location after the jump box.

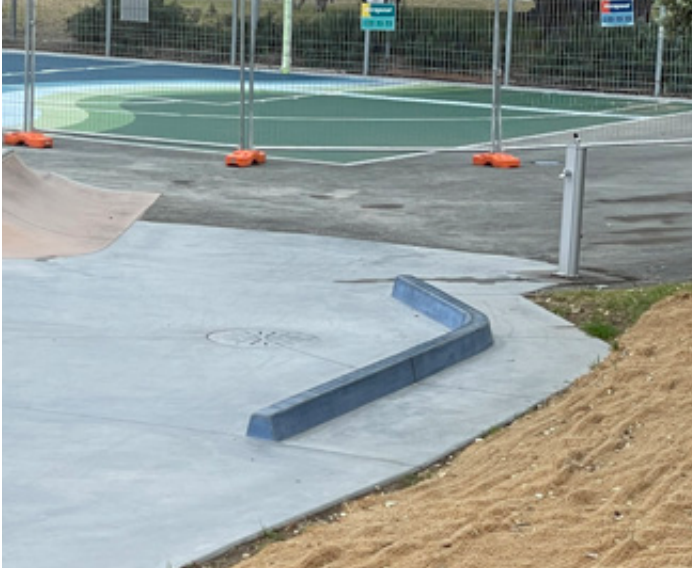
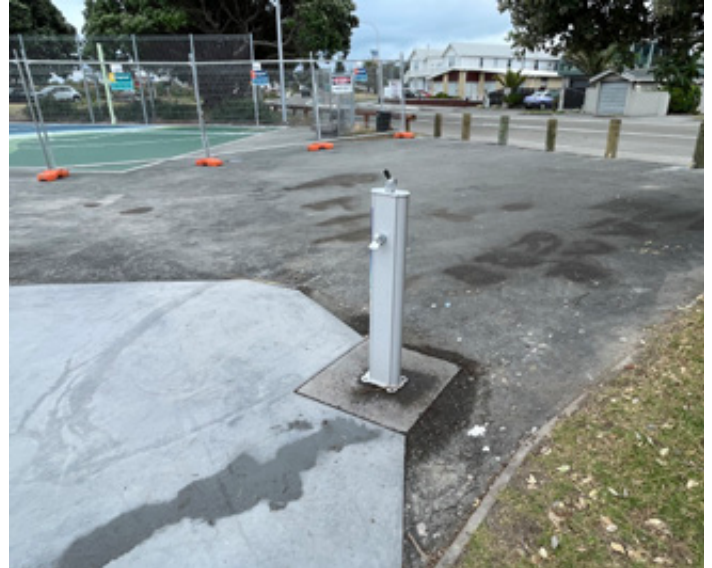
03. DRINKING FOUNTAIN WATER RUN OFF / SAFETY HAZARD:

An area of pooling is occurring where the drinking fountain drains onto the skatepark surface. Wet patches on the concrete can become a safety hazard whereby water creates a slip hazard near the obstacle landing zone. The drinking fountain is also very close to the slappy kerb skate obstacle and could be hazardous if an active user falls into the hard extrusions on the drinking fountain.

RISK RATING: MEDIUM

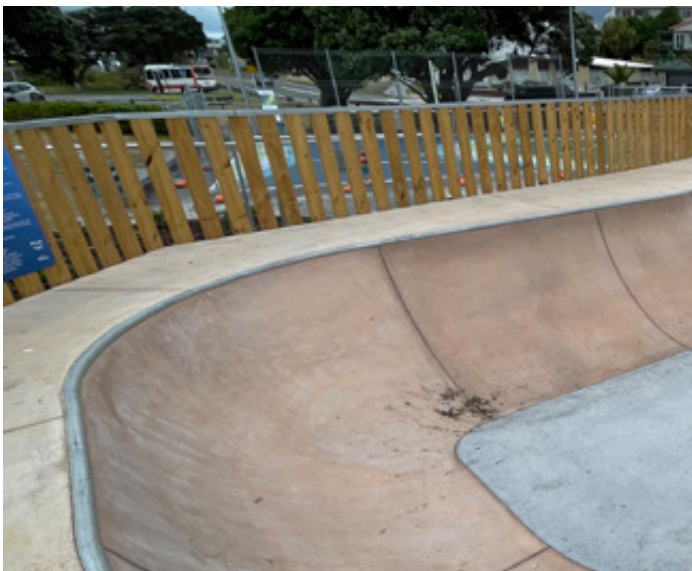
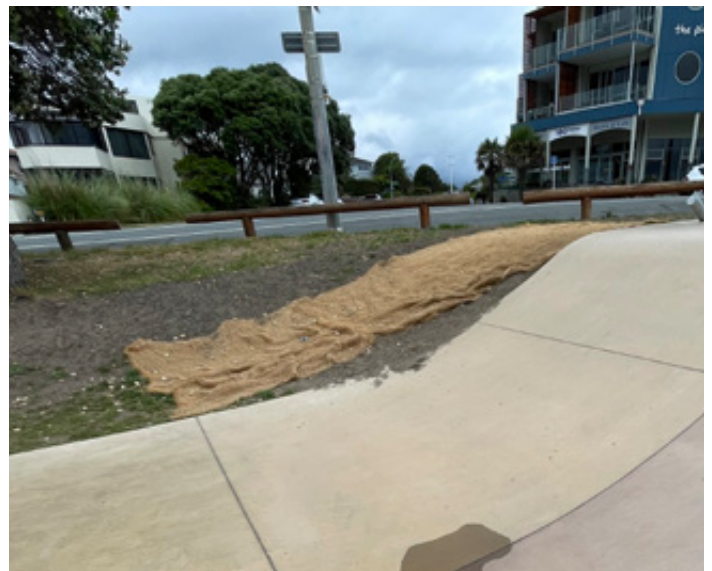
04. LANDSCAPE EROSION AND LANDSCAPE DEBRIS:

Due to the surrounding vegetation, leaf litter and landscape debris is gathering on skate surfaces. This can cause a safety hazards where small wheels can get caught creating 'wheel bite'. Regular maintenance will limit the issue.

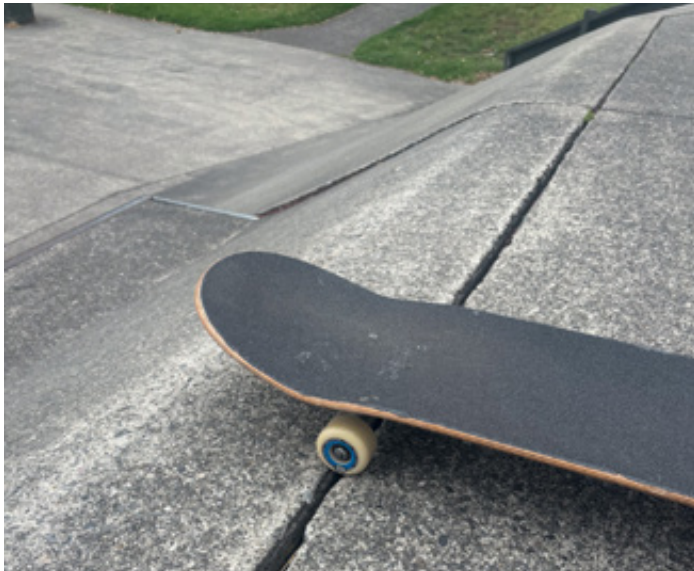
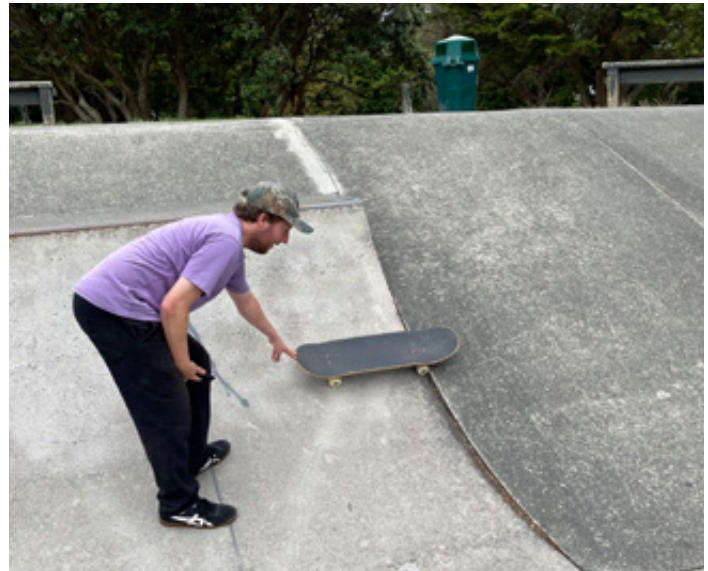
01. GAPS IN JOINTS AND SAW CUTS:

Construction joints within the skatepark are extremely poor quality and are widening, chipping and cracking due to differential settlement. Wide joints, and saw cuts create a hazard for small scooter and skateboard riders as their wheels can become trapped causing the rider to fall unexpectedly creating a safety hazard. Further, wide joints are at risk of widening further and creating holes within the concrete surface.

RISK RATING: HIGH

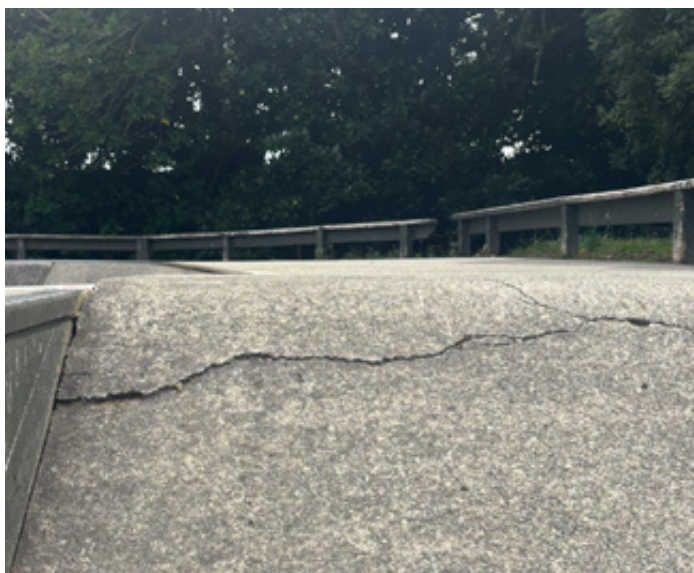
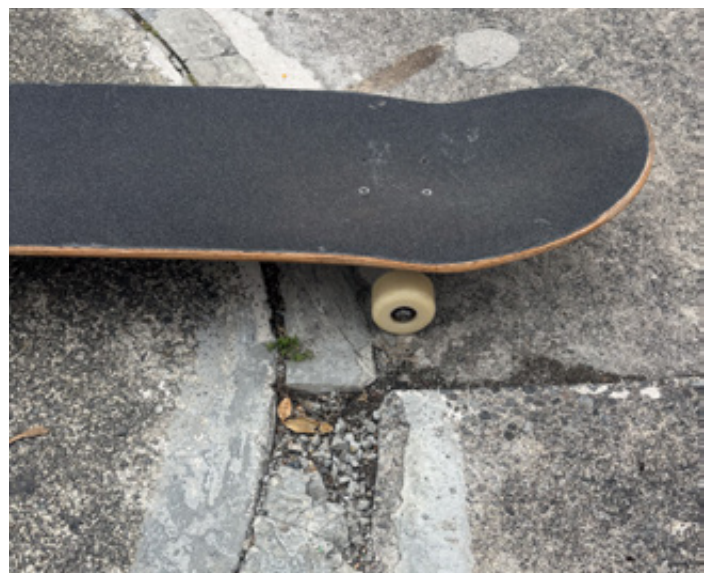
02. CHIPPING + CRACKING:

Large chips and cracks have formed along many concrete joints and throughout the surface of the park. These chipped areas are hazardous to riders as they can catch small wheels causing users to fall creating a safety hazard, some of these chips are extremely unsafe due to locations at high speed critical flow points and large size of features.

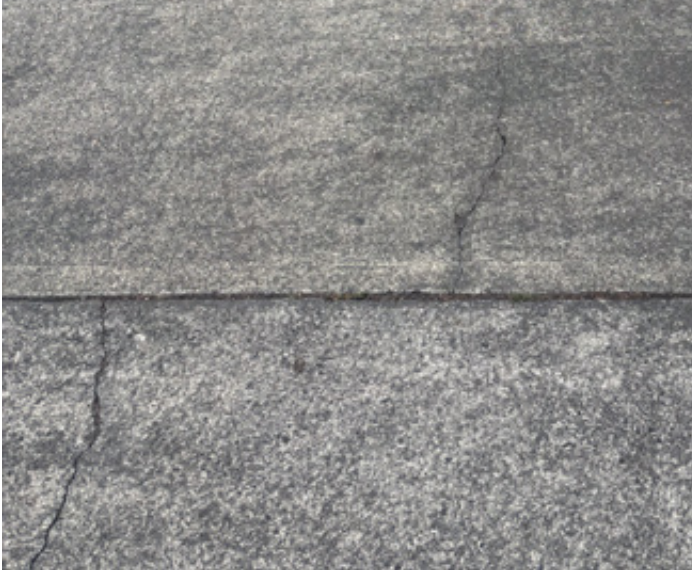
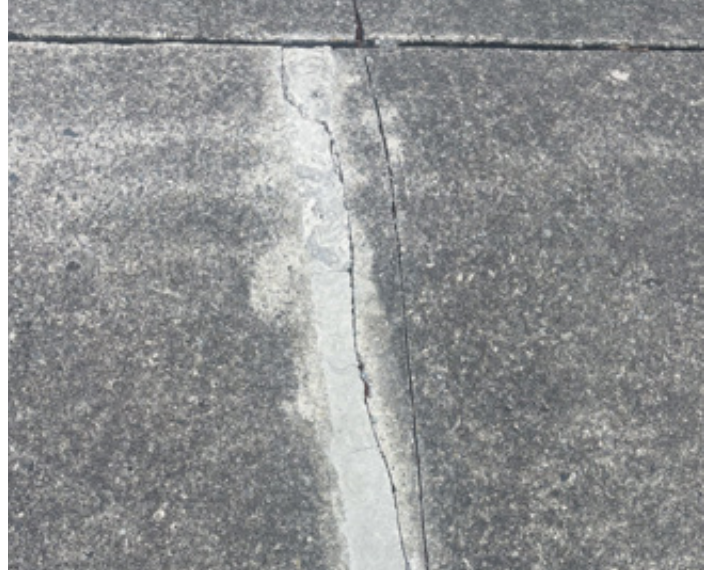
03. FINE CRACKING:

Hairline cracking is evident through sections of the skatepark. Cracks like these currently pose a low risk, however if left unattended can turn into larger cracks and increase the chance of concrete chipping posing a higher risk to riders.

RISK RATING: LOW

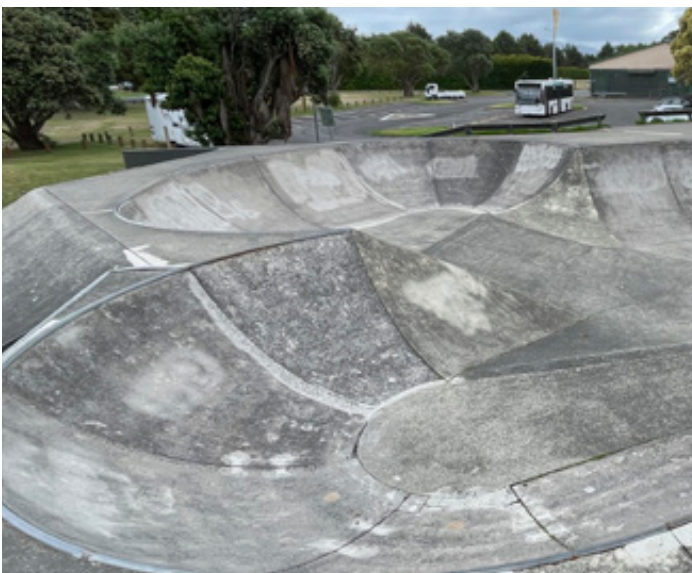
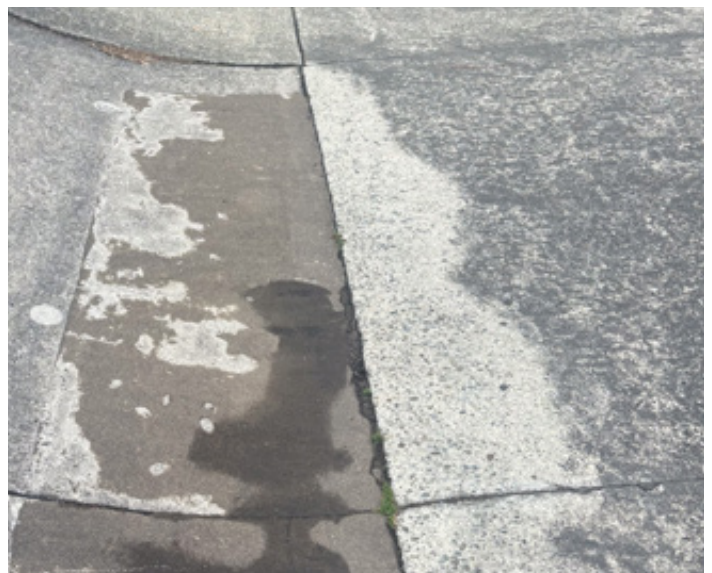
04. ROUGH SURFACE FINISH / DIFFERENTIAL SETTLEMENT:

The surface of the concrete is extremely degraded and rough due to age and weathering. It is evident there have been attempts to grind back differential settlement in some areas and applied surfaces and patching in other areas to remedy poor surface quality. This rough surface can become a safety hazard when it is no longer smooth or functional / is rough + painful to fall on, making it susceptible to injury.

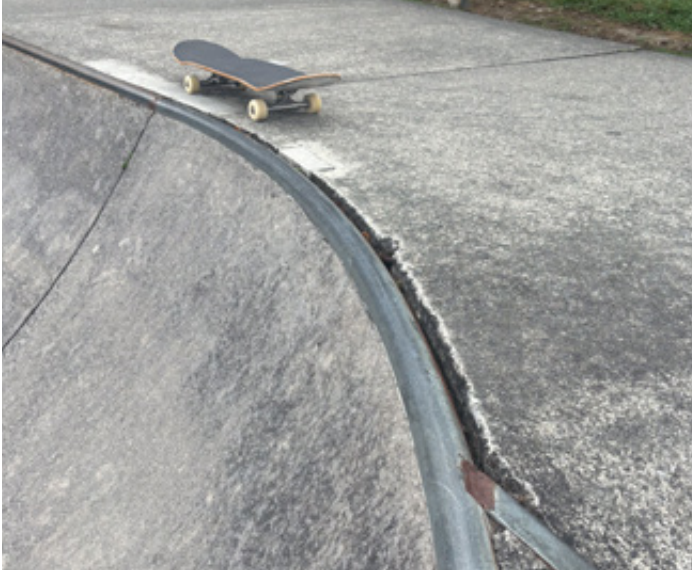
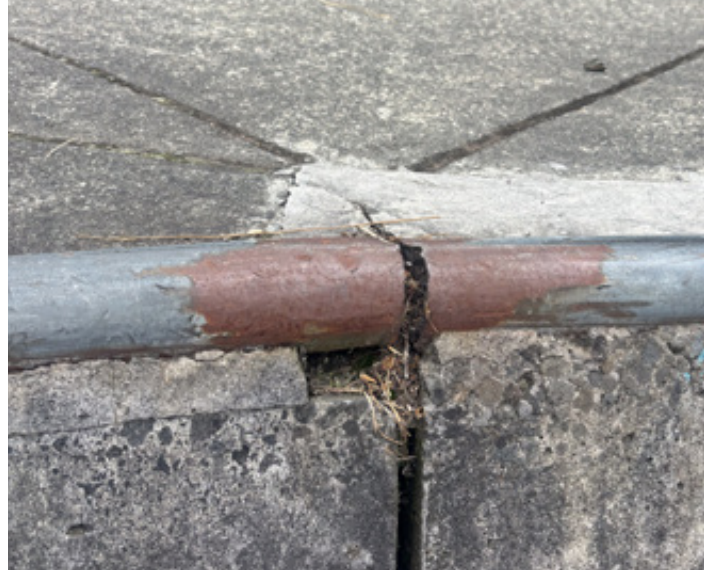
05. COPING CRACKS + CHIPS:

Chipping and cracking is occurring behind and under CHS coping in certain areas throughout the park. This is a safety issue catching trucks and small wheels at a high speed locations in the park.

RISK RATING: HIGH

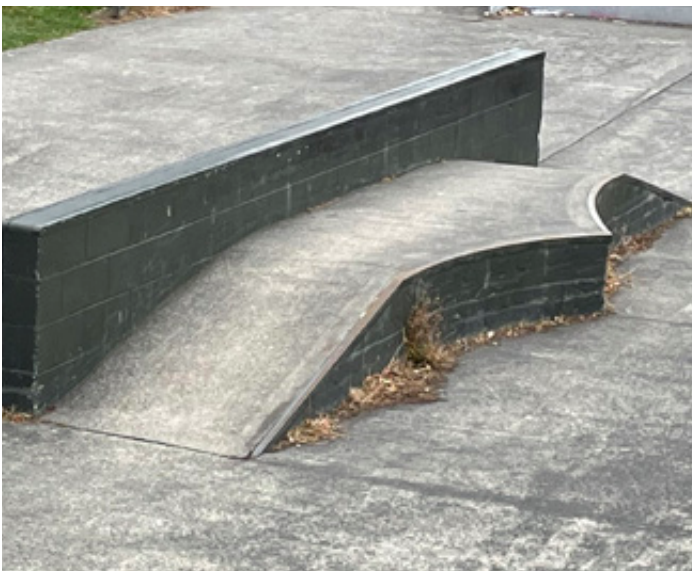
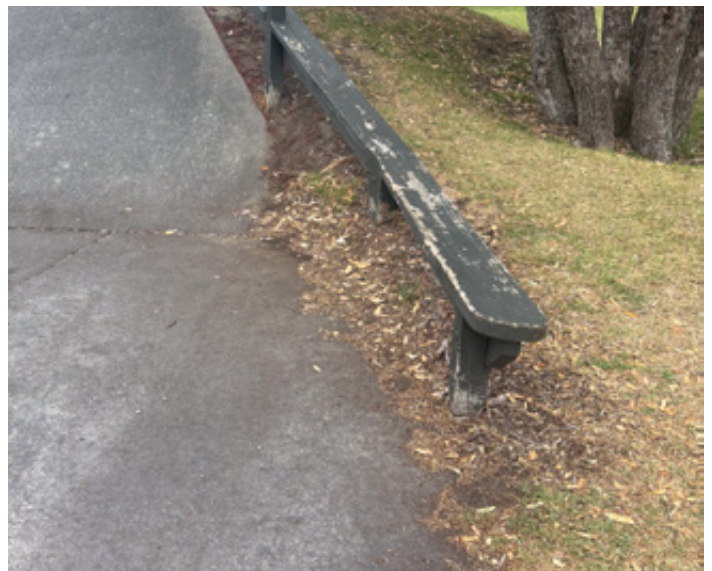
06. LEAF LITTER AND LANDSCAPE DEBRIS:

Leaf litter and landscape debris is gathering on skate surfaces. This can cause a safety hazards where small wheels can get caught creating 'wheel bite'. Regular maintenance will limit the issue.

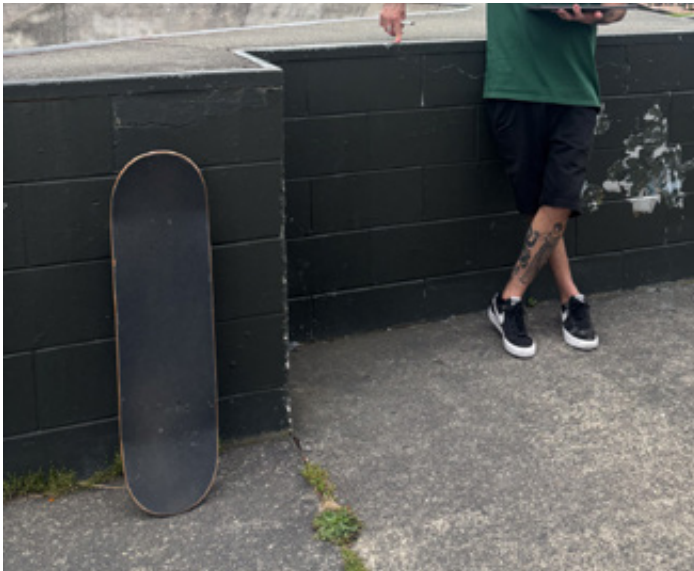
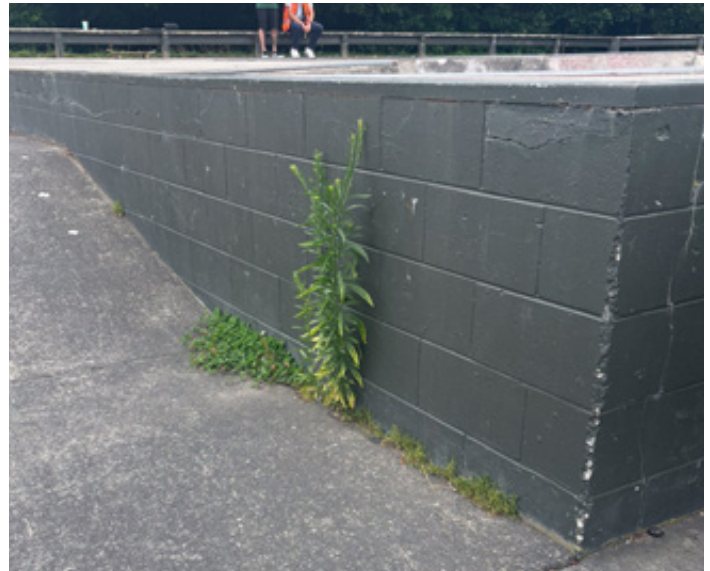
07. FALL HEIGHTS:

There are locations within the facility that have non compliant fall heights exceeding landscape safety standards over 900mm with no balustrades where people can fall onto hard surfaces causing injury.

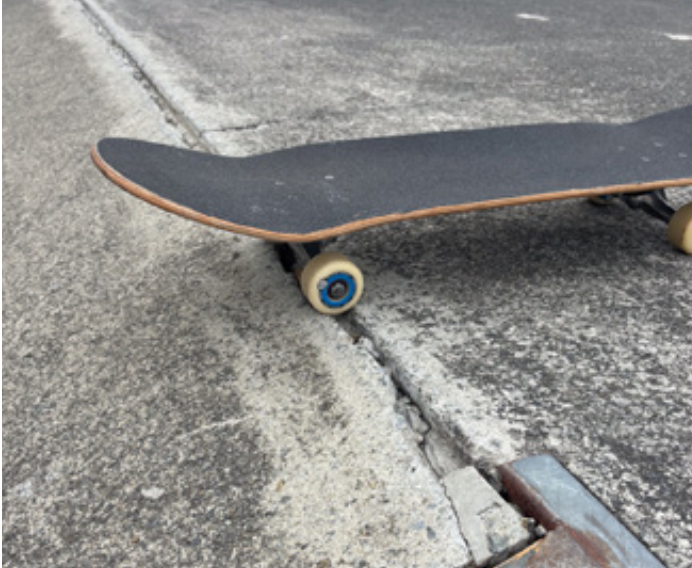
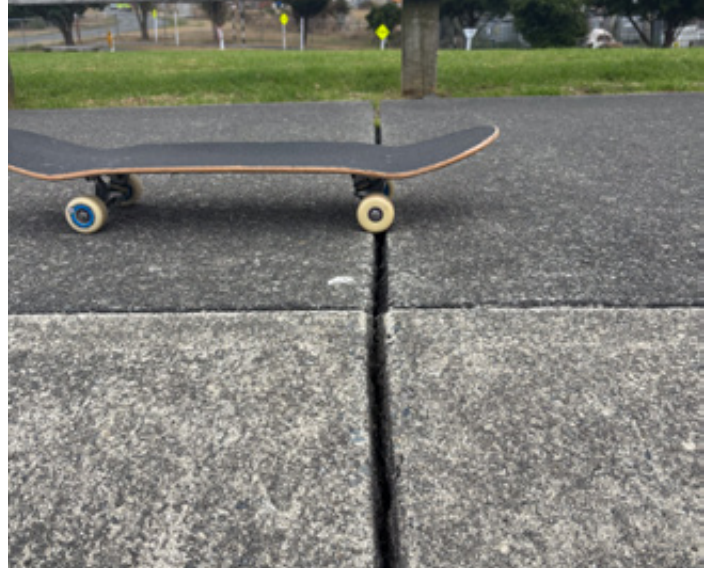
01. GAPS IN JOINTS AND SAW CUTS:

Construction joints within the skatepark are of poor quality and are widening, chipping and cracking. Wide joints, and saw cuts create a hazard for small scooter and skateboard riders as their wheels can become trapped causing the rider to fall unexpectedly creating a safety hazard. Furthermore, some of these are at the top of ramps increasing the hazard risk in a high speed area.

RISK RATING: HIGH

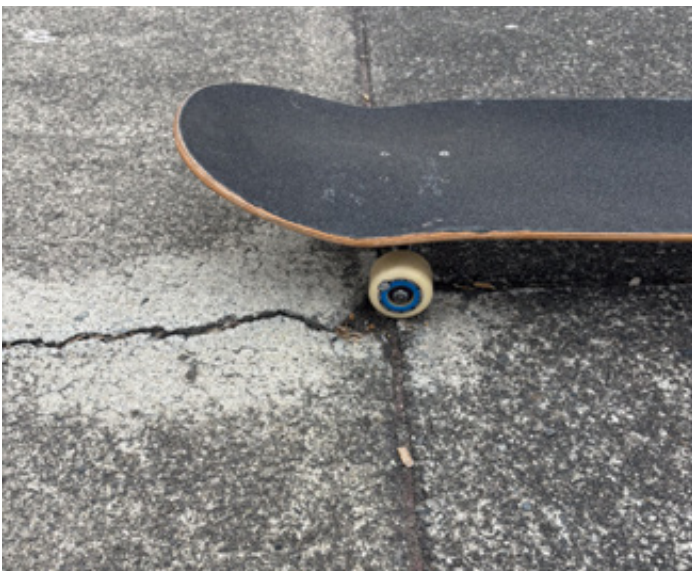
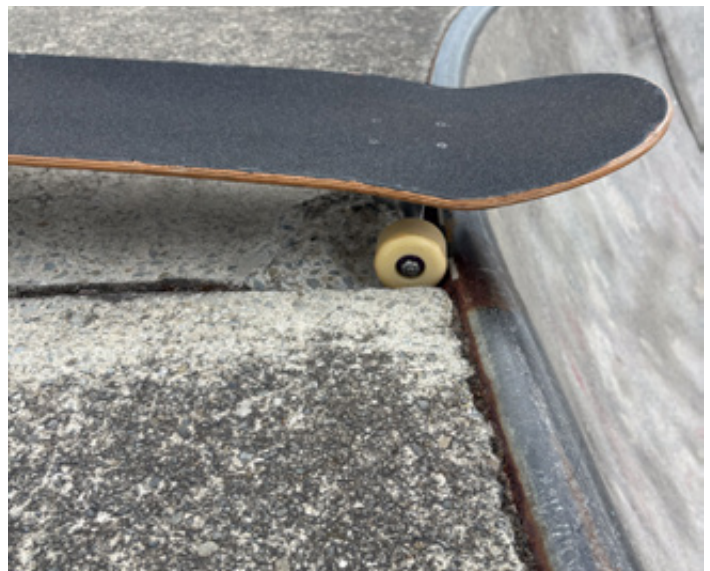
02. CHIPPING AND CRACKING:

Chipping and cracking has formed along many concrete joints and around obstacles. These chipped areas are hazardous to riders as they can catch small wheels causing users to fall creating a safety hazard, many of these chips are at the bottom or top of obstacles where it is unsafe due to higher speeds at critical flow points.

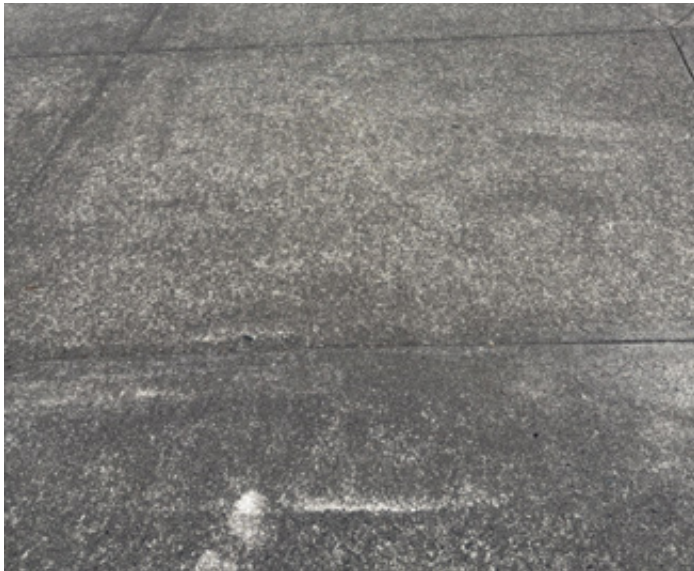
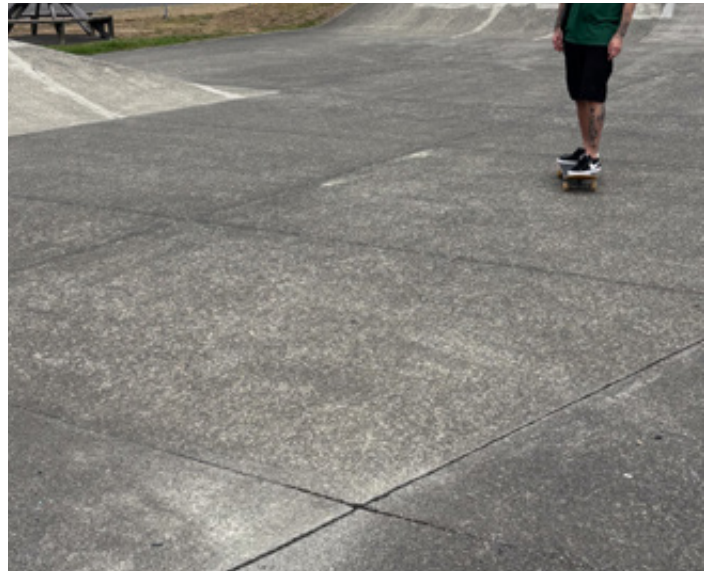
03. ROUGH SURFACE FINISH:

The majority of the skatepark surface is **very rough** and weathered due to age and minimal maintenance. This rough surface is a hazard as it is no longer smooth or functional for most wheeled sports and is rough to fall on, making it more susceptible to injury.

RISK RATING: MEDIUM

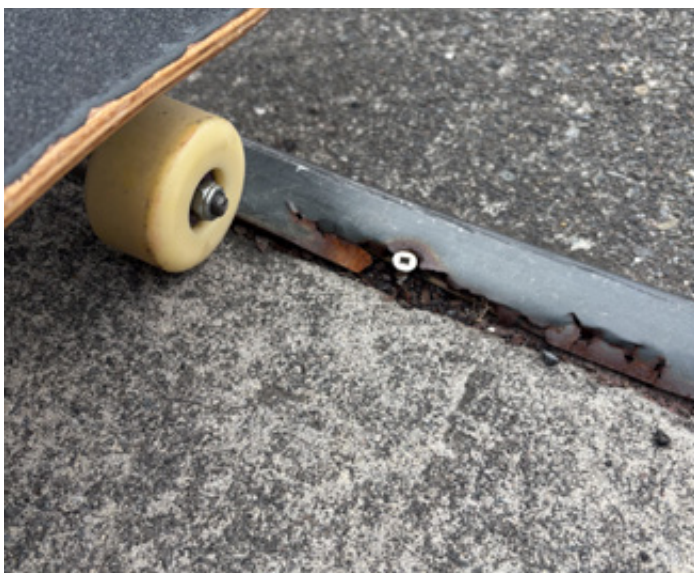
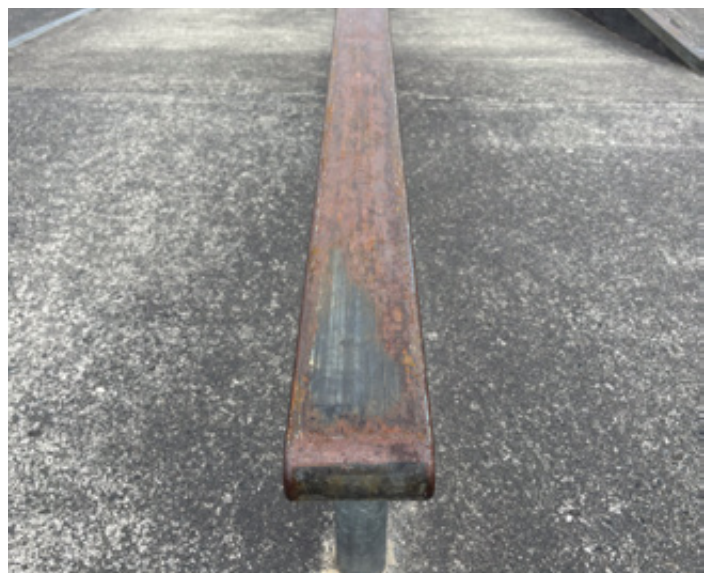
04. RUST AND CORROSION:

Surface rust and heavy corrosion is apparent in some steel coping and rail areas. The friction created from surface rust on steel makes the obstacle unpredictable for function where a user may become stuck and fall. Heavy corrosion creates sharp flakes which may cause injury if a user was to fall onto exposed edges.

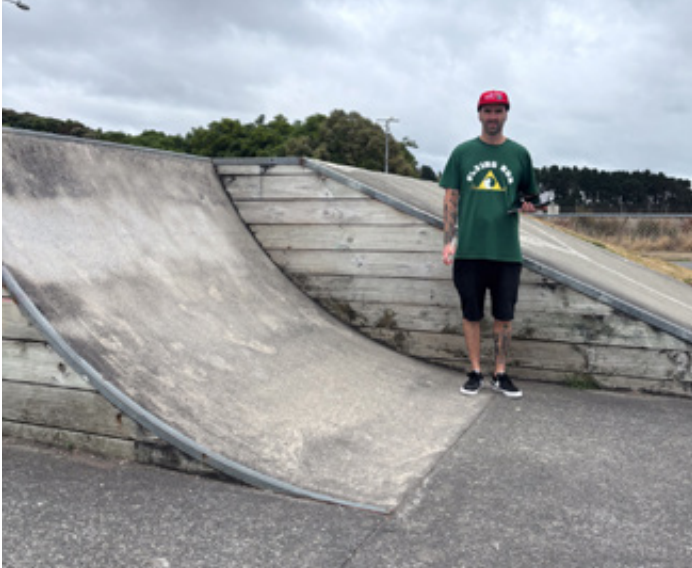
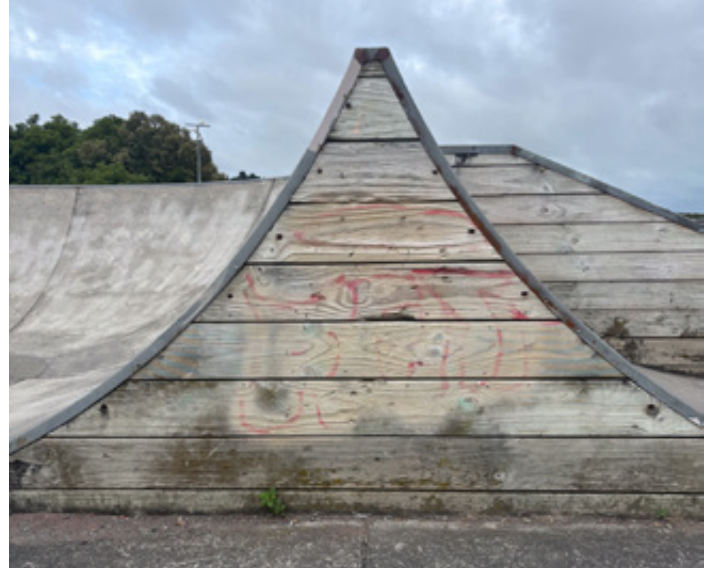
08. FALL HEIGHTS:

The central spine and jump box feature have fall heights exceeding safety standards. Although within the space these vertical drops have no ramp to catch a users fall.

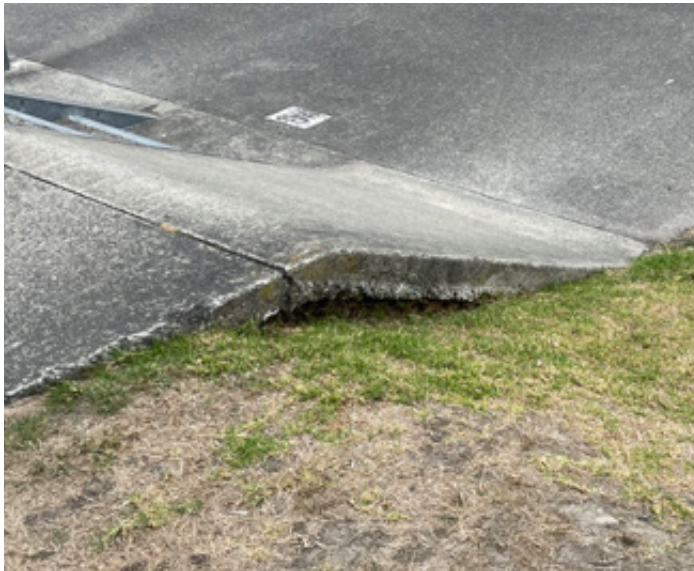
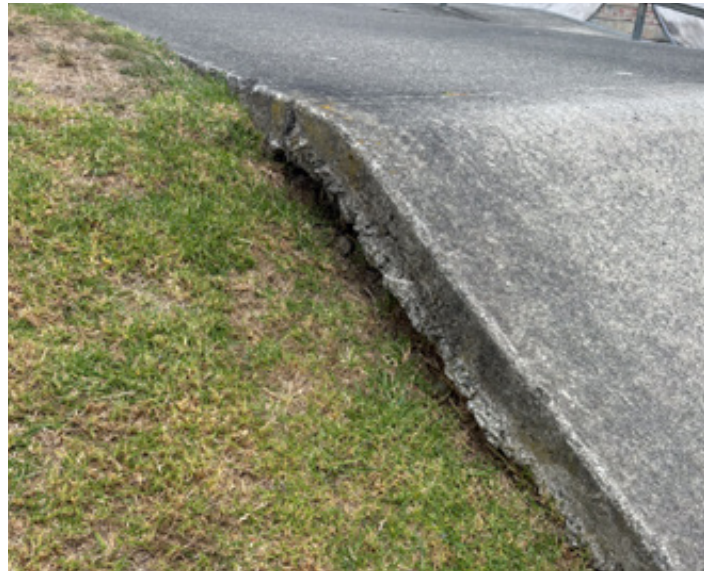
07. LANDSCAPING AND EROSION:

Earth battering around ramp edges has eroded in some areas exposing a floating slab. Overtime this may cause structural impacts to the concrete structure.
