OIR: 2324/809

**Request for Information under the Local Government Official Information and Meetings Act 1987 (the Act) (the LGOIMA)**

## Section Inspection - 8/07/2022 - KSWP003634

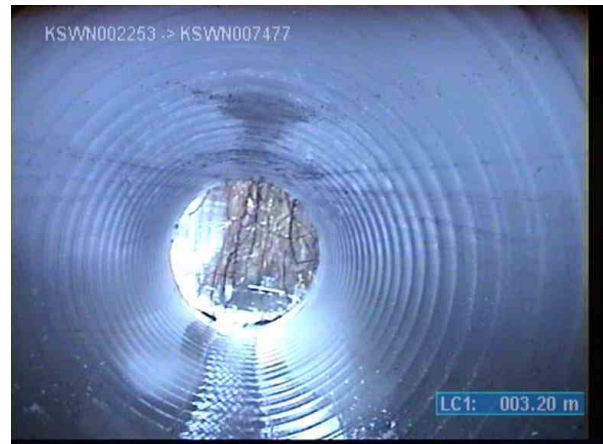
KSWP003634\_23266daf-560e-4aaf-960b-442abe849b0c\_20220708\_155222\_076.jpg, 00:01:17, 3.20m  
Material change / Bosspipe

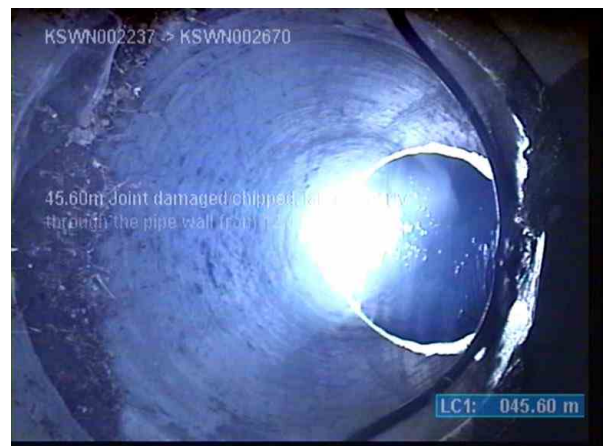
KSWP003713\_bdd97187-9c4c-4e12-97c5-650296e93888\_20220811\_132048\_371.jpg, 00:04:25, 45.60m (2.60m)  
Joint damaged/chipped, large, clearly through the pipe wall from 12 o'clock to 12 o'clock

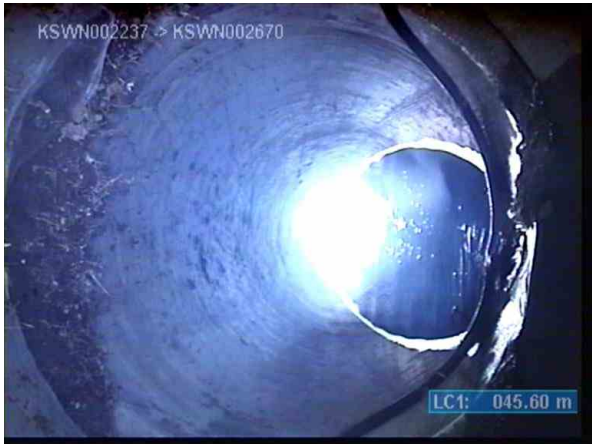
KSWP003713\_4a77d837-2bba-4c40-a44b-a017512c4149\_20220811\_132102\_186.jpg, 00:04:31, 45.60m (2.60m)  
Gap separation width 20mm

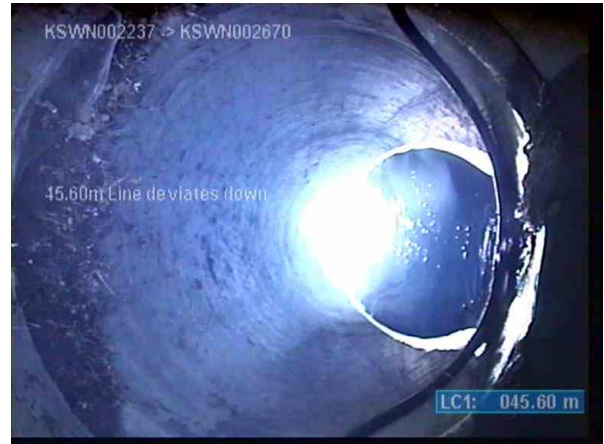
KSWP003713\_71c9edd4-90be-4488-97db-24646cada9ca\_20220811\_132110\_921.jpg, 00:04:37, 45.60m (2.60m)  
Line deviates down

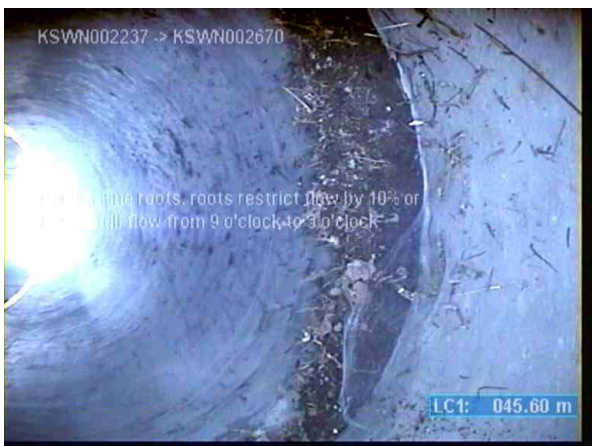
KSWP003713\_90419e6e-c99a-4298-a253-86fee32ccced\_20220811\_132134\_875.jpg, 00:04:52, 45.60m (2.60m)  
Fine roots, roots restrict flow by 10% or less of full flow from 9 o'clock to 3 o'clock

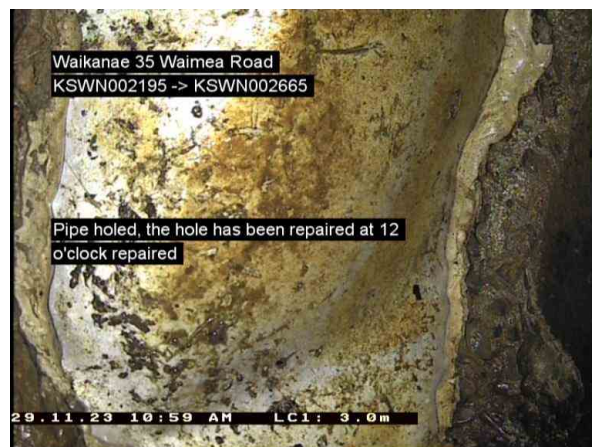
42\_KSWP003751\_196.jpg, 00:02:26, 3.00m (12.40m)  
Pipe holed, the hole has been repaired at 12 o'clock / repaired

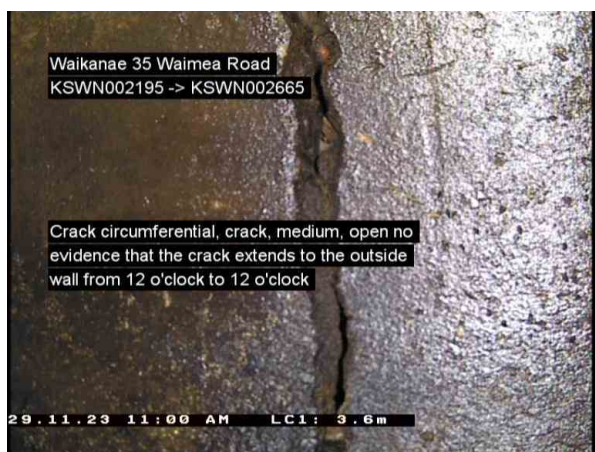
42\_KSWP003751\_197.jpg, 00:02:53, 3.60m (11.80m)  
Crack circumferential, crack, medium, open no evidence that the crack extends to the outside wall from 12 o'clock to 12 o'clock

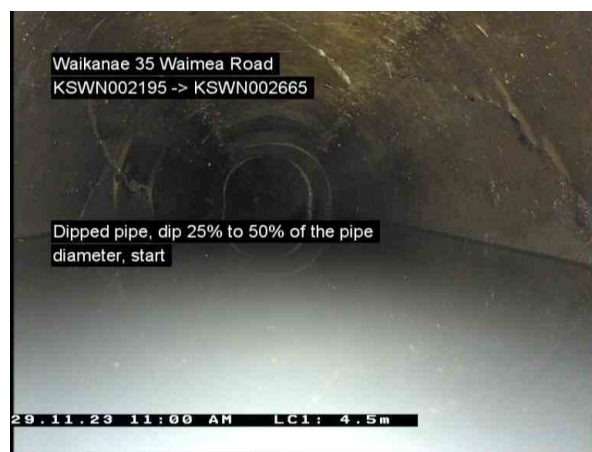
42\_KSWP003751\_198.jpg, 00:03:10, 4.50m (10.90m)  
Dipped pipe, dip 25% to 50% of the pipe diameter, start

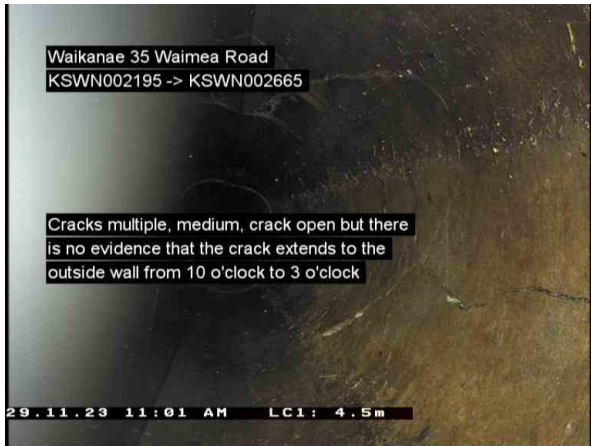
42\_KSWP003751\_199.jpg, 00:03:25, 4.50m (10.90m)  
Cracks multiple, medium, crack open but there is no evidence that the crack extends to the outside wall from 10 o'clock to 3 o'clock

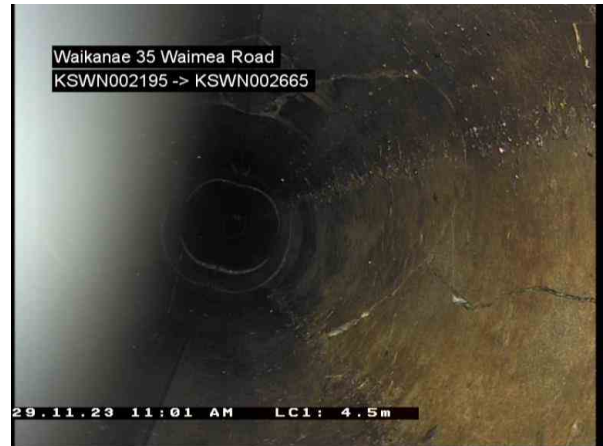
42\_KSWP003751\_200.jpg, 00:03:25, 4.50m (10.90m)  
Cracks multiple, medium, crack open but there is no evidence that the crack extends to the outside wall from 10 o'clock to 3 o'clock

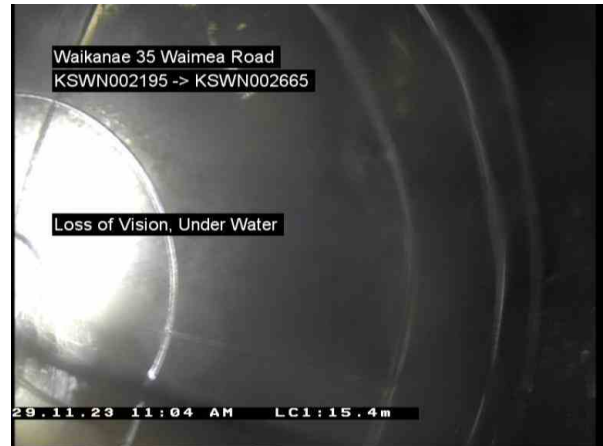
42\_KSWP003751\_204.jpg, 00:06:39, 15.40m (0.00m)  
Loss of Vision, Under Water

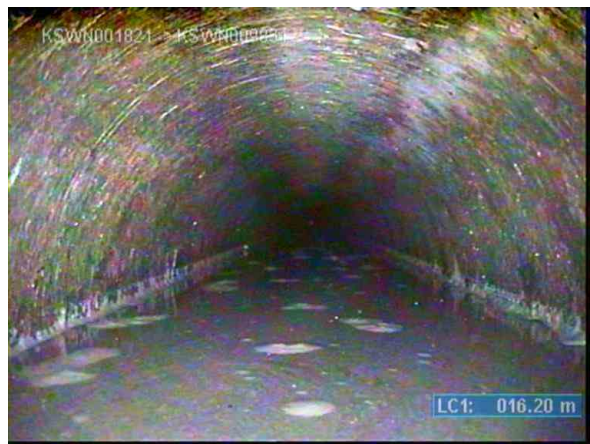
KSWP003815\_6490fce0-0345-4d25-ac2c-1e2e453b3bc3\_2020701\_135213\_247.jpg, 00:03:52, 16.20m  
General comment / High water level going to creek

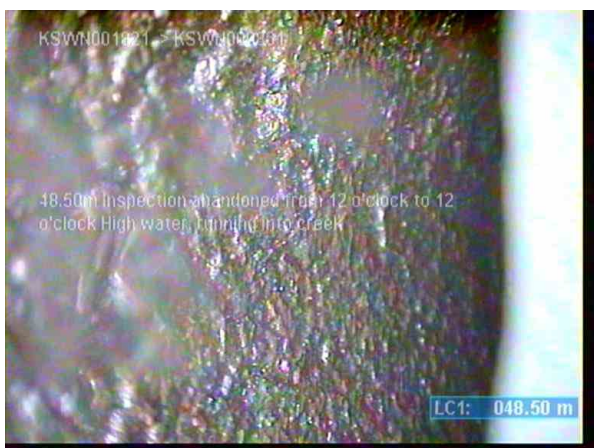
KSWP003815\_c7aa7907-fc96-4a78-b240-7bb6f4c7ad22\_2020701\_140011\_875.jpg, 00:11:27, 48.50m  
Inspection abandoned from 12 o'clock to 12 o'clock / High water, running into creek

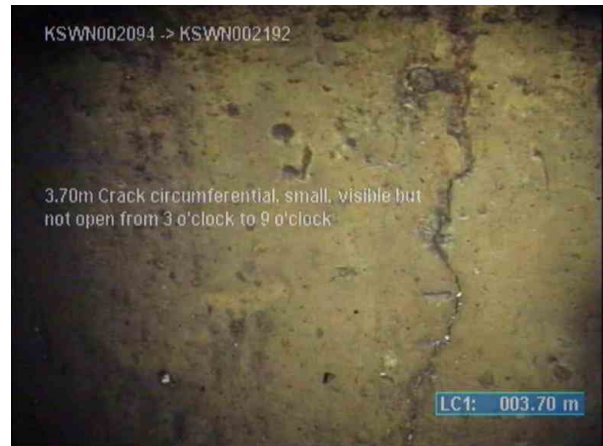
0.00	IS	Inspection start, node reference: KSWN002094	00:00:17	KSWP003 817_224e 464b-ab95				
	3.70	CCS	Crack circumferential, small, visible but not open from 3 o'clock to 9 o'clock	00:01:29	KSWP003 817_0647 5611-4031	2

KSWP003817\_06475611-4031-46c4-9258-8a08b54254d5\_20220812\_112909\_255.jpg, 00:01:29, 3.70m (52.30m)  
Crack circumferential, small, visible but not open from 3 o'clock to 9 o'clock

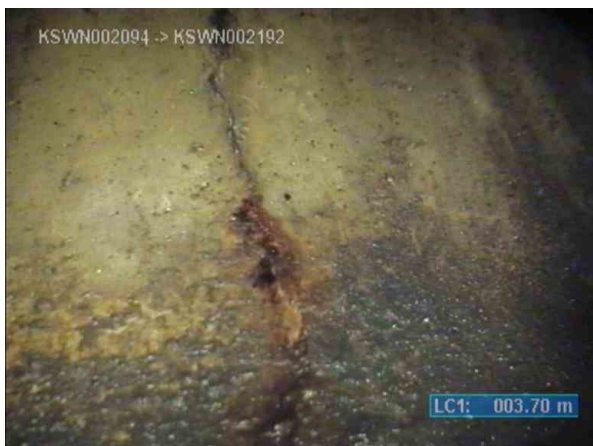
KSWP003817\_62066219-8211-4b68-bca1-bb14b017c30f\_20220812\_112916\_188.jpg, 00:01:29, 3.70m (52.30m)  
Crack circumferential, small, visible but not open from 3 o'clock to 9 o'clock

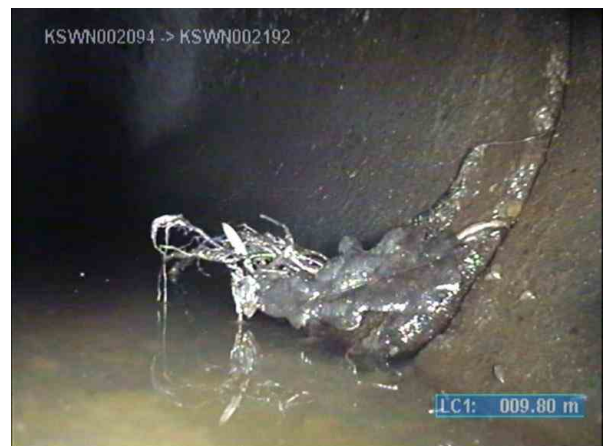
9.80	JFDL	Joint damaged/chipped, large, clearly through the pipe wall from 4 o'clock to 6 o'clock / Roots	00:02:18	KSWP003 817_35b7 8b62-6938	17			
	9.80	RIFS	Fine roots, roots restrict flow by 10% or less of full flow from 4 o'clock to 6 o'clock	00:02:25	KSWP003 817_c21fe 9cd-398c-	3

KSWP003817\_35b78b62-6938-4352-9f91-7300c8ca4902\_20220812\_113006\_929.jpg, 00:02:18, 9.80m (46.20m)  
Joint damaged/chipped, large, clearly through the pipe wall from 4 o'clock to 6 o'clock / Roots

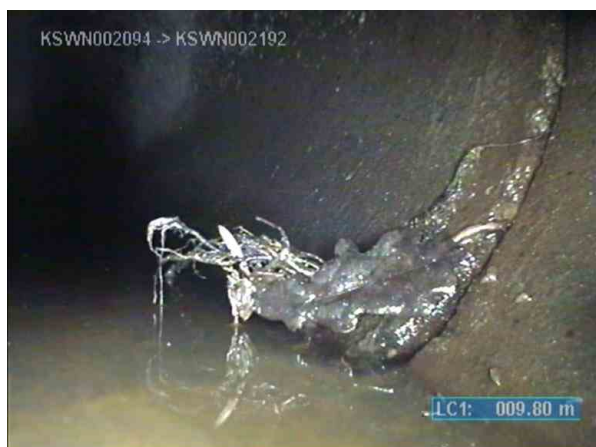
KSWP003817\_c21fe9cd-398c-42ed-b7fb-1d5d78366c5d\_2020812\_113017\_759.jpg, 00:02:25, 9.80m (46.20m)  
Fine roots, roots restrict flow by 10% or less of full flow from 4 o'clock to 6 o'clock

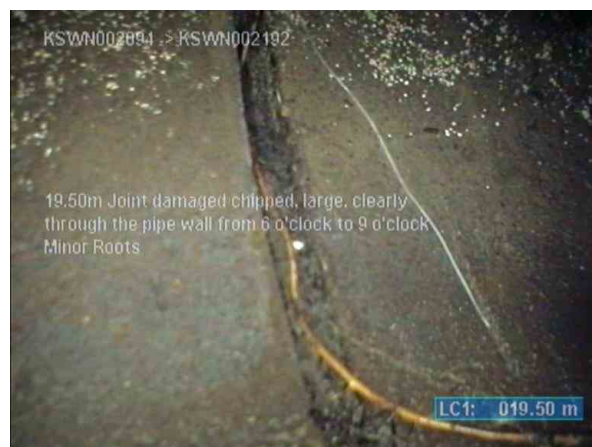
19.50	JFDL	Joint damaged/chipped, large, clearly through the pipe wall from 6 o'clock to 9 o'clock / Minor Roots	00:03:54	KSWP003 817_36c32 fb4-a4dc-4	17

KSWP003817\_36c32fb4-a4dc-41d3-aa9c-aab22b83395a\_2020812\_113157\_910.jpg, 00:03:54, 19.50m (36.50m)  
Joint damaged/chipped, large, clearly through the pipe wall from 6 o'clock to 9 o'clock / Minor Roots

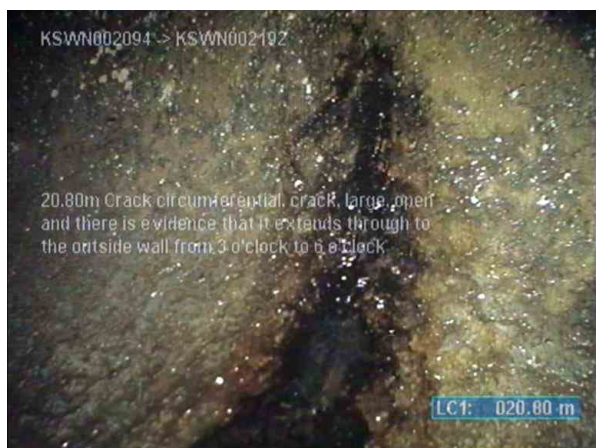
20.80	CCL	Crack circumferential, crack, large, open and there is evidence that it extends through to the outside wall from 3 o'clock to 6 o'clock	00:04:32	KSWP003 817_db4cb f4f-896b-4	12

KSWP003817\_db4cbf4f-896b-4697-8544-55b7a58b3b42\_2020812\_113238\_708.jpg, 00:04:32, 20.80m (35.20m)  
Crack circumferential, crack, large, open and there is evidence that it extends through to the outside wall from 3 o'clock to 6 o'clock

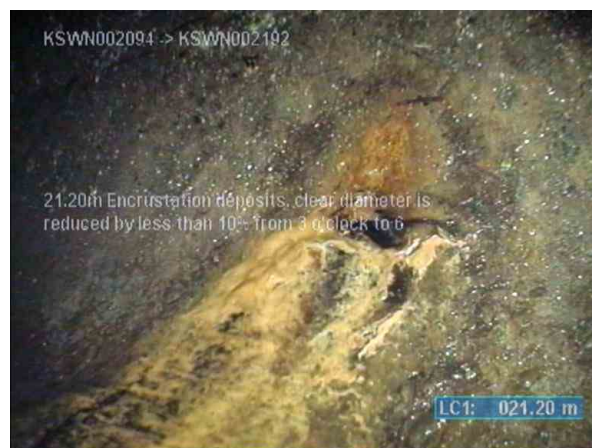
21.20	EDS	Encrustation deposits, clear diameter is reduced by less than 10% from 3 o'clock to 6 o'clock	00:04:55	KSWP003 817_c9bed c18-acc9-4	10			
	21.20	CCL	Crack circumferential, crack, large, open and there is evidence that it extends through to the outside wall from 3 o'clock to 6 o'clock	00:05:04	KSWP003 817_1786 4e24-11e9	12

KSWP003817\_c9bedc18-acc9-4587-be8a-7ff7d5d63b6e\_2020812\_113306\_569.jpg, 00:04:55, 21.20m (34.80m)  
Encrustation deposits, clear diameter is reduced by less than 10% from 3 o'clock to 6 o'clock

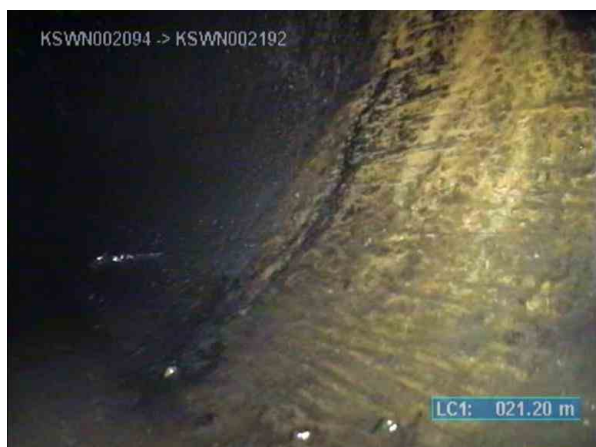
KSWP003817\_0914ca62-fff3-4eec-9a37-9975186a6ff3\_20220812\_113311\_329.jpg, 00:04:55, 21.20m (34.80m)  
Encrustation deposits, clear diameter is reduced by less than 10% from 3 o'clock to 6 o'clock

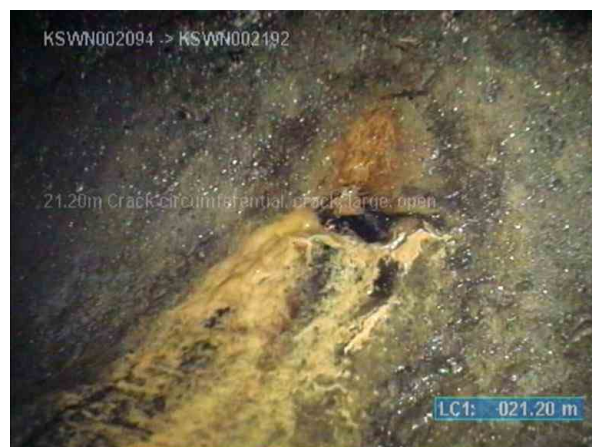
KSWP003817\_17864e24-11e9-4cd5-acf6-a256721788ba\_20220812\_113319\_750.jpg, 00:05:04, 21.20m (34.80m)  
Crack circumferential, crack, large, open and there is evidence that it extends through to the outside wall from 3 o'clock to 6 o'clock

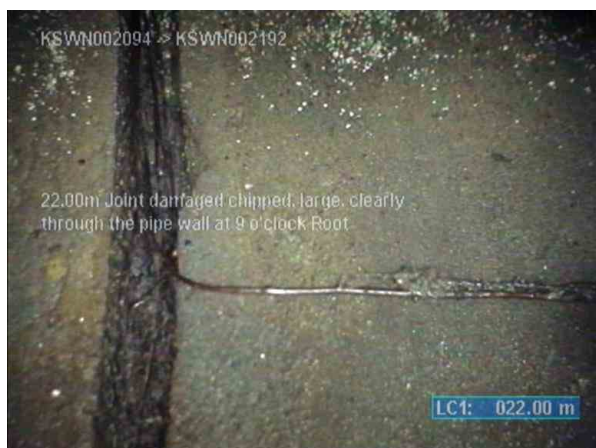
22.00	JFDL	Joint damaged/chipped, large, clearly through the pipe wall at 9 o'clock / Root	00:05:24	KSWP003 817_bf9a6 78e-ebf6-4	17			
	22.00	RIFS	Fine roots, roots restrict flow by 10% or less of full flow at 9 o'clock	00:05:30	KSWP003 817_da90f c7a-621a-	3

KSWP003817\_bf9a678e-ebf6-4e9e-a17c-8ff011637ce3\_20220812\_113348\_222.jpg, 00:05:24, 22.00m (34.00m)  
Joint damaged/chipped, large, clearly through the pipe wall at 9 o'clock / Root

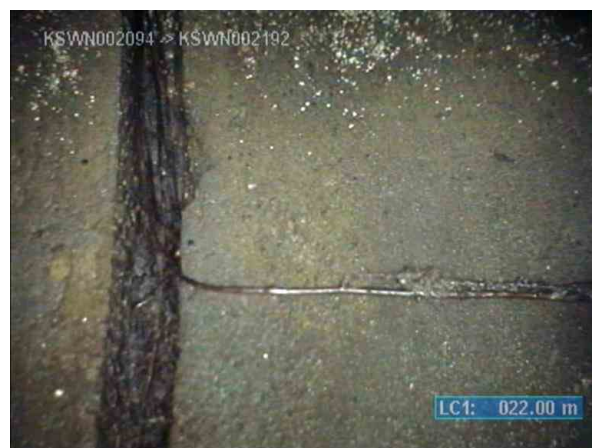
KSWP003817\_da90fc7a-621a-40ac-8dd4-68883b6b4d57\_20220812\_113358\_896.jpg, 00:05:30, 22.00m (34.00m)  
Fine roots, roots restrict flow by 10% or less of full flow at 9 o'clock

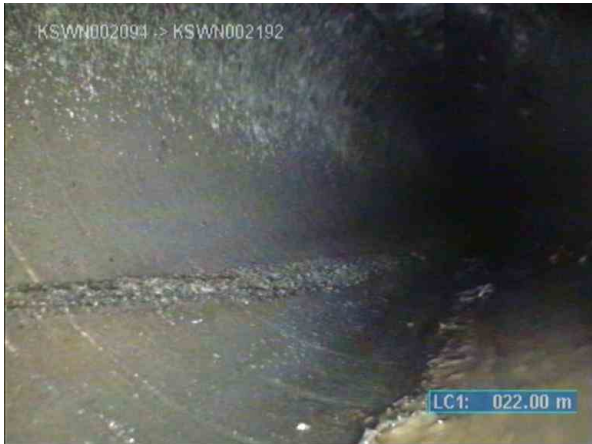
KSWP003817\_af5911e6-1802-49a9-9655-90a61d5d830e\_20220812\_113403\_886.jpg, 00:05:30, 22.00m (34.00m)  
Fine roots, roots restrict flow by 10% or less of full flow at 9 o'clock

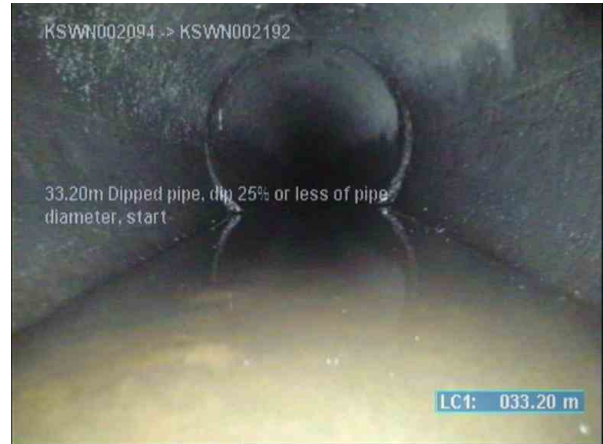
KSWP003817\_c346b211-c8d1-4778-881d-df197c90eed6\_20220812\_113525\_551.jpg, 00:06:53, 33.20m (22.80m)  
Dipped pipe, dip 25% or less of pipe diameter, start

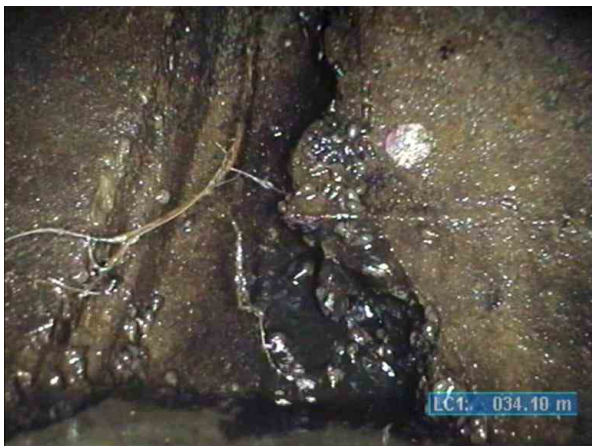
33.20	S01 DPS	Dipped pipe, dip 25% or less of pipe diameter, start	00:06:53	KSWP003 817_c346b 211-c8d1-	1 / 6			
	34.10	JFDL	Joint damaged/chipped, large, clearly through the pipe wall from 3 o'clock to 9 o'clock / Infiltration and broken	00:07:24	KSWP003 817_700b bb4a-d05f-	17

KSWP003817\_700bbb4a-d05f-4d20-bcb1-caed32b5e03b\_20220812\_113613\_212.jpg, 00:07:24, 34.10m (21.90m)  
Joint damaged/chipped, large, clearly through the pipe wall from 3 o'clock to 9 o'clock / Infiltration and broken

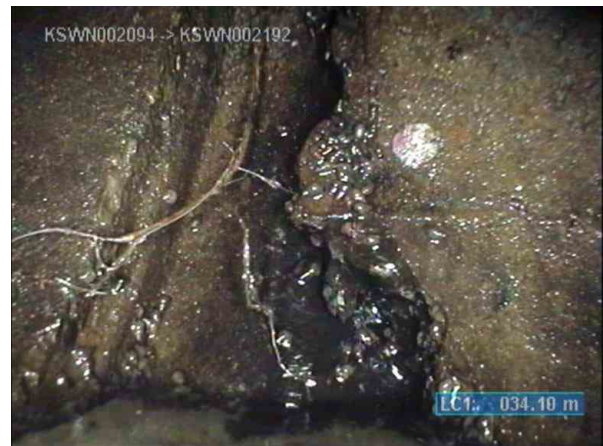
34.10	IPM	Infiltration, running (visibly moving) flow from 3 o'clock to 6 o'clock	00:07:30	KSWP003 817_adfc3 087-874e-	10 / 21			
	34.40	S02 DES	Debris silt, small, clear diameter reduced by less than 10%, start	00:07:47	KSWP003 817_87cce dcd-31e1-	15

KSWP003817\_adfc3087-874e-45aa-86b4-190dc5edbc04\_20220812\_113624\_055.jpg, 00:07:30, 34.10m (21.90m)  
Infiltration, running (visibly moving) flow from 3 o'clock to 6 o'clock

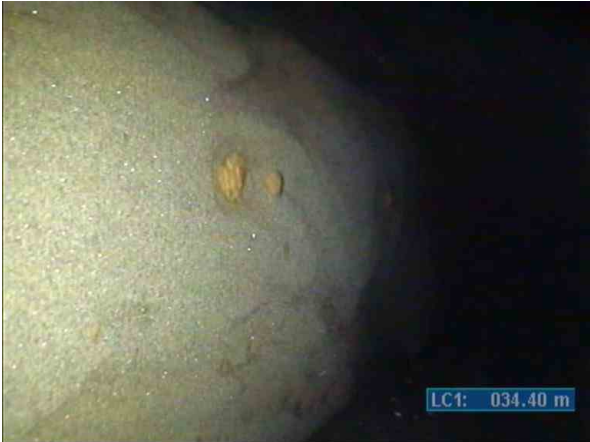
KSWP003817\_87ccedcd-31e1-4b81-b037-d14fae2386ca\_20220812\_113645\_304.jpg, 00:07:47, 34.40m (21.60m)  
Debris silt, small, clear diameter reduced by less than 10%, start

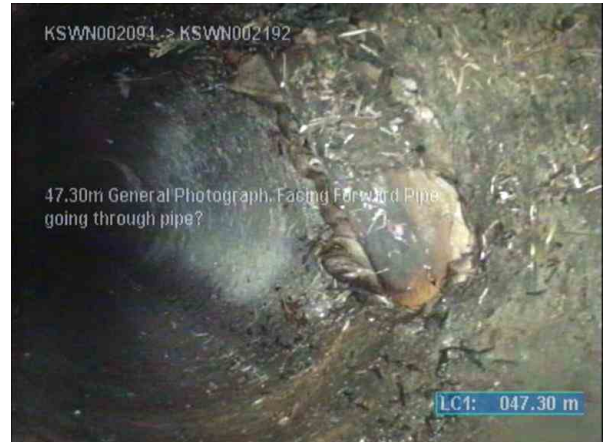
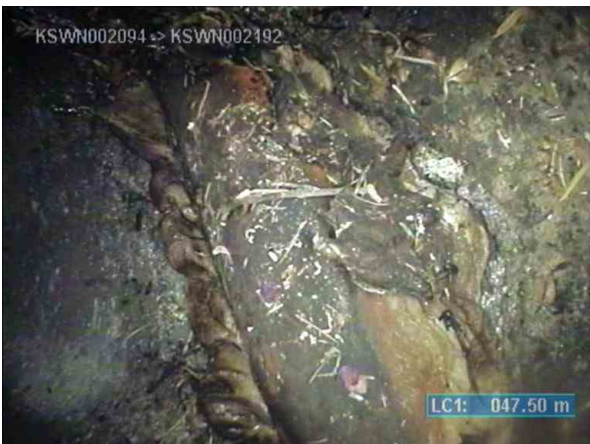
KSWP003817\_571327f2-f20b-48b4-873b-7e7518a073fb\_20220812\_113946\_888.jpg, 00:10:25, 47.30m (8.70m)  
General Photograph, Facing Forward / Pipe going through pipe?

KSWP003817\_7ca395ac-03b1-4232-b42e-49f3617e2889\_20220812\_113954\_174.jpg, 00:10:25, 47.30m (8.70m)  
General Photograph, Facing Forward / Pipe going through pipe?

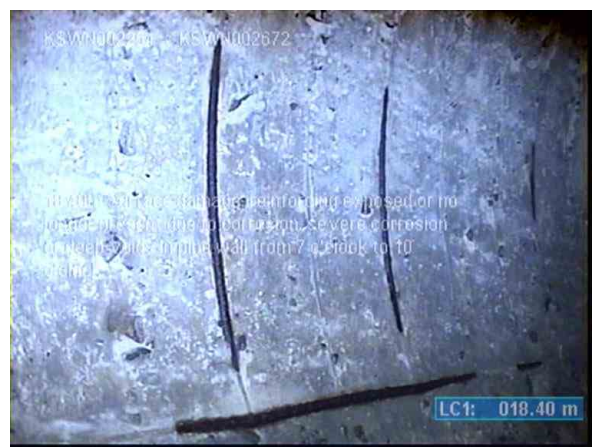
KSWP004512\_0244a32f-c0b6-44dc-be00-d1b417667dd6\_20220711\_125619\_066.jpg, 00:02:44, 18.40m  
Surface damage, reinforcing exposed or no longer present due to corrosion, severe corrosion or deep voids in pipe wall from 7 o'clock to 10 o'clock

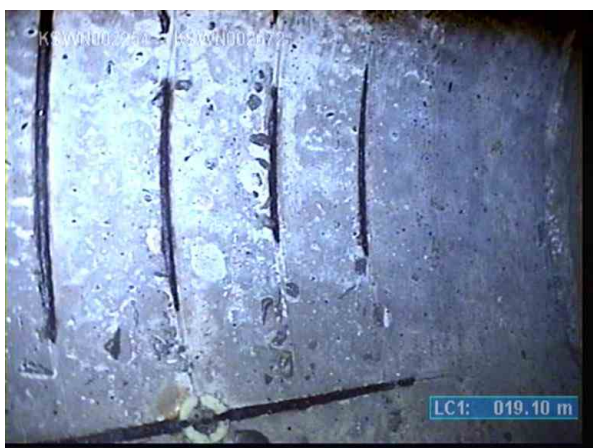
KSWP004512\_060d03ac-41e2-4c53-bf61-835357fe24d4\_20220711\_125640\_322.jpg, 00:03:03, 19.10m  
Surface damage, reinforcing exposed or no longer present due to corrosion, severe corrosion or deep voids in pipe wall from 7 o'clock to 10 o'clock

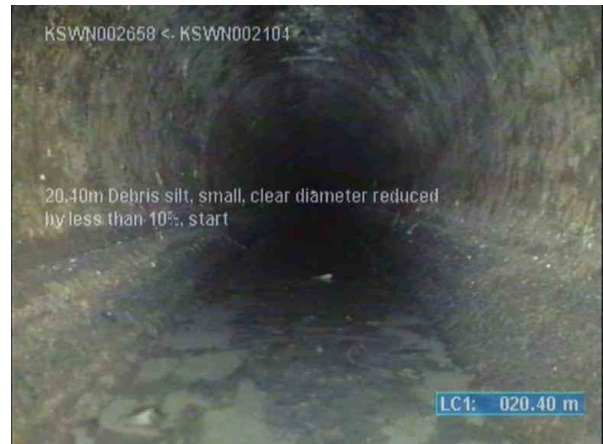
KSWP004528\_3ffb6422-f8c1-4fb4-8ea1-b66669cf51d5\_2020809\_112312\_556.jpg, 00:04:14, 20.40m (28.30m)  
Debris silt, small, clear diameter reduced by less than 10%, start

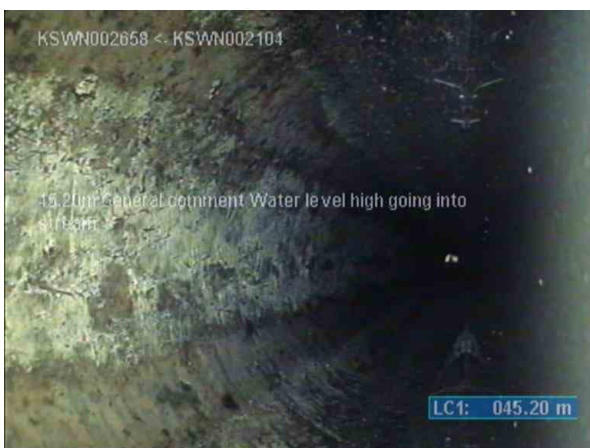
KSWP004528\_519b205c-9559-4adf-97c9-13e5ab0f0c8c\_2020809\_112722\_172.jpg, 00:08:11, 45.20m (3.50m)  
General comment / Water level high going into stream
