13. WAIKANAE SKATEPARK

WAIKANAĒ SKATEPARK

OVERVIEW

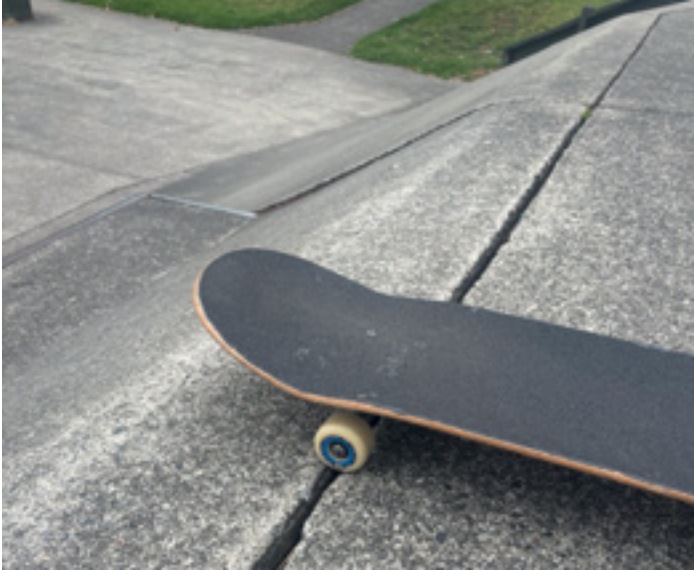
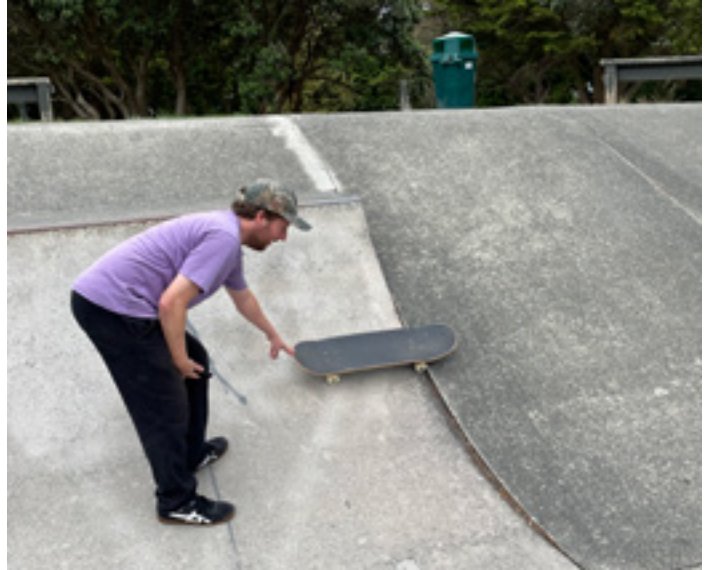
01. GAPS IN JOINTS AND SAW CUTS:

Construction joints within the skatepark are extremely poor quality and are widening, chipping and cracking due to differential settlement. Wide joints, and saw cuts create a hazard for small scooter and skateboard riders as their wheels can become trapped causing the rider to fall unexpectedly creating a safety hazard. Further, wide joints are at risk of widening further and creating holes within the concrete surface.

RISK RATING: HIGH

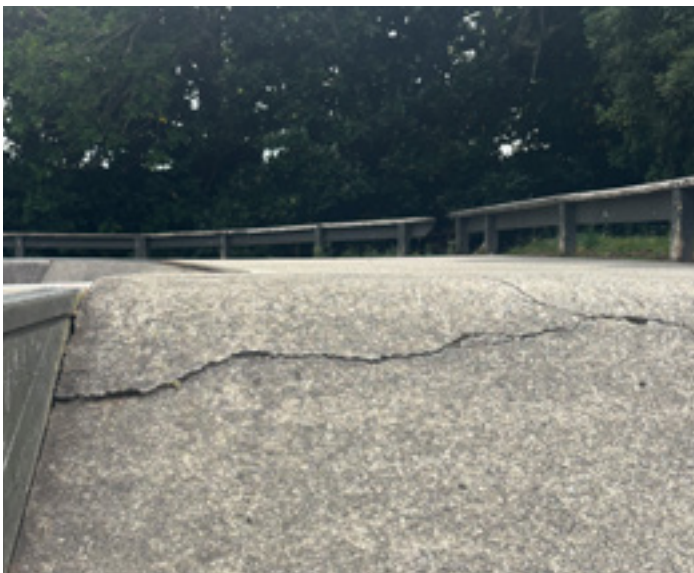
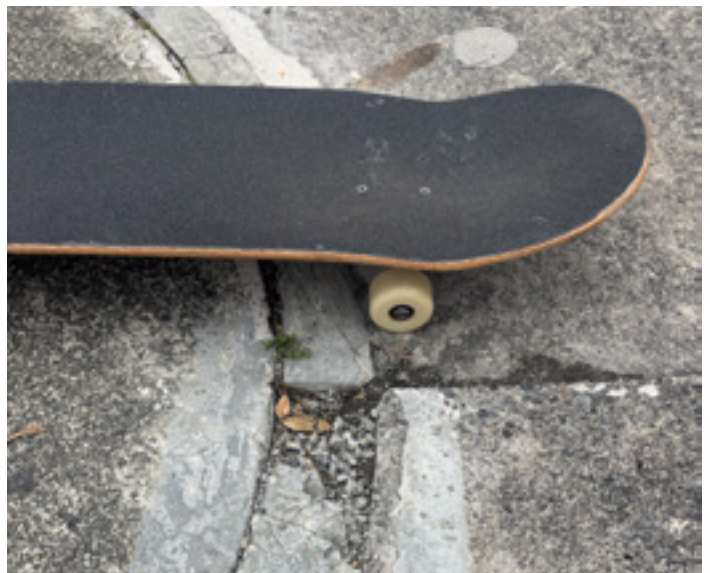
02. CHIPPING + CRACKING:

Large chips and cracks have formed along many concrete joints and throughout the surface of the park. These chipped areas are hazardous to riders as they can catch small wheels causing users to fall creating a safety hazard, some of these chips are extremely unsafe due to locations at high speed critical flow points and large size of features.

RISK RATING: HIGH

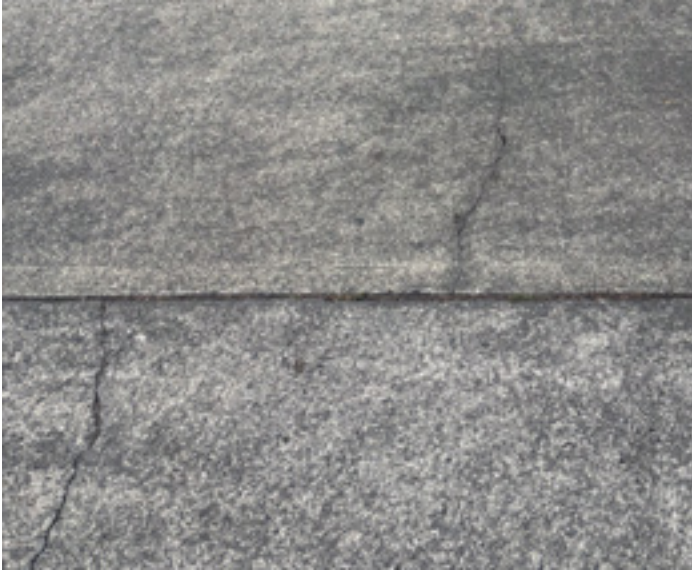
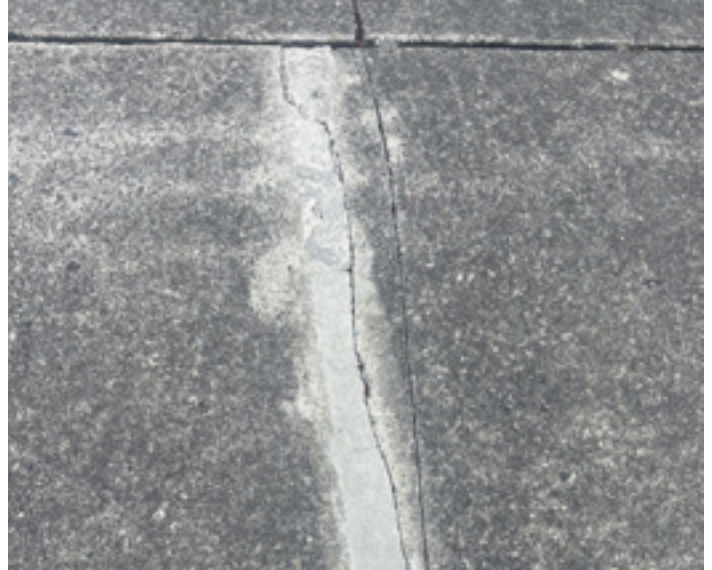
03. FINE CRACKING:

Hairline cracking is evident through sections of the skatepark. Cracks like these currently pose a low risk, however if left unattended can turn into larger cracks and increase the chance of concrete chipping posing a higher risk to riders.

RISK RATING: LOW

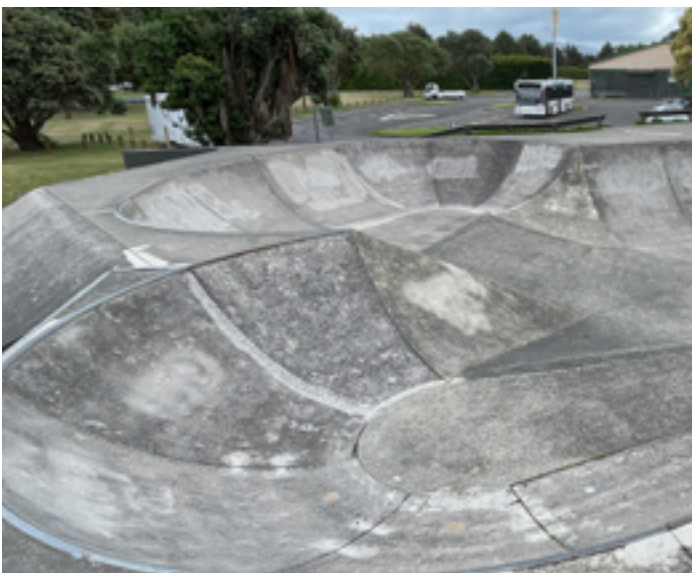
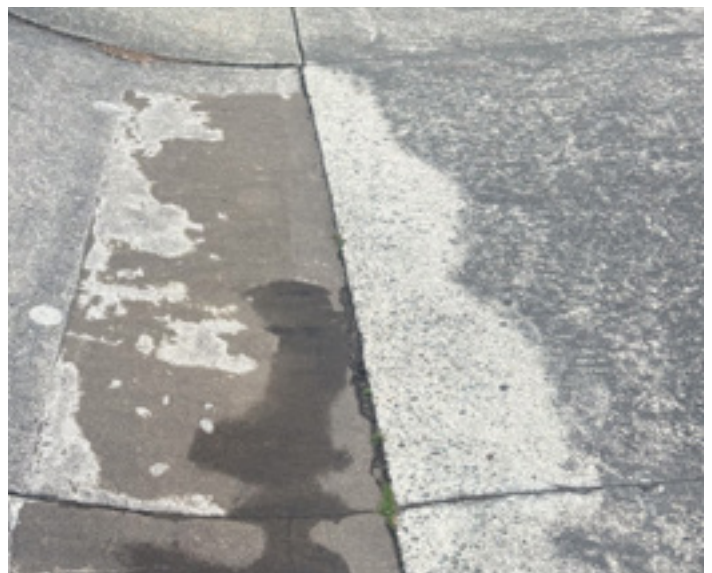
04. ROUGH SURFACE FINISH / DIFFERENTIAL SETTLEMENT:

The surface of the concrete is extremely degraded and rough due to age and weathering. It is evident there have been attempts to grind back differential settlement in some areas and applied surfaces and patching in other areas to remedy poor surface quality. This rough surface can become a safety hazard when it is no longer smooth or functional / is rough + painful to fall on, making it susceptible to injury.

RISK RATING: HIGH

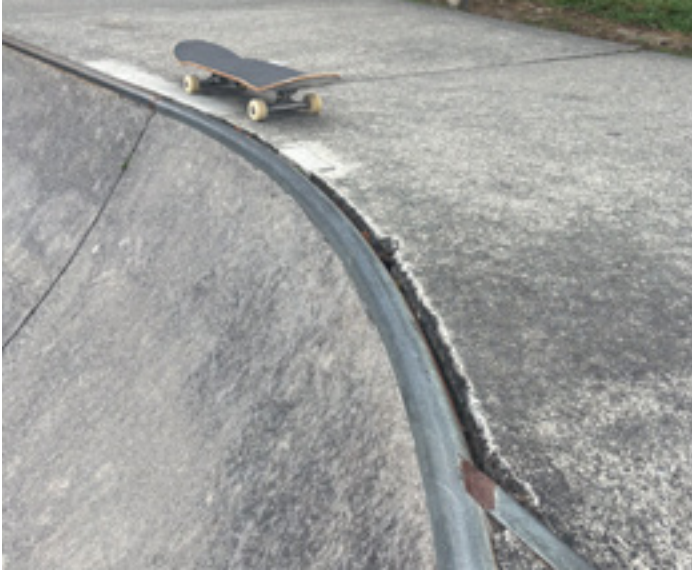
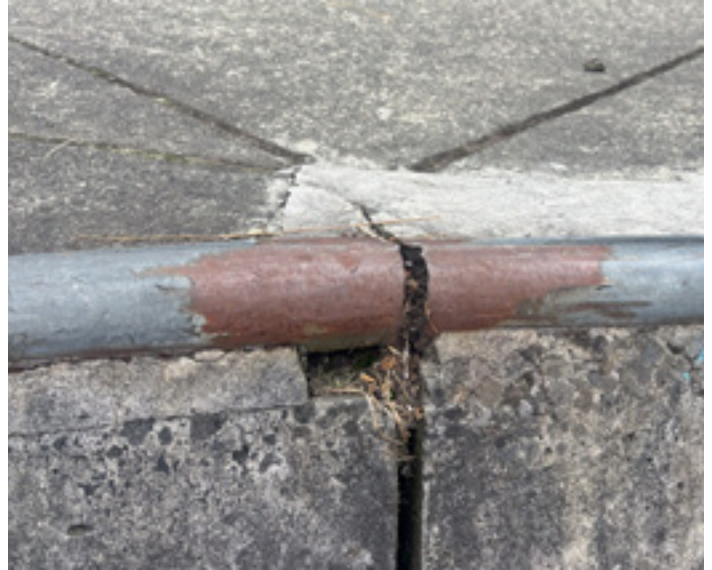
05. COPING CRACKS + CHIPS:

Chipping and cracking is occurring behind and under CHS coping in certain areas throughout the park. This is a safety issue catching trucks and small wheels at a high speed locations in the park.

RISK RATING: HIGH

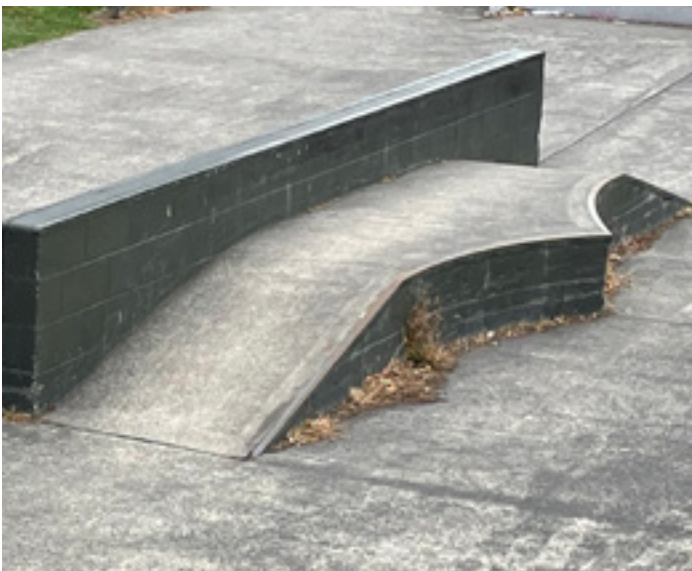
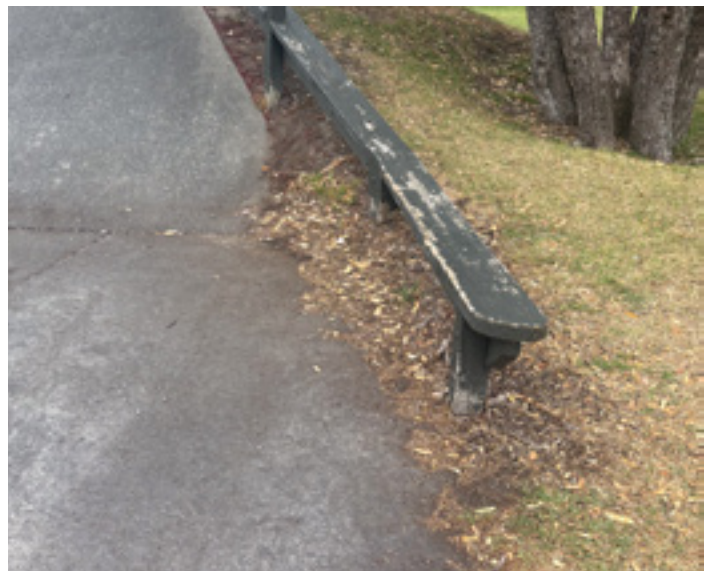
06. LEAF LITTER AND LANDSCAPE DEBRIS:

Leaf litter and landscape debris is gathering on skate surfaces. This can cause a safety hazards where small wheels can get caught creating 'wheel bite'. Regular maintenance will limit the issue.

RISK RATING: LOW

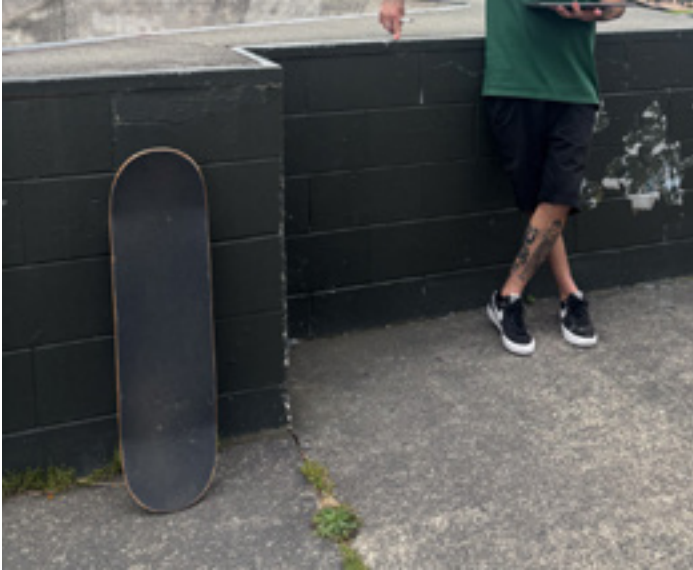
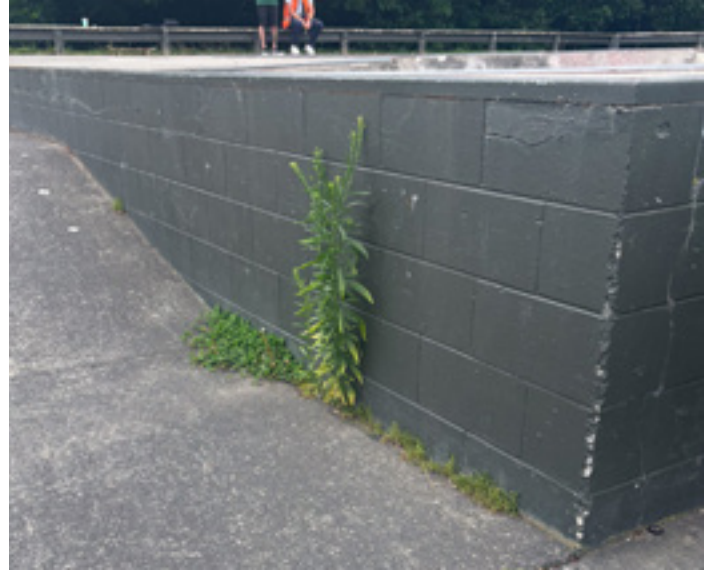
07. FALL HEIGHTS:

There are locations within the facility that have non compliant fall heights exceeding landscape safety standards over 900mm with no balustrades where people can fall onto hard surfaces causing injury.

RISK RATING: HIGH
