WATERFALL ROAD SLIP

Job No: 85767.002

Waterfall Road 2017 Landslip Geotechnical Hazard and Risk Assessment

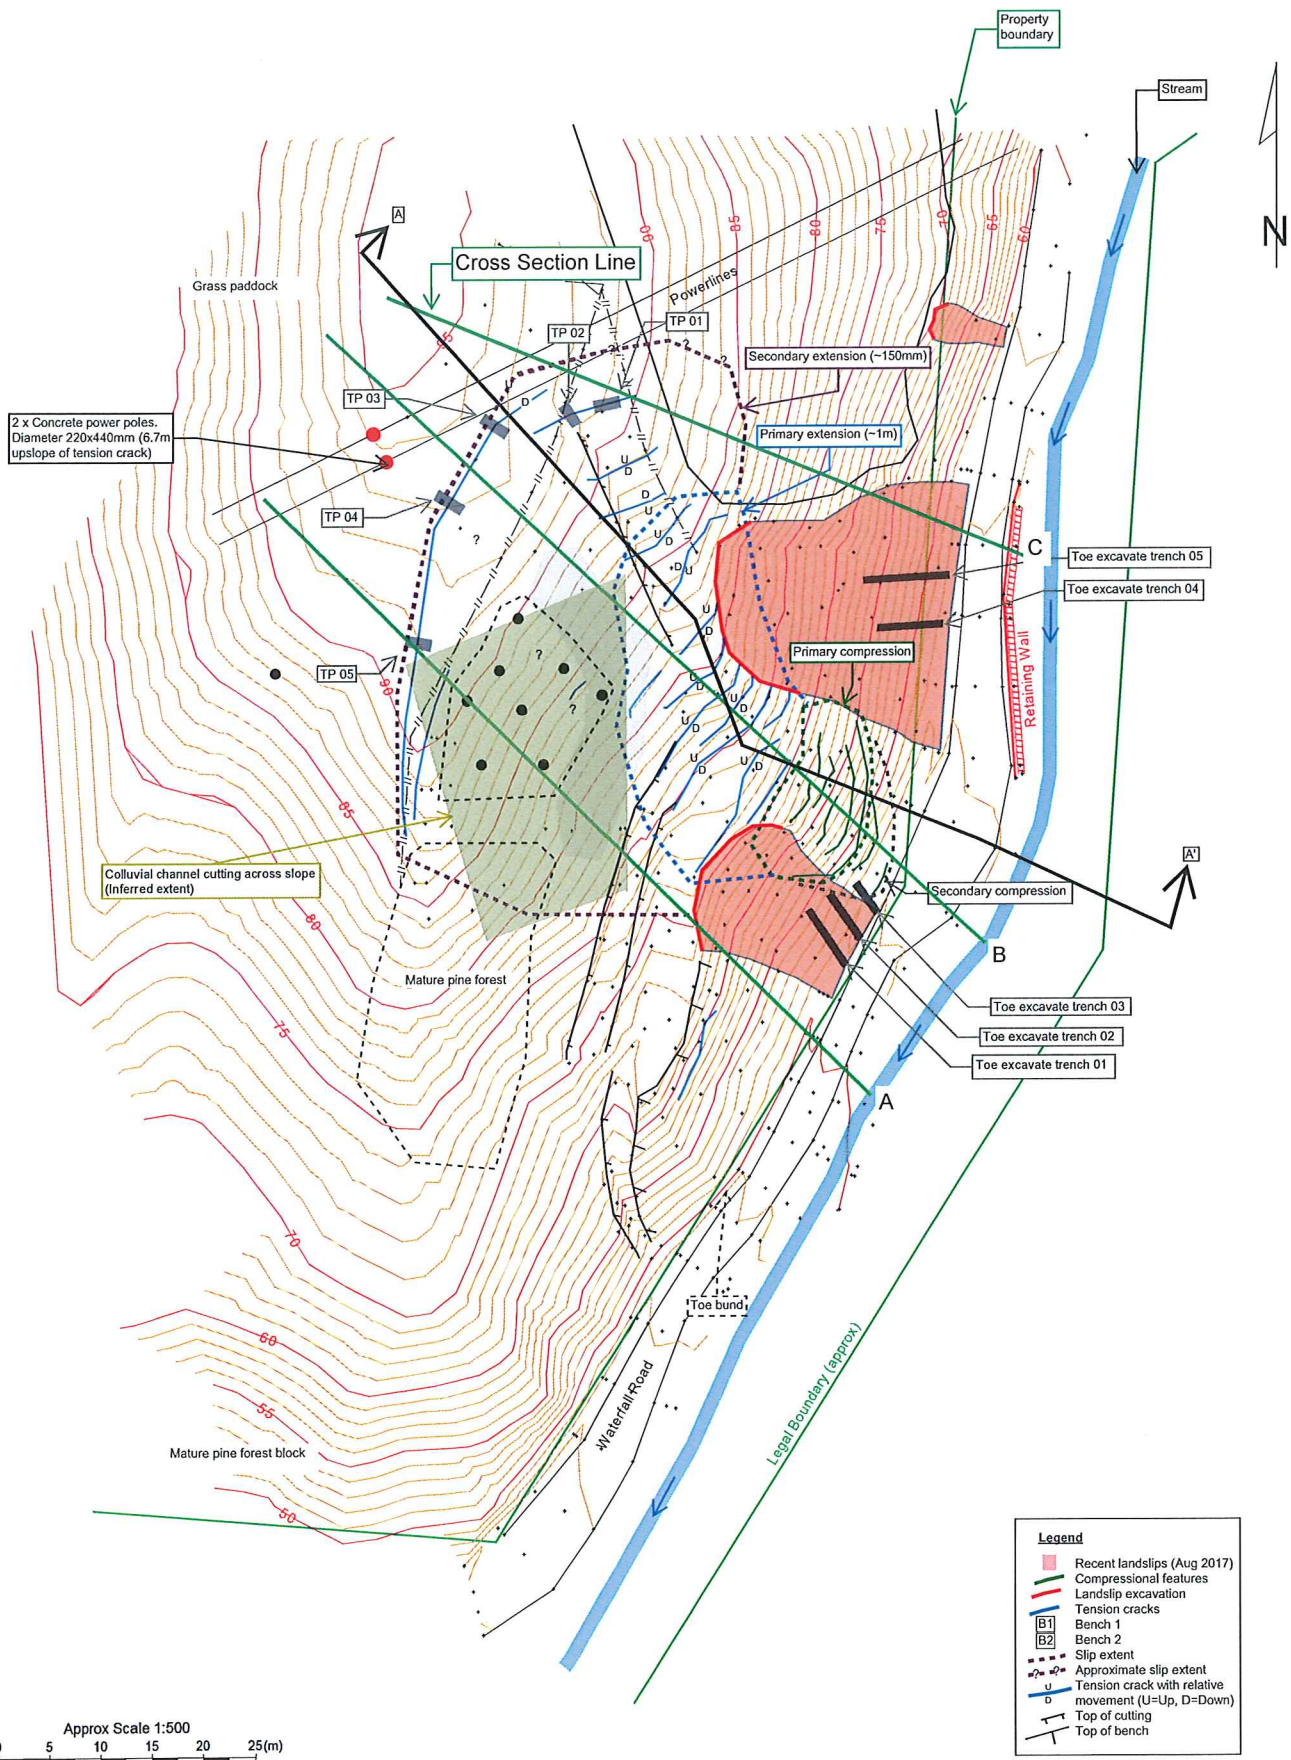
The locations of the investigations, and geometry of the landslip, are presented on Figure 1. A cross section presenting the inferred geology and structural features of the landslip is presented on Figure 2. The alignment of the cross section A to A' is labelled on Figure 1.

Figure 1 presents the general overview of the site and identifies two key assets located within the immediate area of the landslip. The first asset is Waterfall Road, located at the toe of the slope. The second asset is a pair of power poles, located upslope of the landslip at the top of the slope. We understand power poles are owned by Electra Energy Ltd. (Electra).

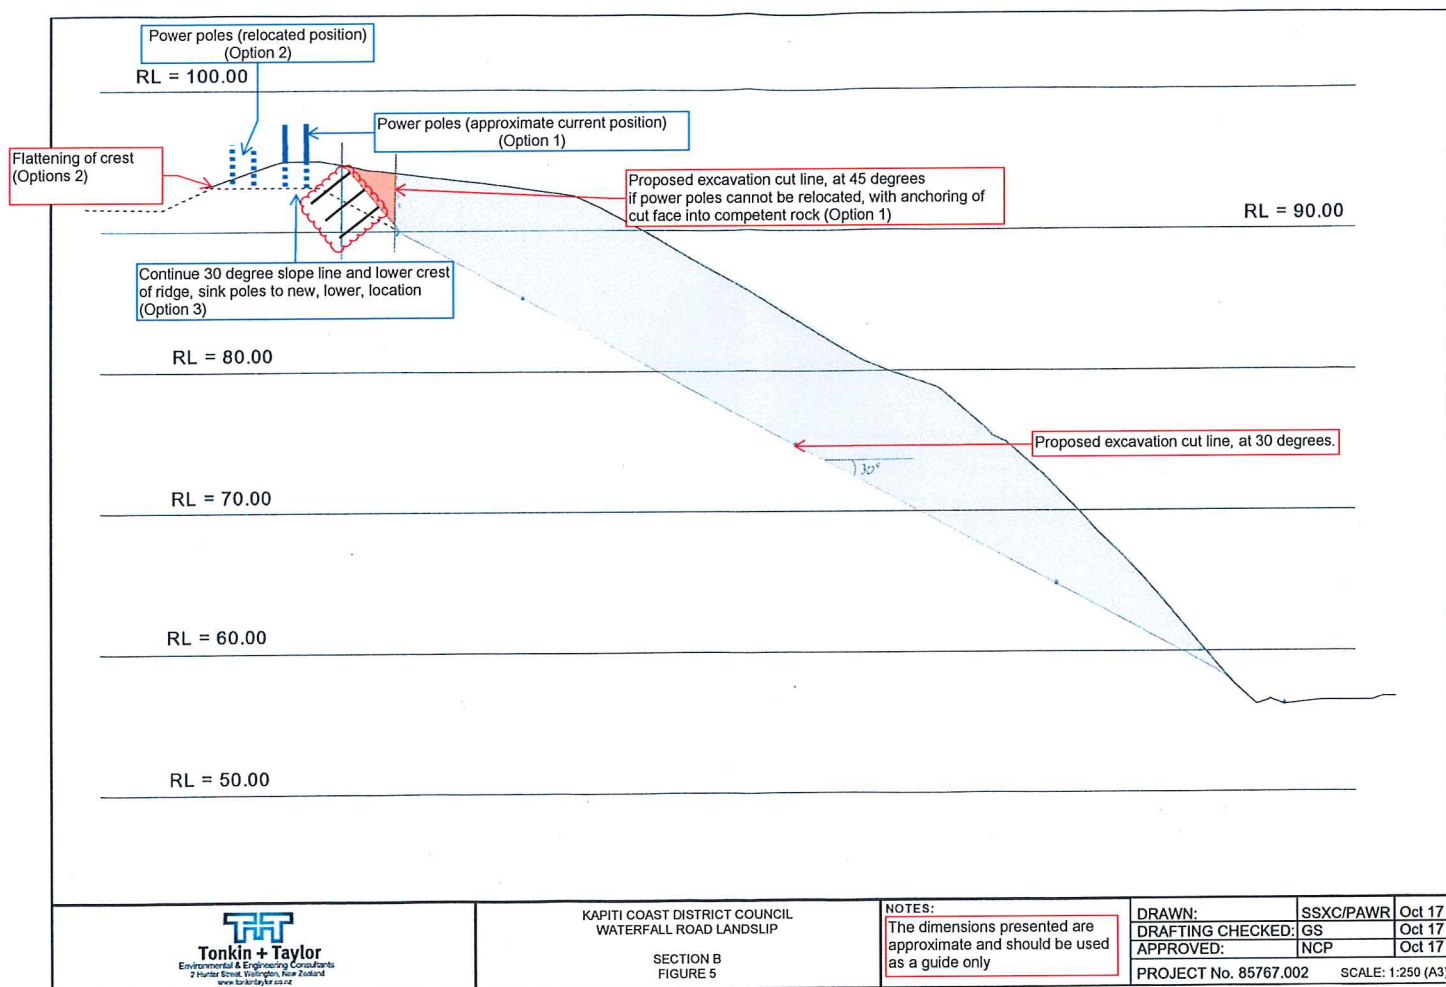
The proposed cut model assumes the power poles remaining in-situ and, a 4m high batter slope at 1H:1V (45° angle) will be required at the crest of the cut, leaving approximately 2.7m between the crest of the cut and the nearest pole. This is likely to cause stability issues for the power pole foundations.

- 1 Anchoring the foundation material located around the base of the power pole. This would involve an approximately 8 to 10m long section of slope with the anchors and sprayed shotcrete. This option is shown on Figure 5 as the 1:1 slope labeled in red;
- 2 Relocate the power poles along the ridge the north and onto stable ground, approximately 20m towards the north-north-west. This location is considered to be a suitable distance away from the landslip. A suitable location to relocate the poles is shown on Figure 7;
- 3 Lower the ridge by 4 to 5m, and lower the power pole to this new elevation. The resolution of the power poles issue will be required prior to earth works commencing and it is understood that KCDC are in discussions with Electra about the preferred relocation works.

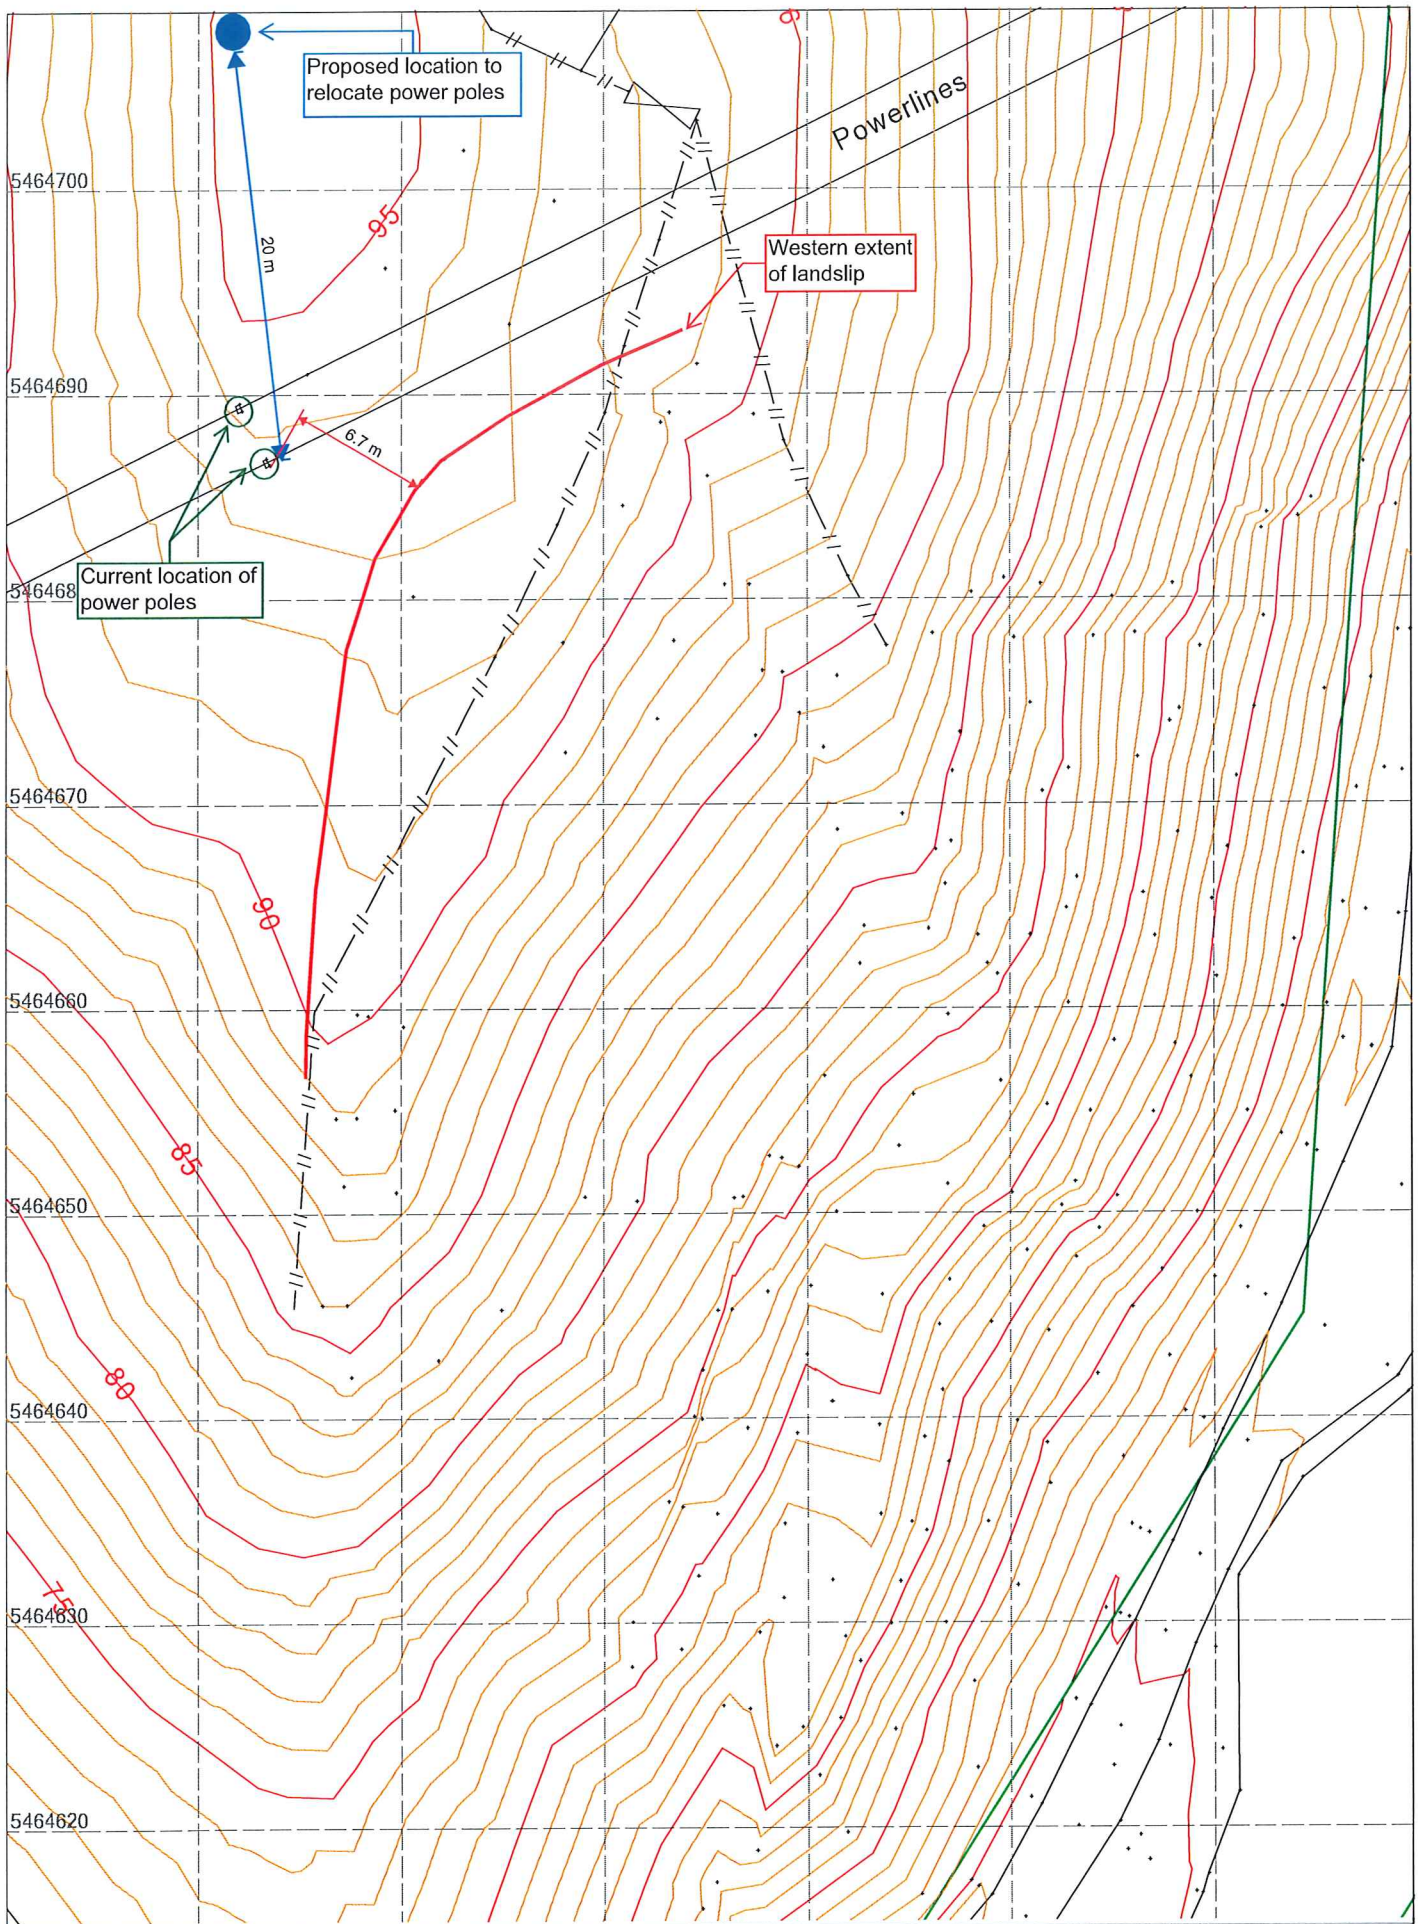
KAPITI COAST DISTRICT COUNCIL
WATERFALL ROAD LANDSLIP
PROPOSED POWER POLE RELOCATION
FIGURE 7

The level of risk to the power poles associated with containing slip movement range from no land damage, through to undermining and collapse of the power poles. It cannot be ruled out that the tension cracks identified during previous investigations will continue to move upslope and beyond the power poles. Such extension is likely to result in instability of the power pole foundation.

We recommend KCDC and Electra work through options to relocate or lower the power poles (Options 2 or 3, respectively), and we can assist if required. These options are considered lower cost, less time consuming and lower risk. Earthworks for the re-profiling of the slope can proceed and no slope specialist slope stabilisation work (i.e. anchors and shotcrete) would be required.
