# **Building Condition Report**

# Address: Otaki Theatre, Otaki

Date: 27 March 2020

Project Number: 200057

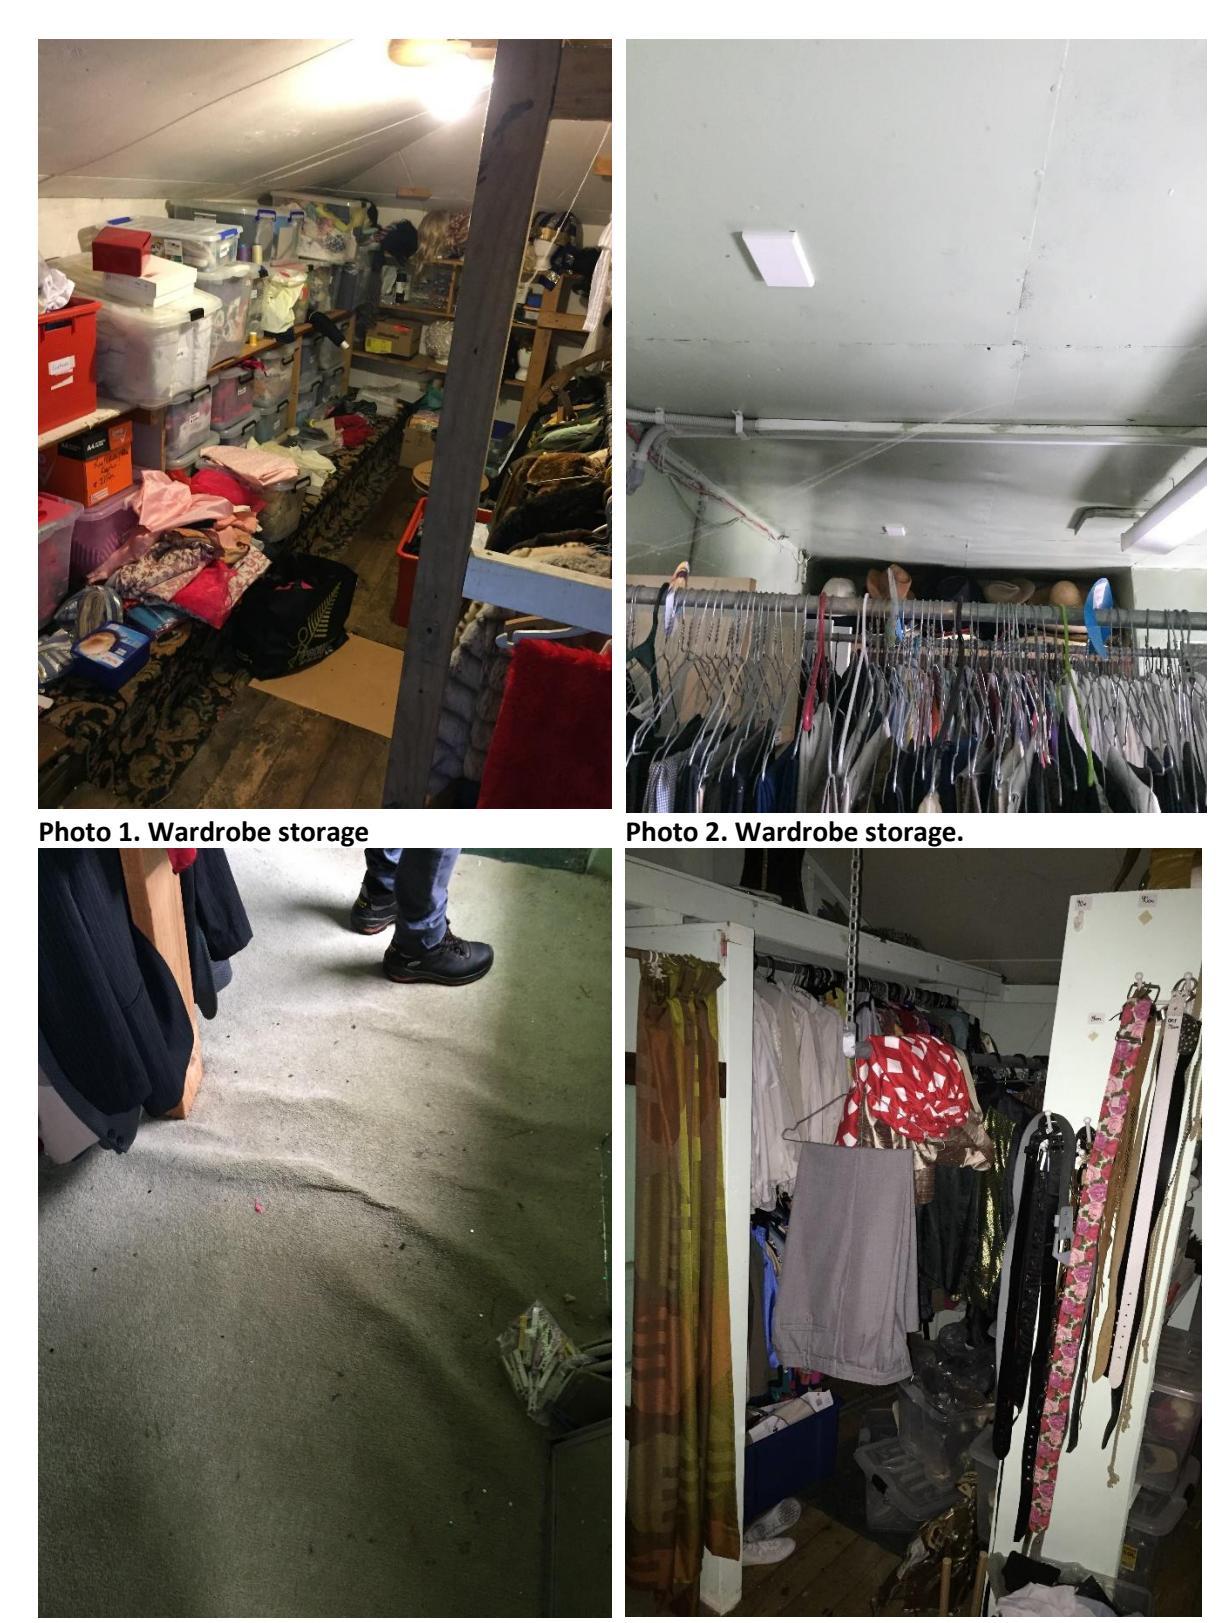
Photo 3. Carpet in wardrobe storage

Photo 4. Wardrobe storage

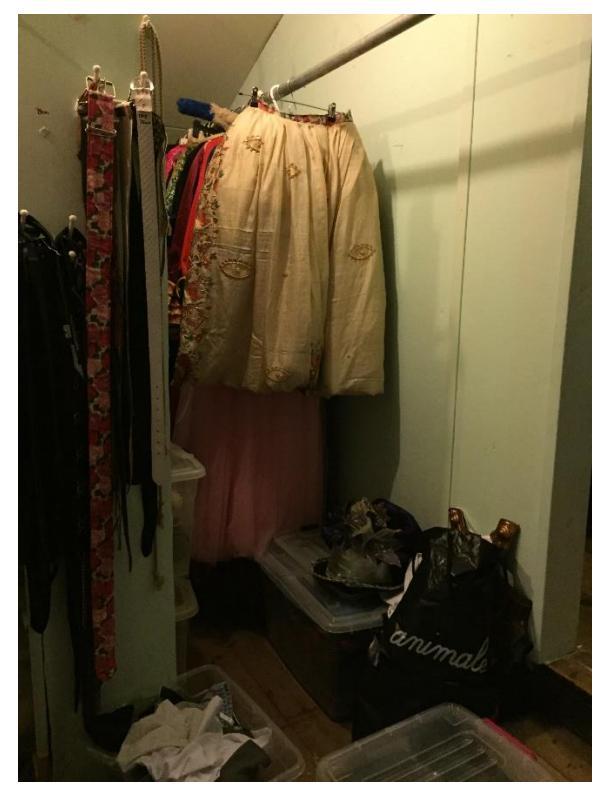
Photo 5. Wardrobe storage.

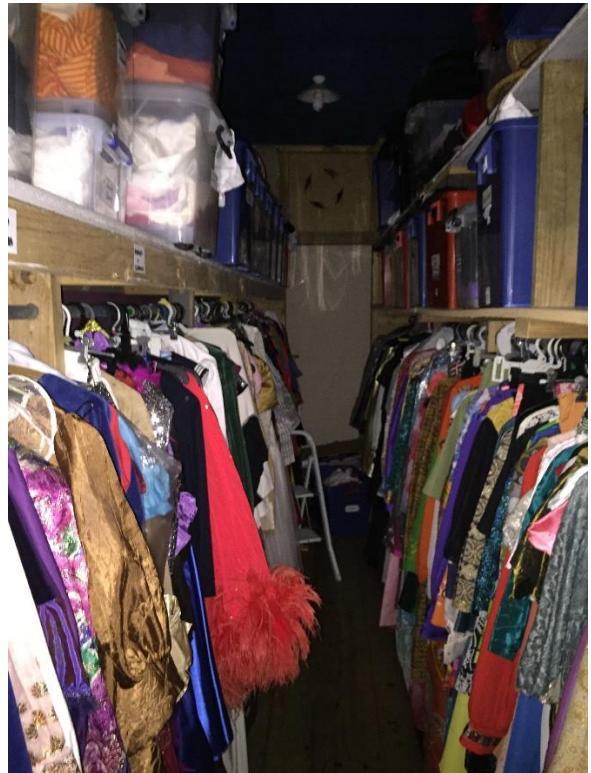
Photo 6. Wardrobe storage.

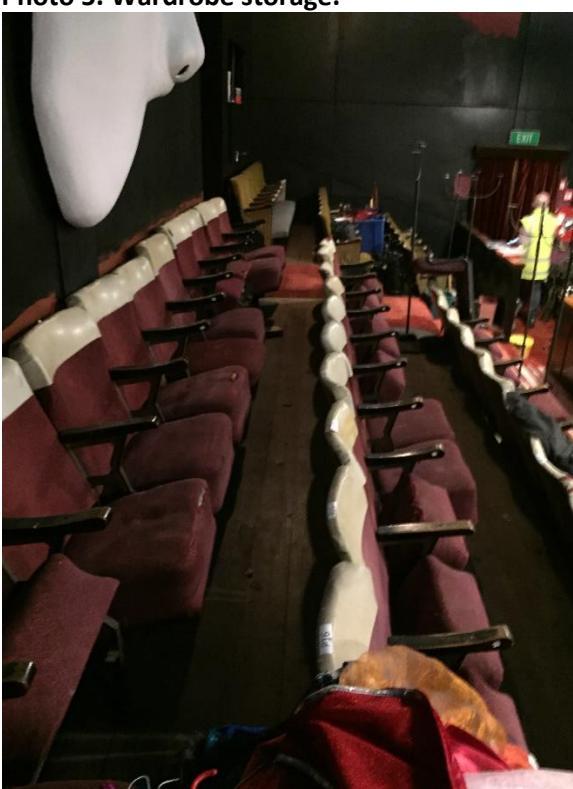
Photo 7. Old seating in upper auditorium. All Photo 8. Entrance lobby is in poor condition. other seating has been replaced. More seating held in storage to replace old seats.

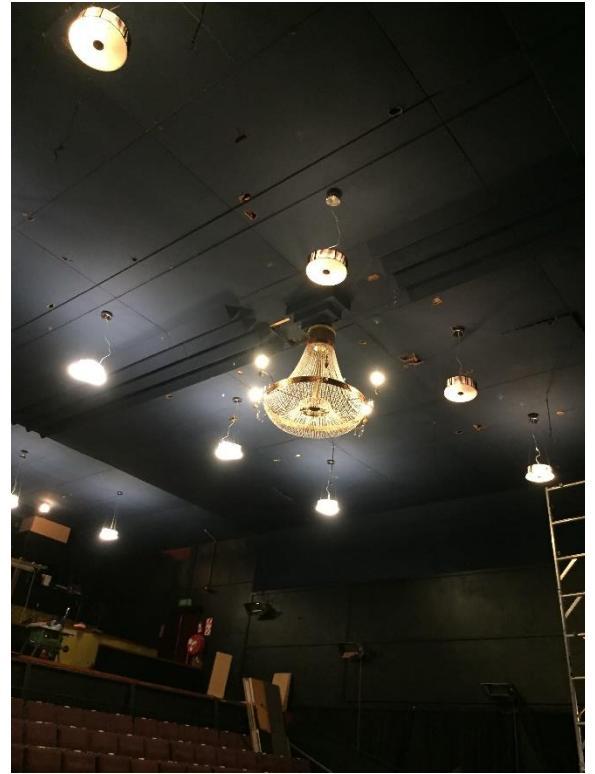
The carpet is worn on the stairs and areas of the floor are bare boards. The ceiling is a continuation of the main auditorium so also has holes and dislodged soft board sheets. There is a mixture of old and new seating. The old seating is in poor condition with holes and rips in many of the seats (The Otaki Plyers have spare seating to be installed but they may not have enough to replace all).

Photo 9. Ceiling has holes and dislodged sheets. Access to repair will be difficult due to height and tiered seating.

- Remove and replace or repair damaged sections of carpet.
- Either sand, repair and polyurethane the exposed floor or lay carpet throughout.
- Replace damaged seating.
- Refix, repair and replace loose and damaged soft board sheets on the ceiling.
- Repaint entire ceiling.

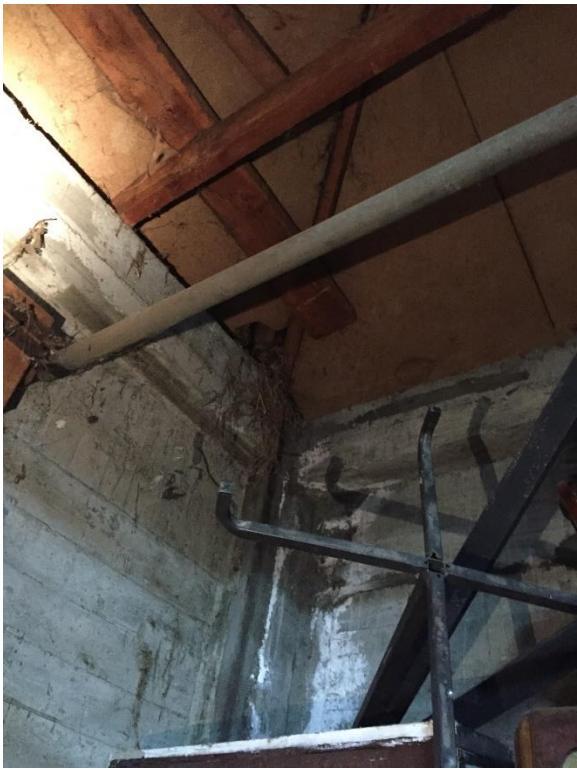
The original spouting is copper. Some sections have been replaced by PVC. The junction between the two dissimilar system on the right rear of the building leaks and discharges down the wall. There is evidence of moisture intrusion inside the building that potentially originates from this junction.

Photo 10. Moisture ingress from leaking spouting on NE corner of building.

- All down pipes be linked into the storm water system.
- The junction between the dis similar spouting systems be modified to eliminate the leaks.
- The gully traps be cleared of debris.
- The bathrooms be refurbished and new fittings and fixtures installed.

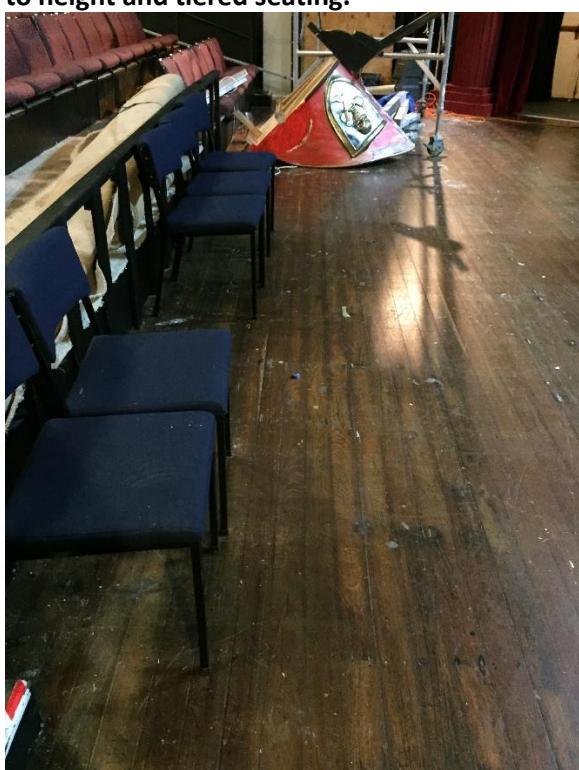
The timber flooring is in good condition however the polyurethane is in poor condition with excessive wear, marks and chips.

Photo 11. Floor in lower auditorium. Sand and re finish.

- Repaint entire ceiling
- Sand, repair and polyurethane floor.

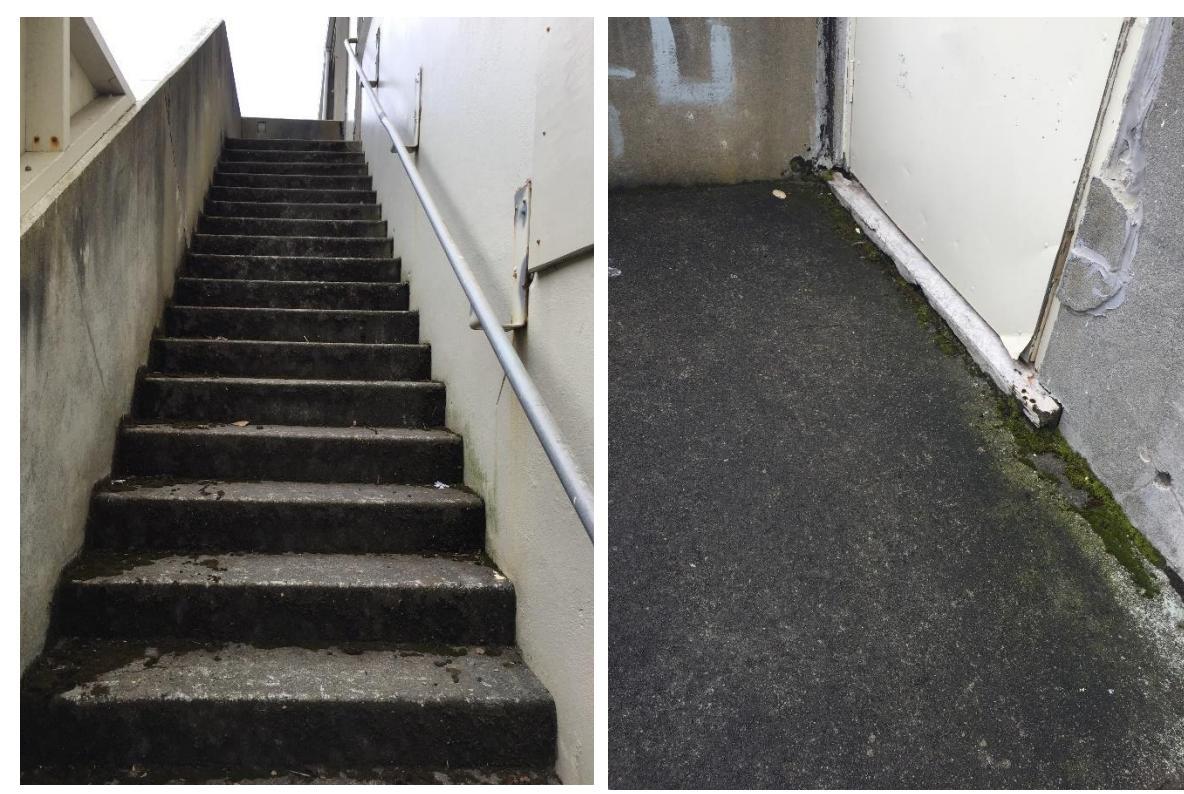
- The concrete stairs are dirty and a potential slip hazard. The stairs need to be cleaned and a non slip surface applied.
- Concrete is spalling and exposing the reinforcing steel. It is recommended that the steel be treated

Photo 13. Fire escape stairs. Clean and etch for slip resistance.

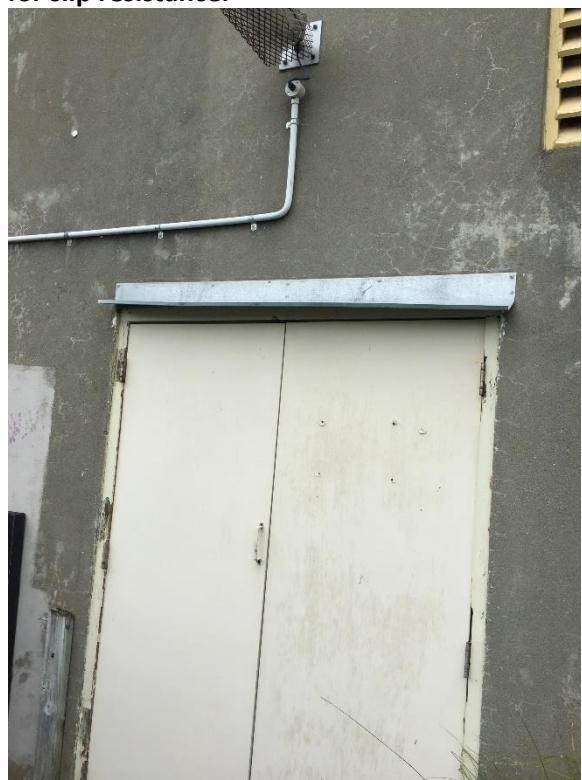
- The louvre above the ground floor fire escape door is rotten. Replacement is recommended.
- The ground floor fire escape doors have been successively repaired over the years and should be considered for replacement with a weathertight pair of doors.

Photo 15. Fire escape doors from lower auditorium. Multiple repairs. Recommend replace with weather tight doors.

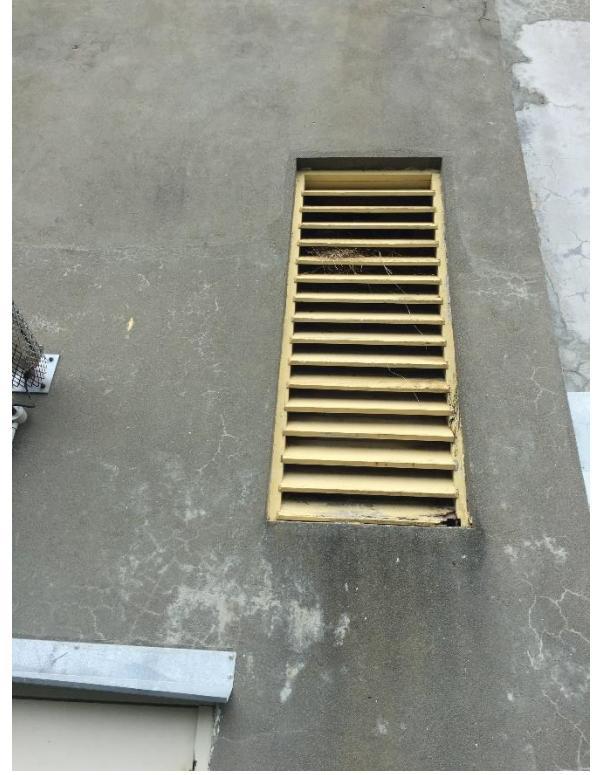
Photo 16. Rotten louvres on West wall. Replace.

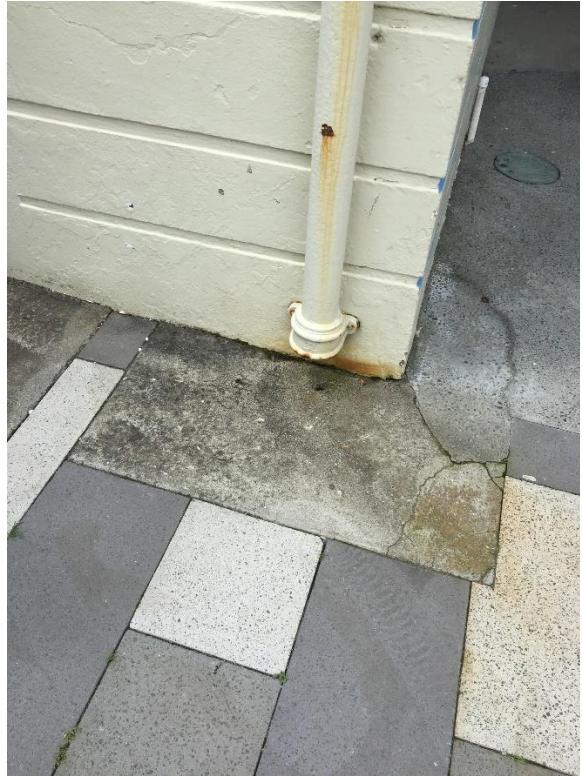
Photo 17. Down pipe from butynol roof discharges on to footpath.

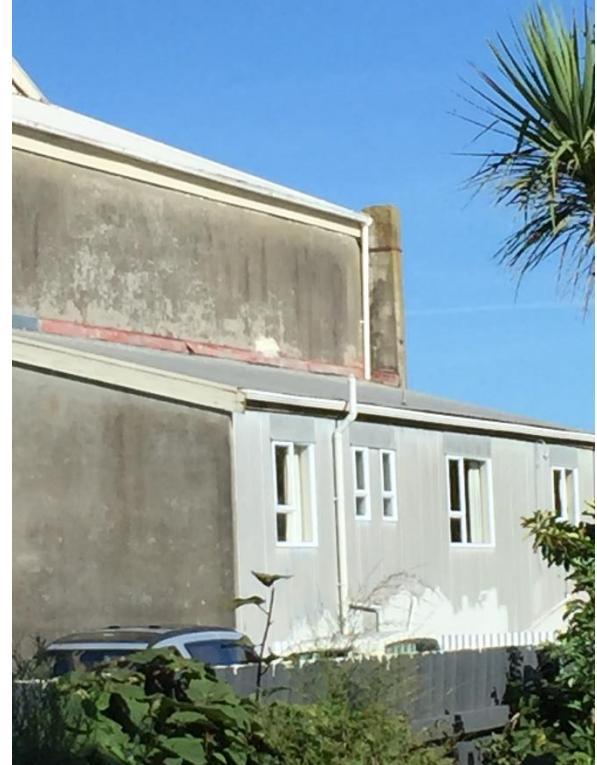
Photo 18.Dislodged flashing over lean to extension.

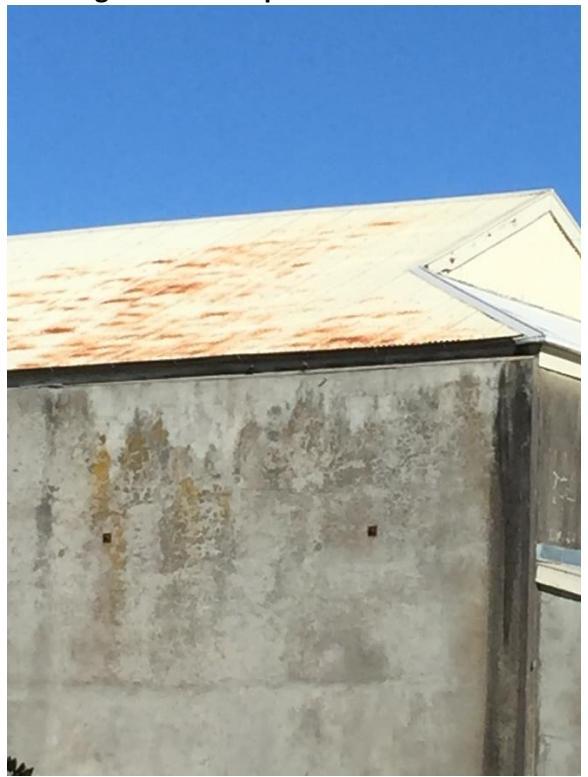
- The main roof and has extensive rust and a history of leaks.
- There are internal gutters on the Southern end of the main roof that could not be accessed or inspected. Internal gutters are considered high risk and must be regularly cleaned.
- The butynol roof is in poor condition with numerous patches having been applied.
- The internal scuppers on the butynol roof are blocked.
- The tie rods supporting the veranda are rusting and require repair/remediation.
- The barge boards on the gable ends of the main roof have areas of rot.
- The corrugated iron roof over the "lean to" is in good condition however the apron flashings between the main building and the roof have dislodged and have the potential to leak.

The main roof is generally in poor condition and in need of repair or replacement. The barges on the gables are rotting and should be replaced. Although the internal gutters have not be inspected as they could not be accessed it is very likely that they will be in poor condition as they have not been regularly maintained. To repair and paint the main roof requires the entire area to be scaffolded. Scaffolding will be a significant cost and considering the life of the roof will not be significantly extended by painting only it is recommended that the main roof be removed and replaced.

Photo 19. Rusting roof.

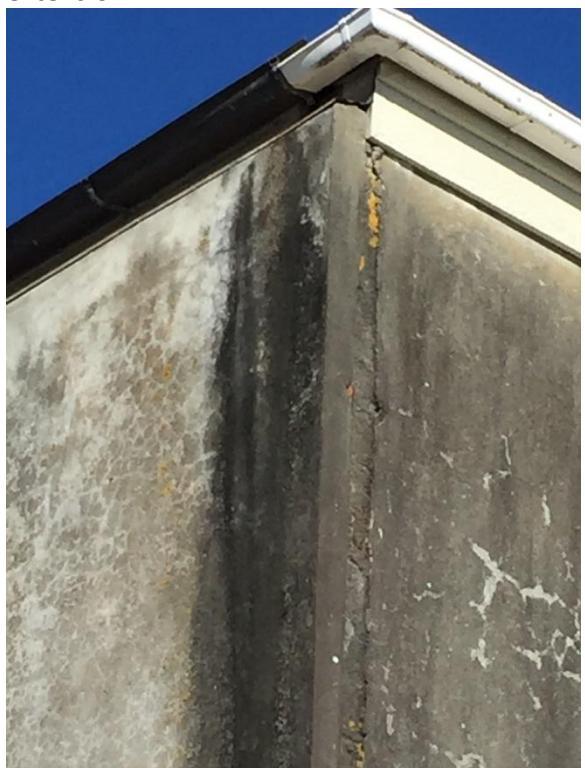
Photo 20. Leaking spouting on right rear corner.

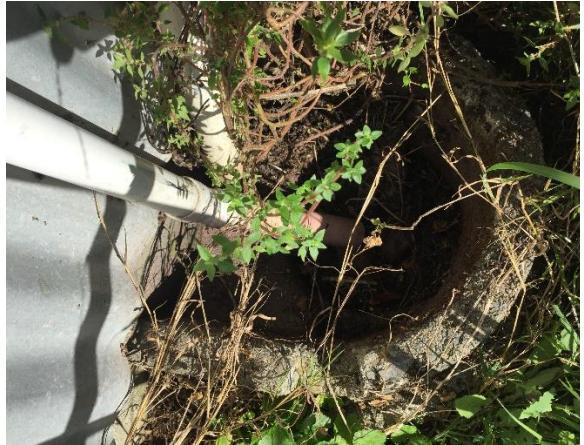
Photo 21. Blocked gully trap on rear of building

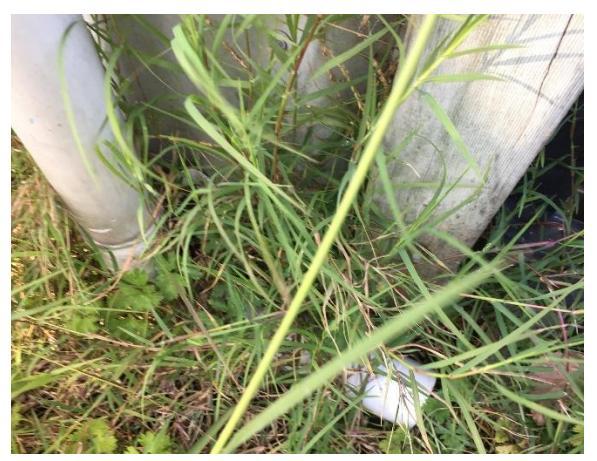
Photo 22. Down pipe discharges onto ground on left rear of lean to extension.

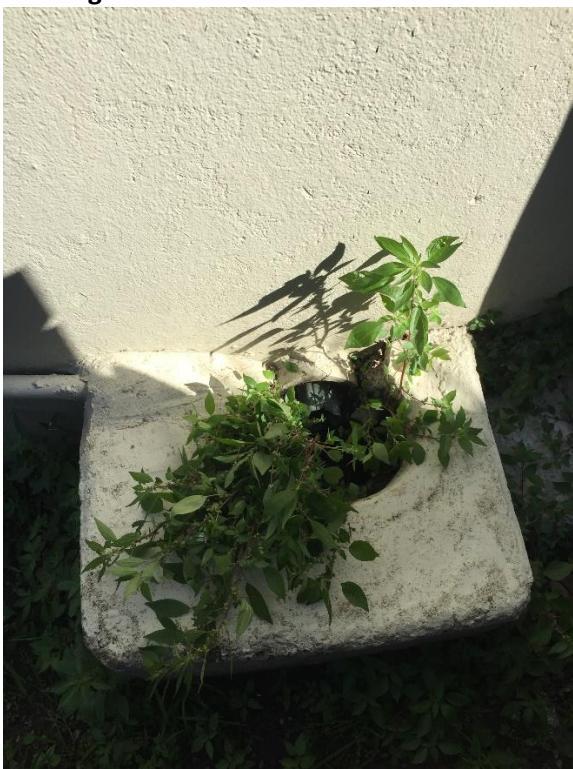
Photo 23. Blocked guly trap from men's toilet

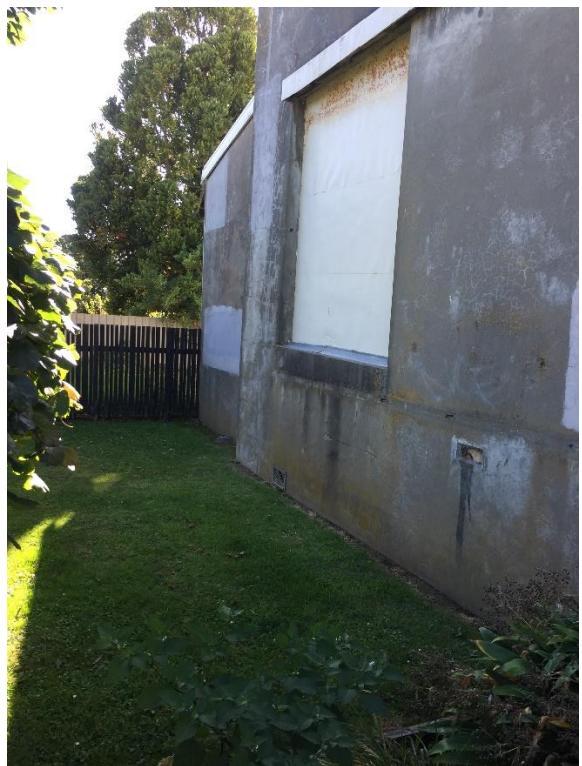
- The cargo door has been sealed shut. The lintel above has spalling concrete with the reinforcing steel being exposed. It is recommended that the door be removed completely and the opening blocked of permanently with a concrete block infill

Photo 24. Disused door. Remove and in fill wall with concrete blocks.

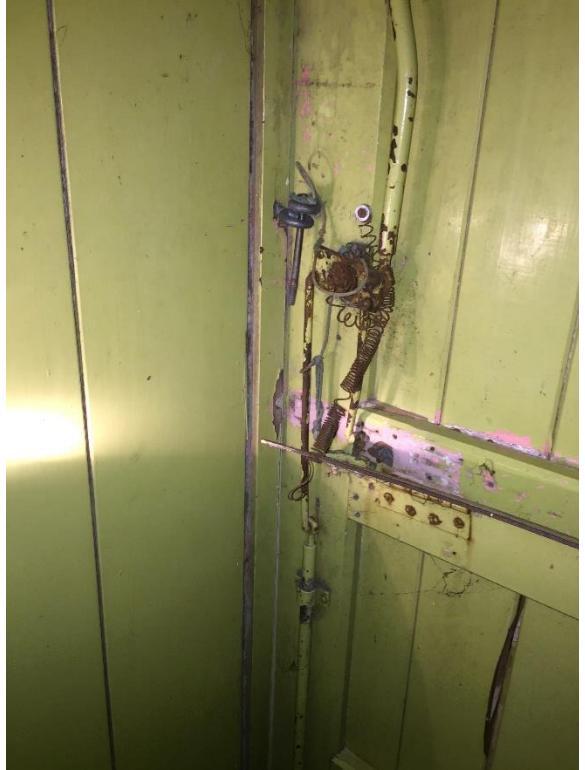
Photo 25. Lock on fire exit door from upper auditorium

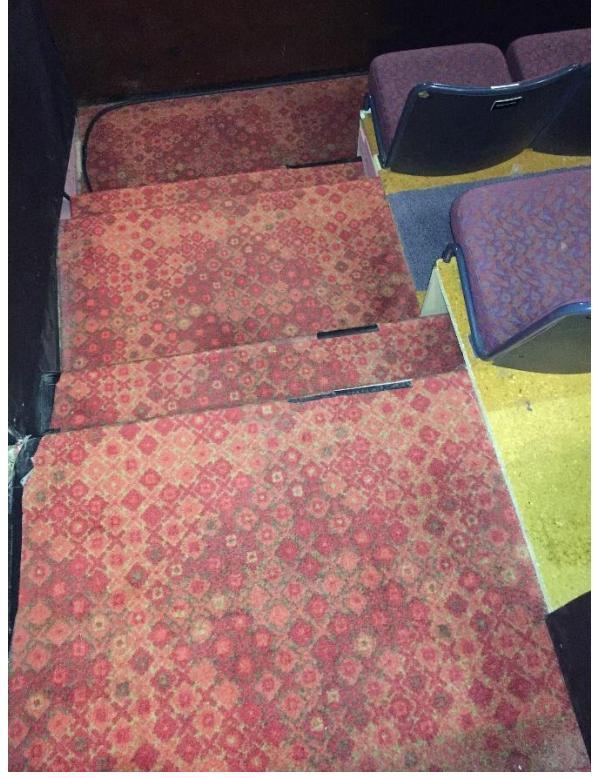
Photo 26. Damaged carpet in upper auditorium

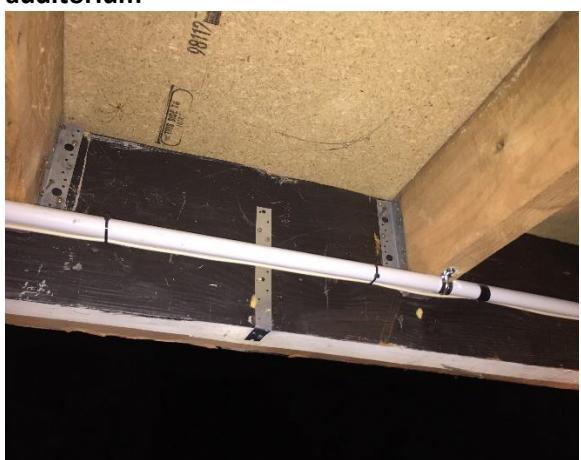
- The floor joists for the storage area are 200 x 50 supported at one end by joist hangars screwed to the outer wall and at the other end by joist hangars screwed to a 350 x 100 beam. The beam is supported by three 100 x 100 posts.
- The joist hangars are fixed with flooring screws. This is not in accordance with the manufacturer's recommendation. Either proprietary nails or 35mm tech screws should be used when fixing joist hangars.
- The posts supporting the beam are not continuous over their entire length.
- There are no mechanical fixings between the posts and beam.
- There are no mechanical fixing between the posts and floor.
- The single hand rail has a sheet of ply fixed to it to prevent falling however the hand rail and ply are not continuous along the entire edge of the mezzanine.
- The only access onto the mezzanine is by a ladder.

Photo 27. Right stage mezzanine. Incorrect fixings

- Replace the joist hangar fixings with proprietary fixings in accordance with the manufacturer's recommendations.
- Replace the posts and post to beam/floor fixings in accordance with a specific design.
- Construct a stair to access the mezzanine.
- Extend the handrail to comply with the NZBC Recommended Acceptable Solution F4 Safety from Falling.
- Confirm the load capacity of the floor.
- Confirm bracing requirements.

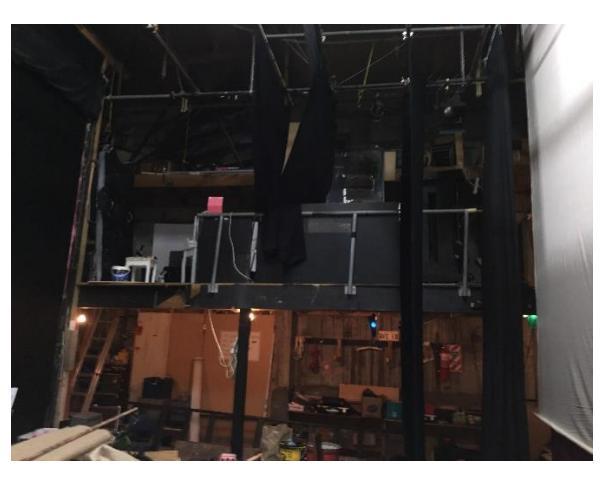
Photo 28. Right stage mezzanine. Handrail not continuous.

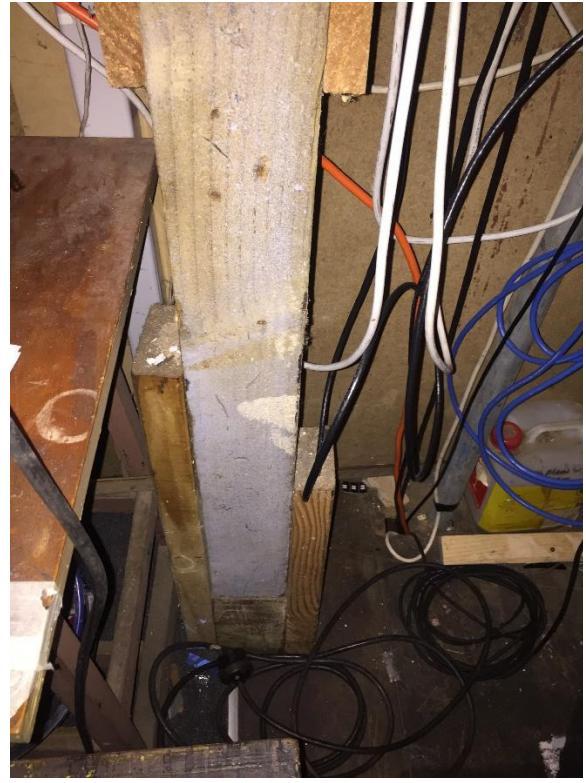
Photo 29. Right stage mezzanine. Post not continuous.

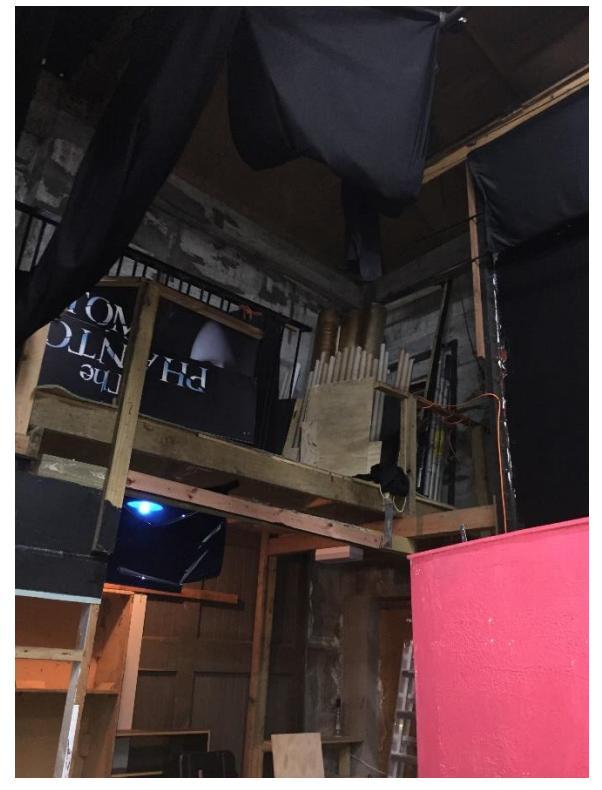
Photo 31.Left stage mezzanine. No handrail. Adhoc construction.

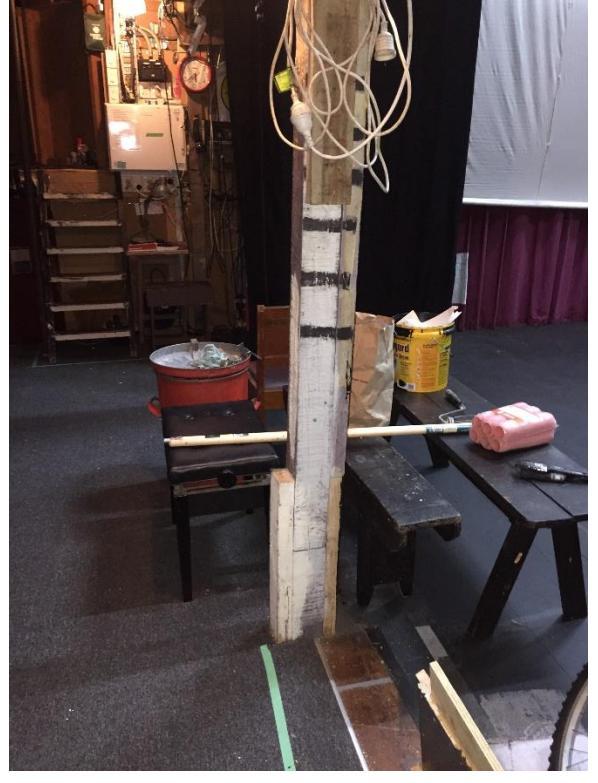
Photo 30. Right stage mezzanine. Post not continuous.

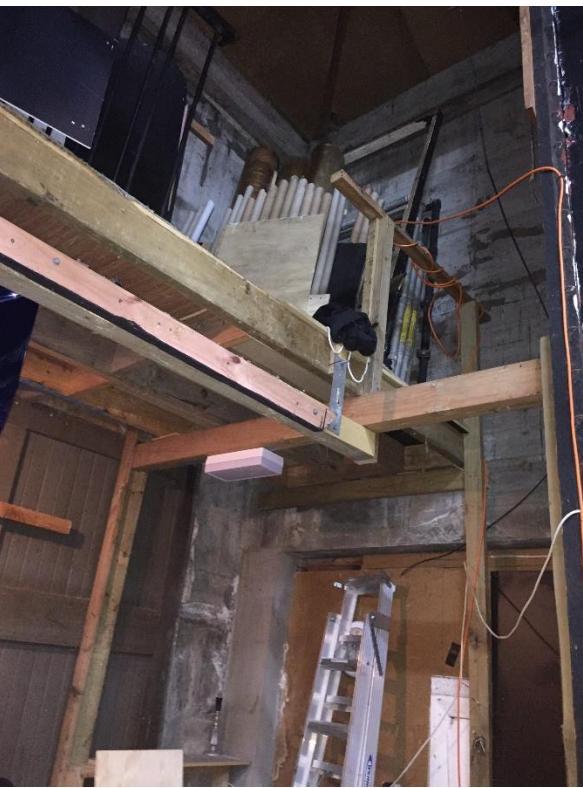
Photo 32. Left stage mezzanine. Adhoc construction.

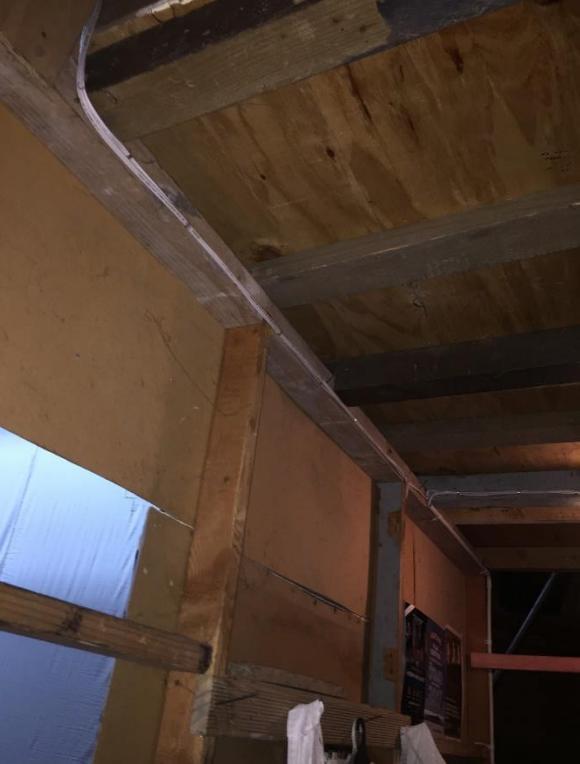
Photo 33. Left stage mezzanine. Undersized floor joists and stringer.

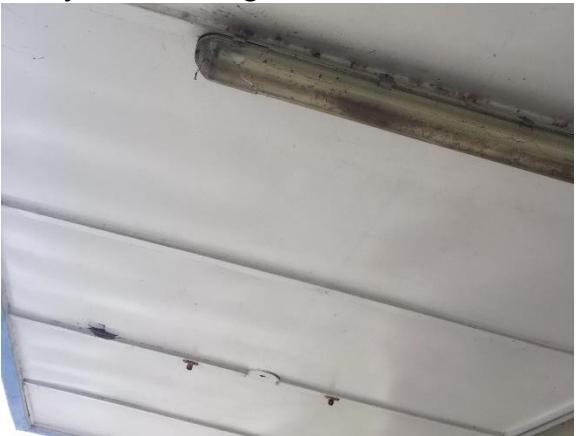
- The soffits under the veranda are fibre cement sheet from the era when asbestos was commonly used in their composition. The sheets are broken and pose a health and safety risk.
- The stairs have a vinyl flooring laid on them. The vinyl is cracked and will require replacement. The cracking does not pose an immediate trip hazard.
- The main doors are timber and in good condition although to ensure their longevity it is recommended they be prepared and re polyurethened.

Photo 35. Soffit. Potential asbestos.

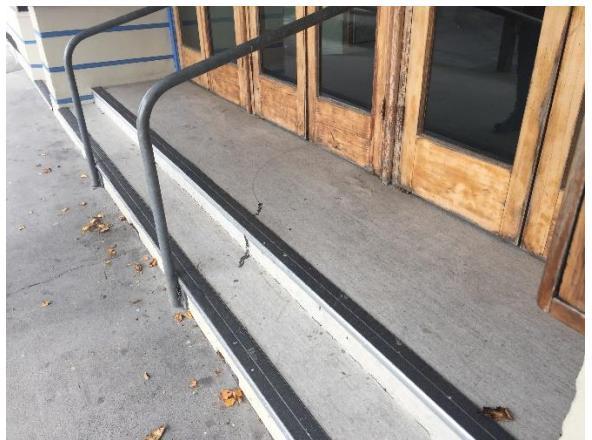
Photo 36. Front of building. Cracked vinyl on steps.

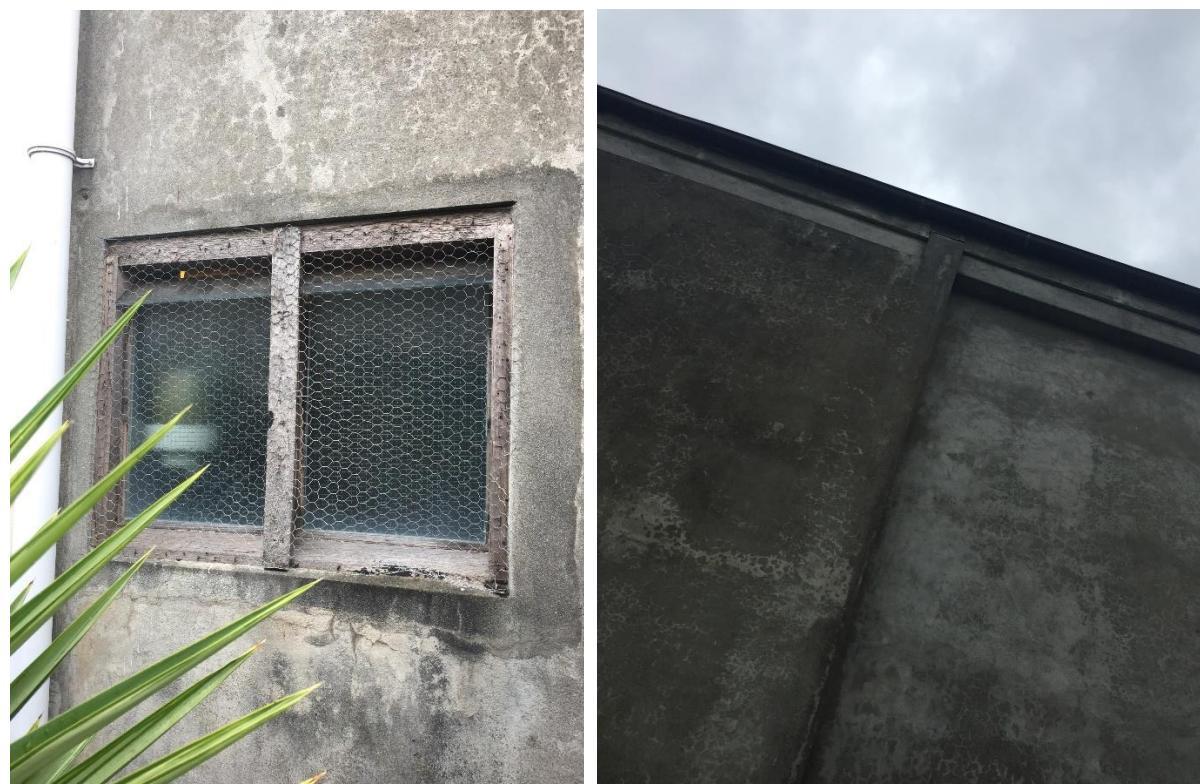
- There are fixings missing of the down pipes.
- The timber window in the Men's Toilet is in poor condition and needs replacing.
- Concrete is spalling and exposing the steel in the column above the fire exit doors.
- There is no head flashing above the fire exit doors.
- The sub floor vent towards the rear of the building requires replacing.
- The sub floor vents into the subfloor are below ground level and partially blocked.
- The cap flashing on the rear of the wall needs to be replaced as it has dislodged.
- Fascia requires preparing and painting.
- As the wall is unpainted it is not sealed and will allow moisture to penetrate. Evidence of moisture
  penetration can be observed inside the building. It is recommended the exterior be painted in order
  to prevent moisture ingress.

Photo 37. Window in men's toilet.

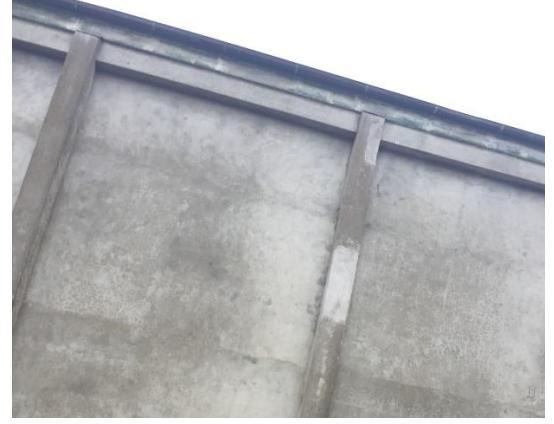
Photo 39. Right wall. Previous repairs.

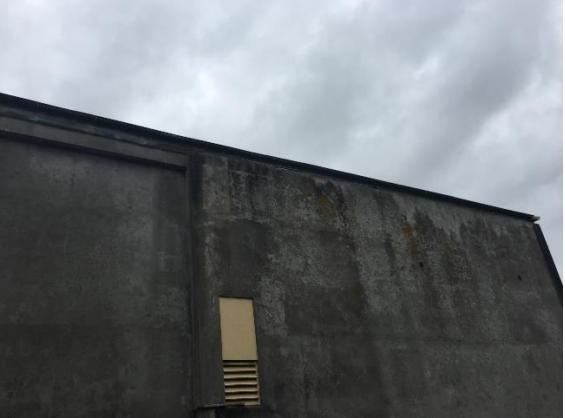
Photo 40.Remove and replace flashing in top of wall.

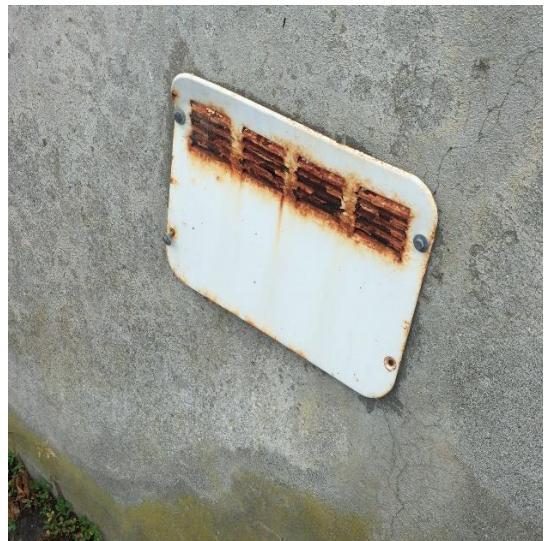
Photo 41. Remove and replace vent.

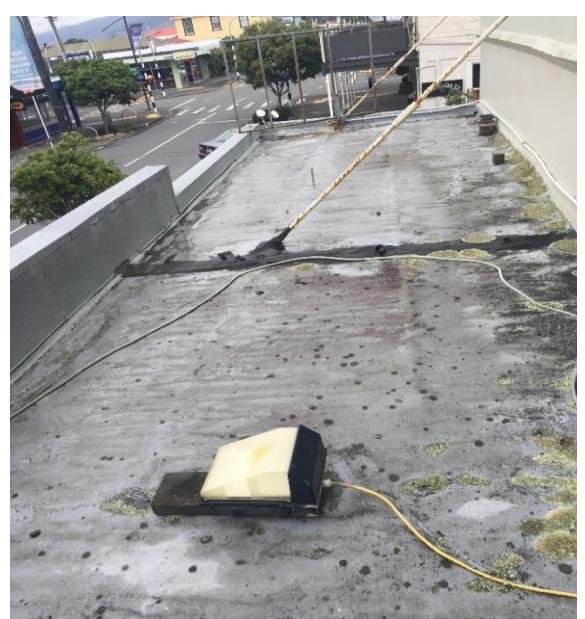
The lower level butynol roof is in poor condition and requires replacing. It is recommended that the ply substrate be replaced at the same time as the butynol is being replaced.

Photo 43. Butynol roof. Replace.

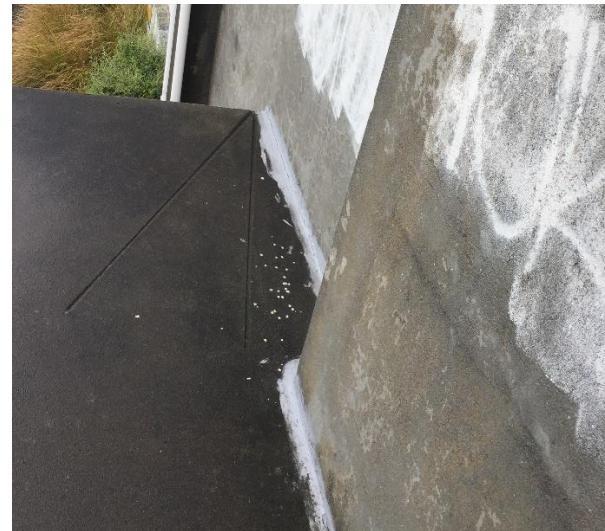
The lower level flat concrete roof falls back towards the building. The bunker below the roof backs onto the ladies toilet so this is a potential source of moisture causing the moisture issues in the ladies toilet.

Photo 42. Left wall. Source of moisture into ladies toilet. Over roof.

Attempts have been made to water proof the junction between the roof and wall with the use of sealants. Sealants are only a temporary fix. It is recommended that that the area be over roofed with a colour steel long run roof falling away from the building.

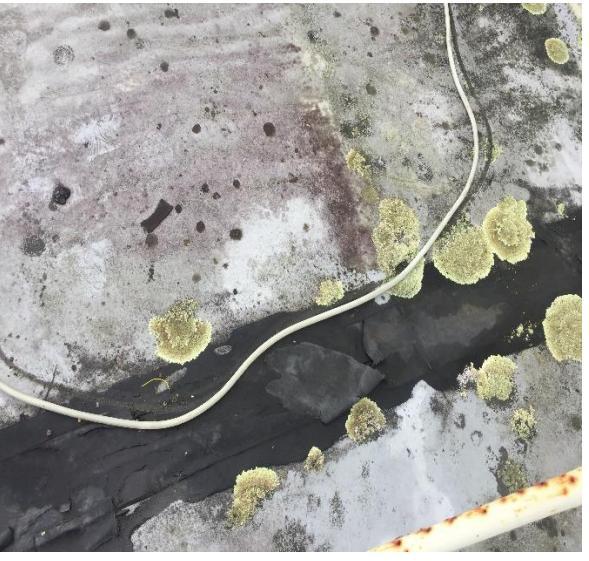
The ties supporting the veranda are rusting and need to be cleaned, inspected and repaired as required.

Photo 45. Stay supporting veranda roof. Maintenance required.

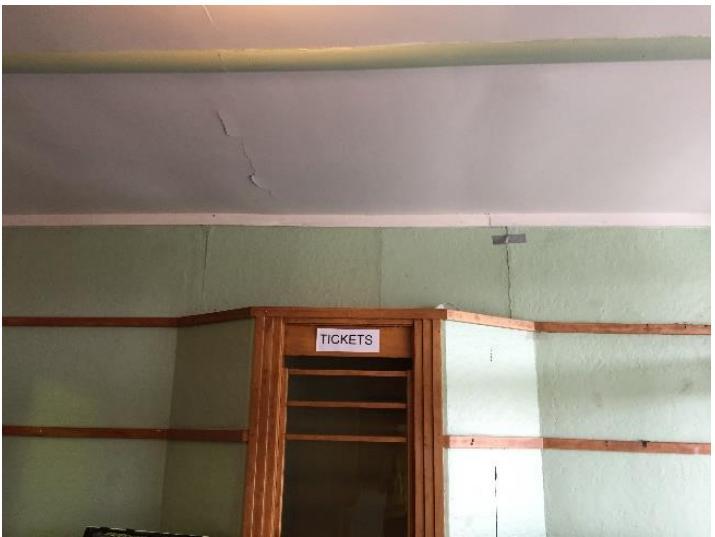
Figure 2 shows cracking in the lining of the lobby.

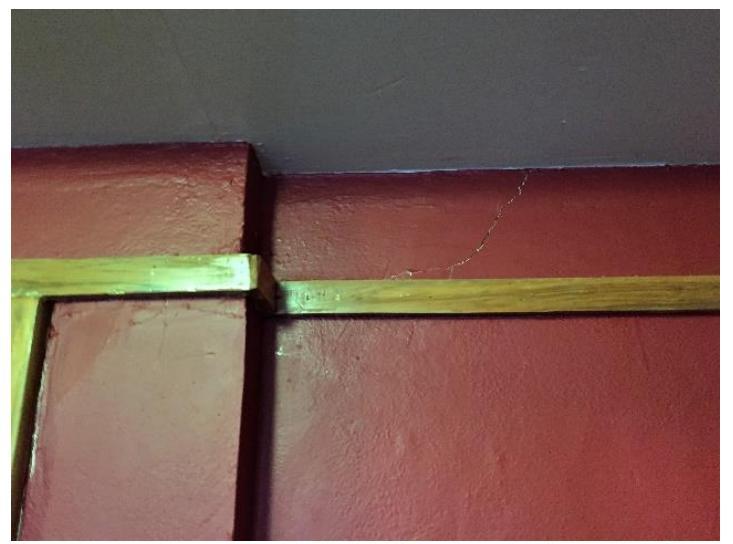
Figure 3 shows cracking in the lining of the lobby.

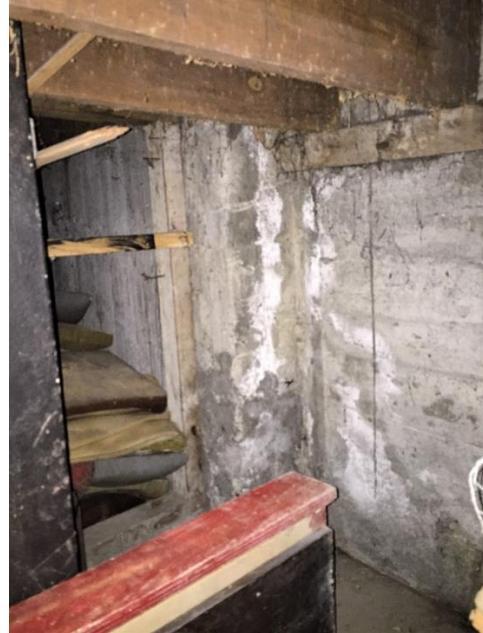
Figure 7 shows the sub-floor foundation wall and efflorescence.

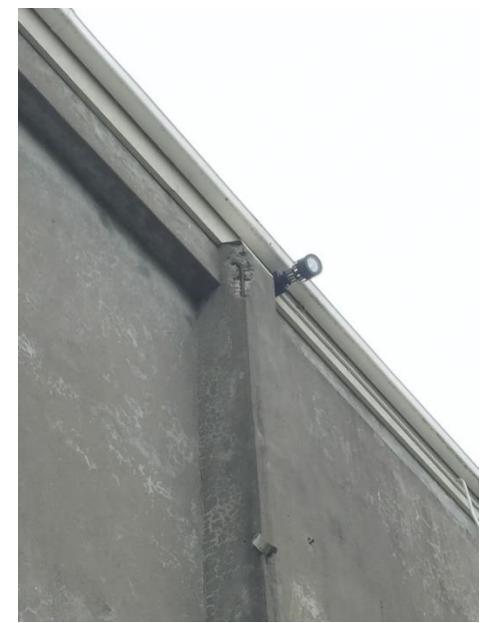
Figure 9 shows spalling on reinforced concrete column.

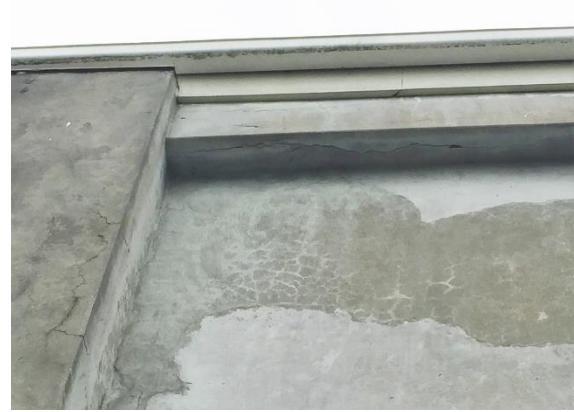
Figure 10 shows cracking on the underside of a bond beam.

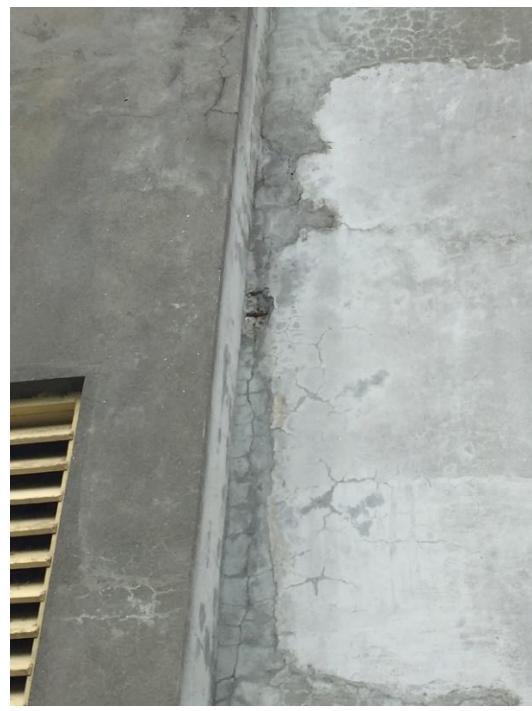
Figure 11 shows spalled concrete with exposed reinforcement and fine cracking.

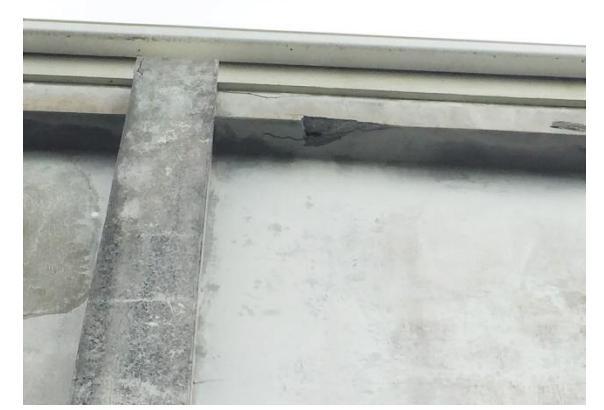
Figure 12 shows spalled concrete on a reinforced concrete bond beam.

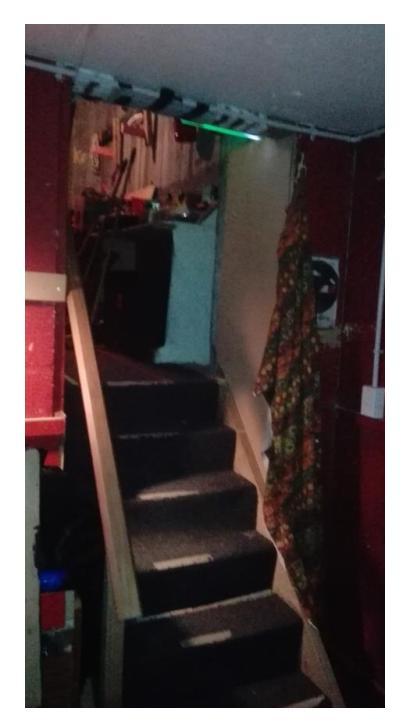
The eastern corridor leading from the stage area does not satisfy this requirement near the steps (photo below).

#### Photo 1: showing height clearance from top of stair to ceiling does not satisfy requirements

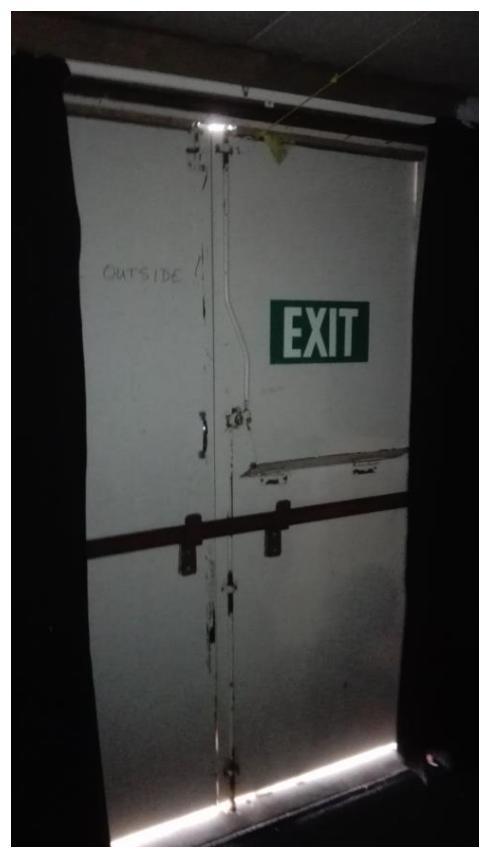
Panic fastenings are provided to the exit doors where locks are present, however bars used to secure the doors should be removed (see photo below).

Photo 2: showing bars used for security which need to be removed.
