# **Building Condition Report**

# Address: Otaki Theatre, Otaki

Date: 27 March 2020

Project Number: 200057

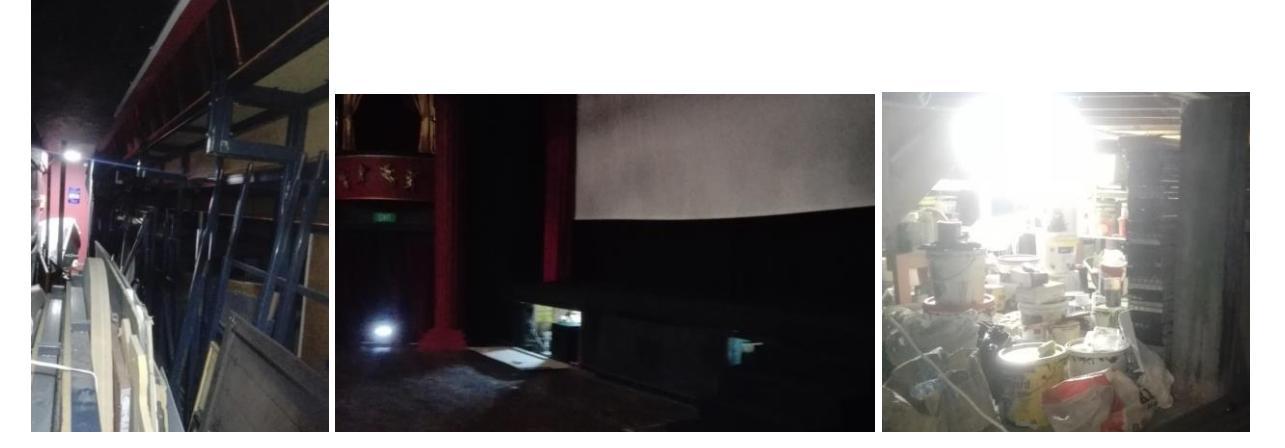
The underside of the auditorium tiered seating including stage if it is capable of being used, shall be a 60 minute firecell in accordance with paragraph 4.8.1, C/AS2. The existing is not fire rated and therefore the underside of the tiered seating and stage shall not be used for storage.

Photos 3, 4 & 5: showing storage below tiered seating & stage. These items shall be removed.
