**Lower Maungakotukutuku Dam  
Interpretative Geotechnical Report**

August 2010

Kapiti Coast District Council

**Issue 2**

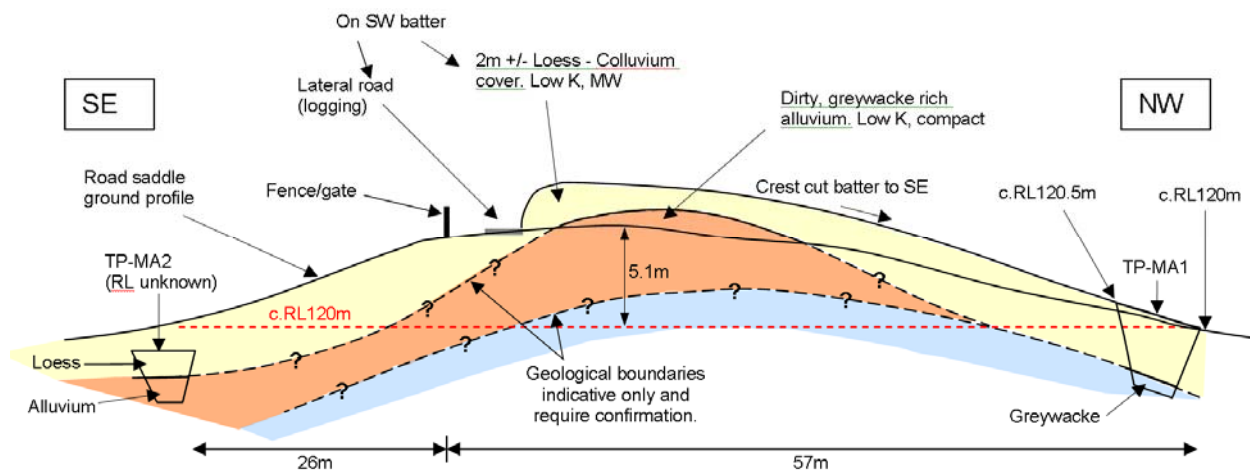
**Figure 4.1. Geological field section through the road saddle.**

At the southern most saddle (road saddle) test pitting identified greywacke bedrock overlain by loess and alluvium. A geological field section through the road saddle is shown in Figure 4.1. Levels shown on the section were estimated based upon topographic mapping and require verification with survey control.

It is suggested these materials will have very low permeability and it anticipated that no treatment of the saddle will be necessary for a reservoir full supply level of RL 120.5m.

Survey control is required to establish the extent of earthworks required for either saddle.

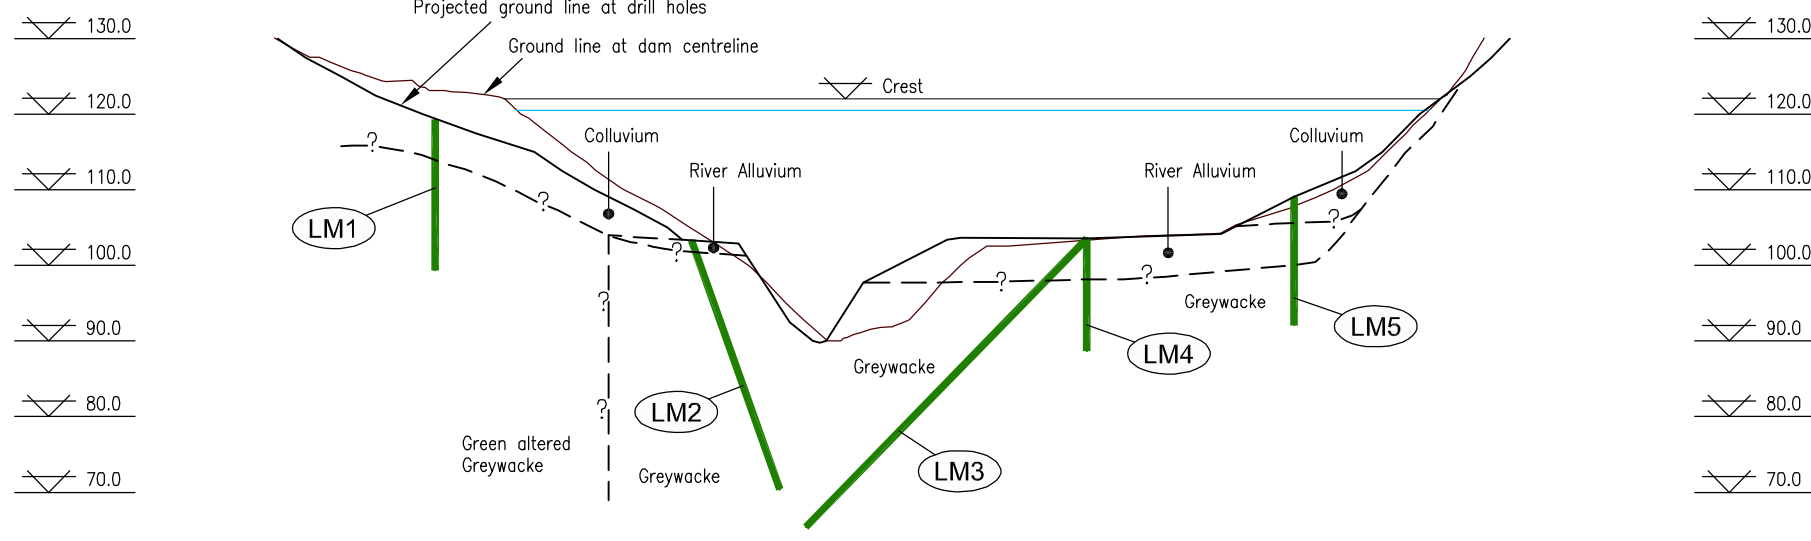
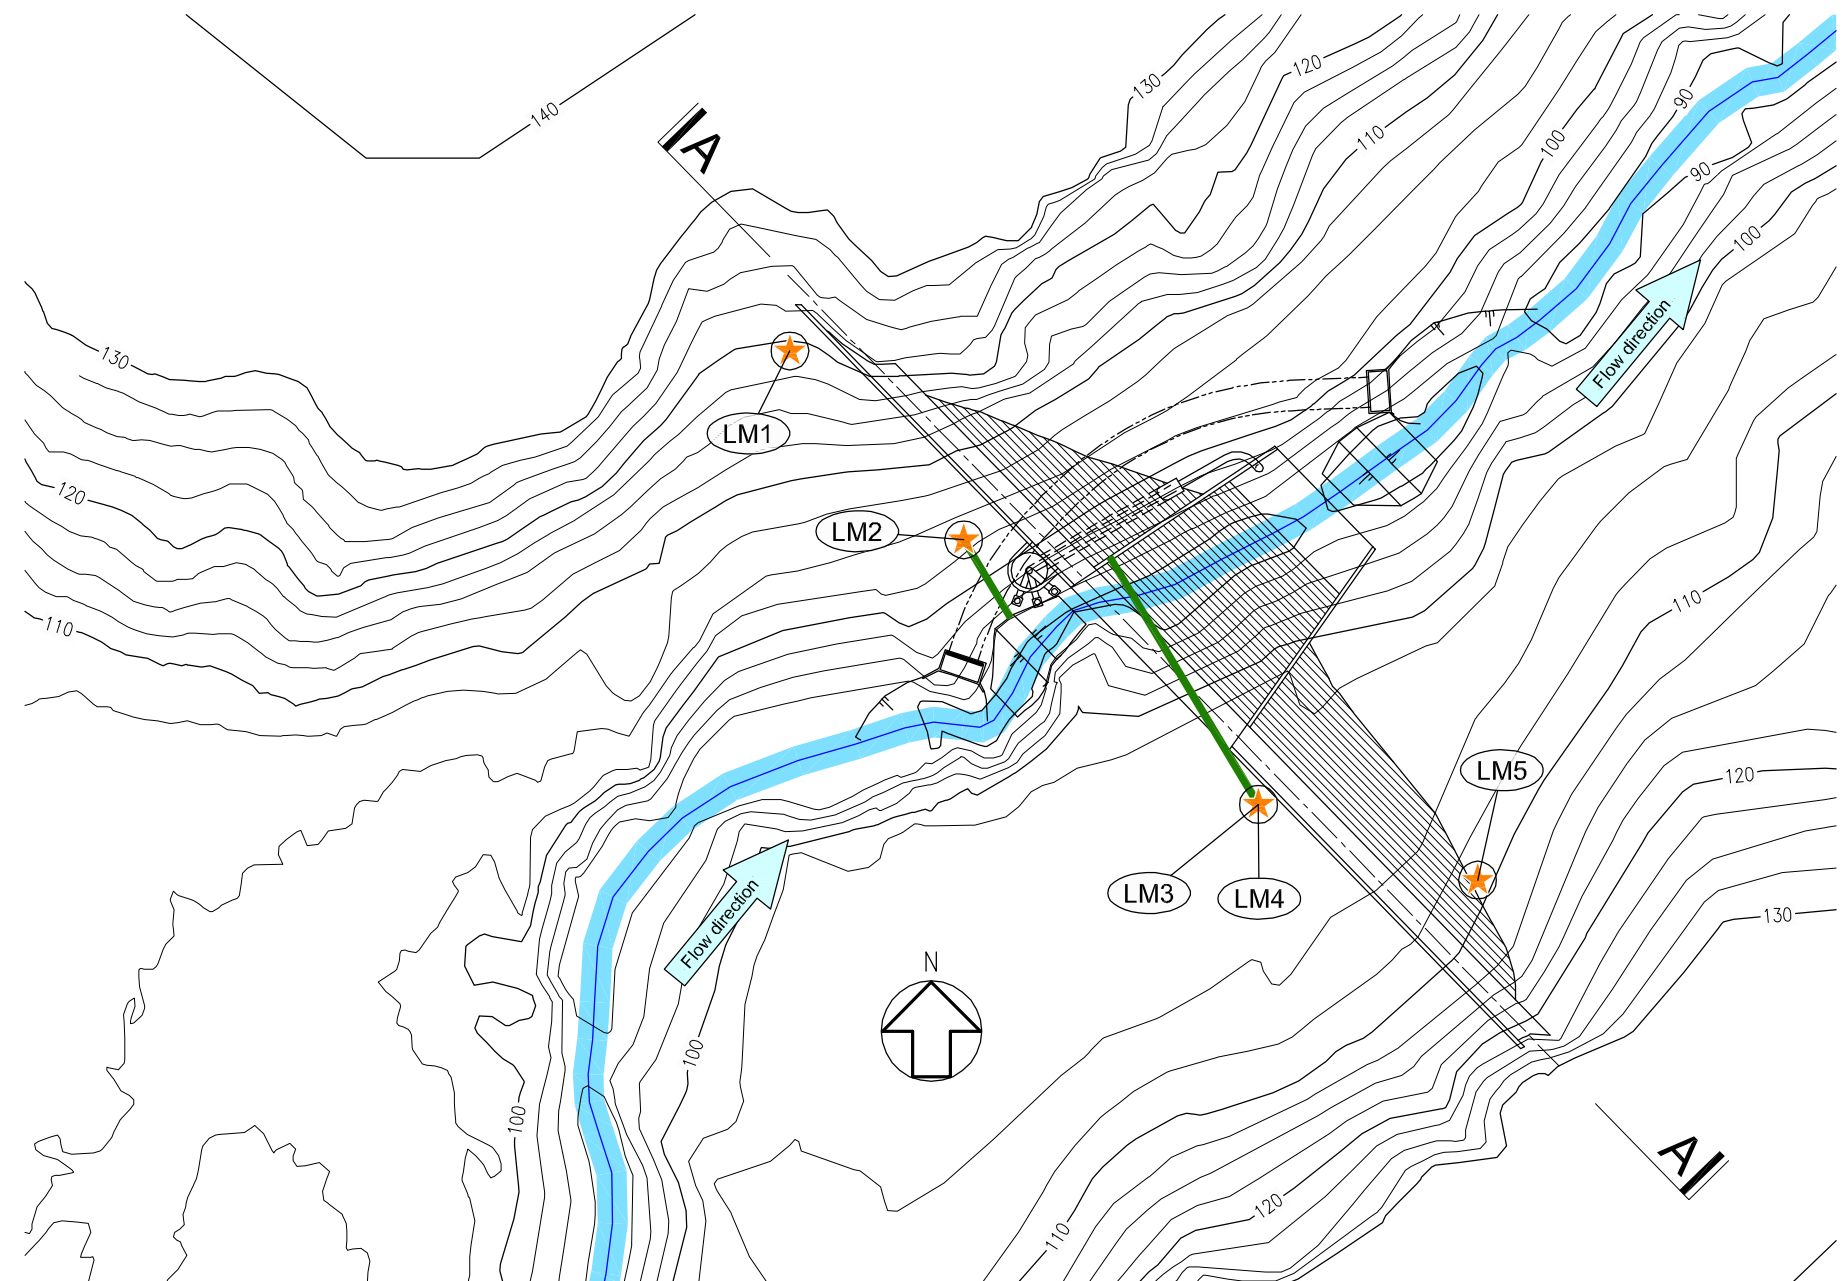
CONCEPTUAL GEOLOGICAL SECTION A-A (LOOKING DOWNSTREAM)

A geological section across the dam site, based upon reconnaissance level geological mapping and the drilling investigations is shown in Drawing WS909/20/25, included in Appendix A.

Beneath the left bank the greywacke is pervasively altered, evidenced by the green rock exposed in the gorge and in drillhole LM1. The greywacke is strongly sheared however most discontinuities are compact and indurated.

Across the section of the dam footprint the greywacke is generally strong to very strong, siliceous and black, however there are sub-vertical shear zones within the sides of the inner river gorge. One shear zone comprised light grey pulverised rock with a high clay content. This shear zone is approx 300mm wide and aligned on a bearing of approx N 120° E. Other sub-vertical shear zones were between 100mm to 300mm wide and also aligned sub-parallel to the proposed axis of the dam. These shear zones are very weak and easily broken.
