PRELIMINARY ECOLOGICAL ASSESSMENTS OF SIX BULK WATER SUPPLY OPTIONS FOR KAPITI COAST

JULY 2010

Report No. 2381b

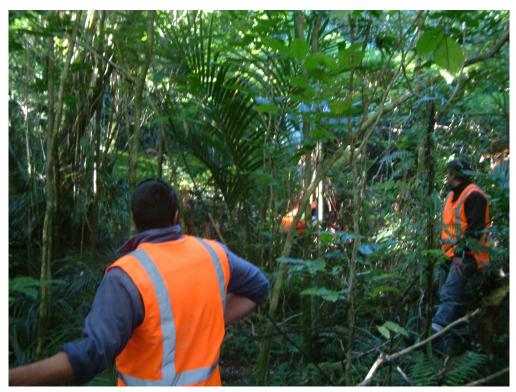
Plate 1: Dense understorey vegetation near proposed test drilling site LM3/LM4.

Understorey vegetation, including that present at the proposed drilling sites, was reasonably dense, reflecting stock exclusion and possum control. Understorey vegetation comprised seedlings and small trees of kohekohe, heketara, rewarewa, kawakwawa (*Macropiper excelsum*), mahoe, tawa, and pate. A range of shrub and small tree species was present, including kanono, karamu, *Coprosma rotundifolia*, hangehange (*Geniostoma ligustrifolium*), pigeonwood, ramarama (*Lophomyrtus bullata*), nikau, supplejack vines (*Ripogonum scandens*), silver fern (*Cyathea dealbata*), mamaku, wheki, and kiekie (*Freycinetia banksii*). In most places, a carpet

of ferns clothes the ground, including hen and chicken fern (*Asplenium bulbiferum*), kiokio (*Blechnum novae-zelandiae*), and a variety of filmy ferns (Plate 1).
