RAUMATI ESCARPMENT RESERVE MANAGEMENT PLAN

December 2006

Prepared By Kapiti Coast District Council and Boffa Miskell Ltd

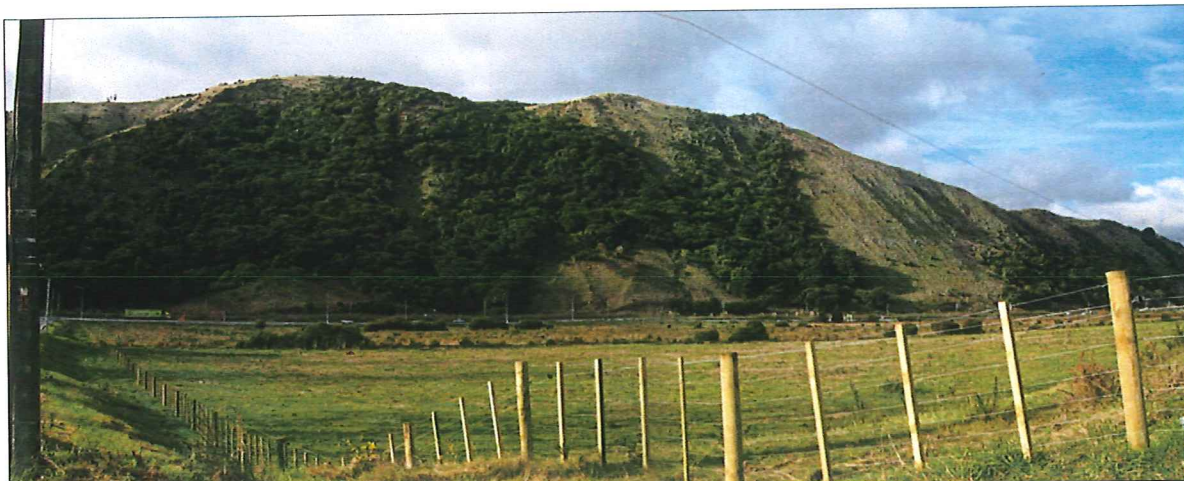
Photograph 1:

View of the escarpment from Poplar Avenue shows the distinctive remnant stands of coastal forest vegetation on the face of the escarpment. Matihuka walkway follows the top of the escarpment

face. The balance land is grassland and scrub. See Photographs 1-2

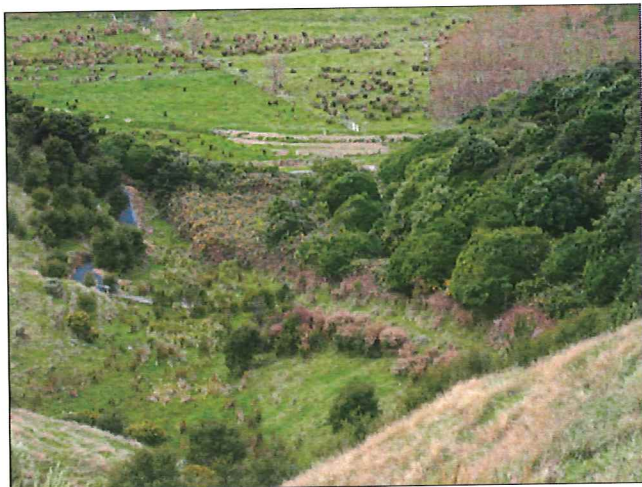
Photograph 5:

The only public access to the reserve is at the southern end, from Waterfall Road across KCDC land. The first part of the access track has recently been upgraded, and is visible in the middle ground of the photograph. The remainder of the access path to the top of the escarpment is unformed and slippery in wet conditions.

The only public access point to the reserve is at the southern end, from Waterfall Road, across a 2.7ha block of KCDC land, that is currently being leased and grazed as a means to manage pest plants. Additional signage at the Waterfall Road would make it easier for visitors to identify. Photographs 5 – 6.

A walkway links Waterfall Road entrance to the top of the escarpment and the southern end of the Mataihuka Walkway. The southern access route passes through a damp gully and up a steep grass slope. The first part of the track at the Waterfall Road entrance has recently been upgraded and graveled and the remainder of the southern access is generally unformed and slippery in wet conditions.

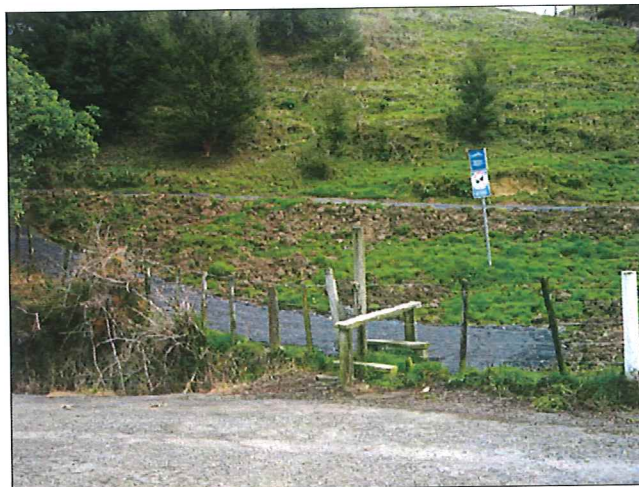
Photograph 7:

The entrance at Waterfall Road has been upgraded and the path gravelled.

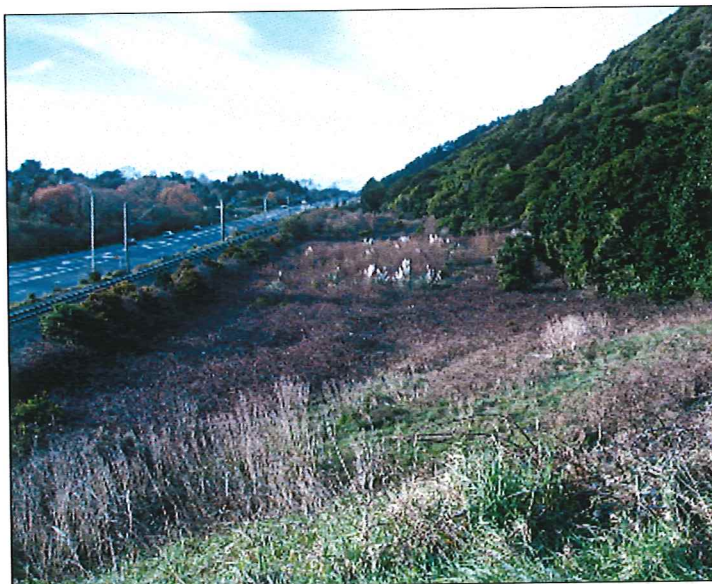
Photograph 9:

Blackberry and other pest plant species are established in the area between the railway and the toe of the escarpment and is being controlled through spraying by KCDC and GWRC.

KCDC and GWRC have used herbicide sprays to control the blackberry. However, this has created some concerns for the residents nearby and across SH1.
