# Raumati coastal hazards

## SUMMARY

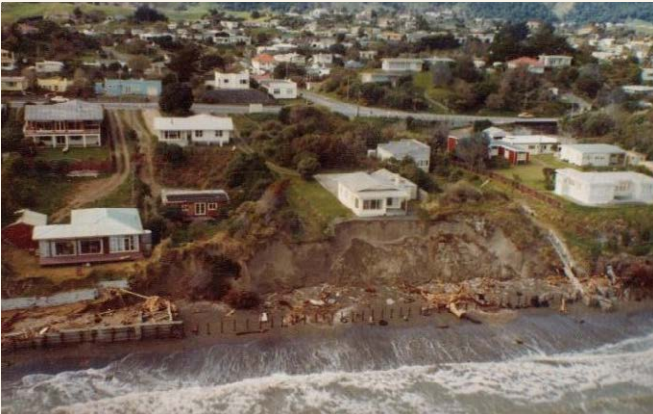
A. Coastal erosion behind failed structures on Rosetta Road following a significant storm in 1976.

The present-day erosion hazard is what could occur in an extremely large storm (which has a 1% chance of occurring each year in the immediate/near future), and if the existing protection structures failed, as shown in photo A. Along the Raumati shoreline, this would 'most likely' result in 16 to 24 m of erosion.

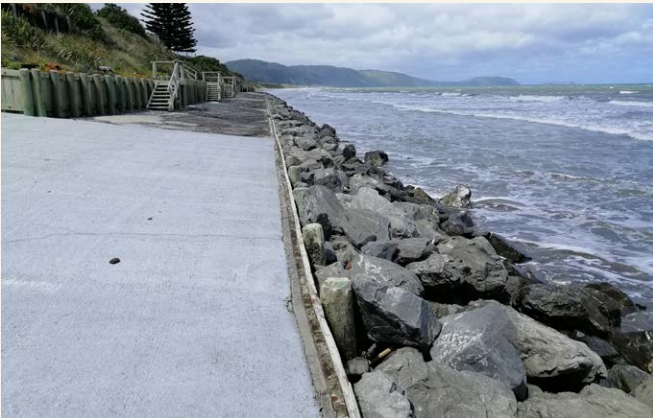
B. Structures along Old Coach Road.
