Paekākāriki coastal hazards

SUMMARY

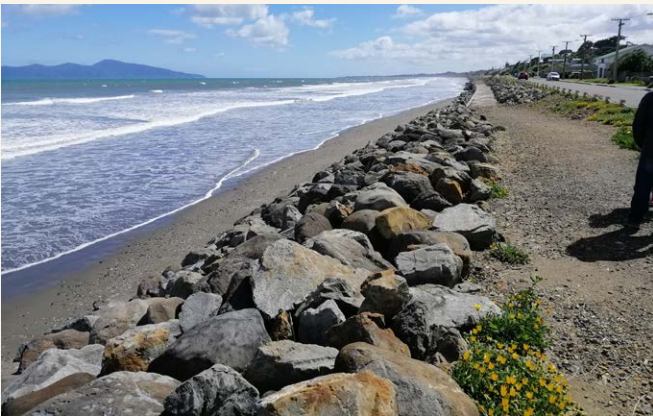
A. Rock revetment structure along The Parade.

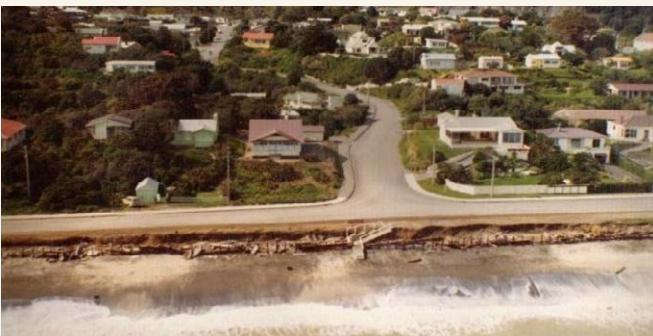
B. Structure failure and coastal erosion following September 1976 storm.

The present-day erosion hazard is what could occur in an extremely large storm (which has a 1% chance of occurring each year in the immediate/near future), and if the existing protection structures failed, as shown in photo (B). Along the Paekākāriki coast, short term erosion is 'most likely' to be 7 to 20m of erosion.

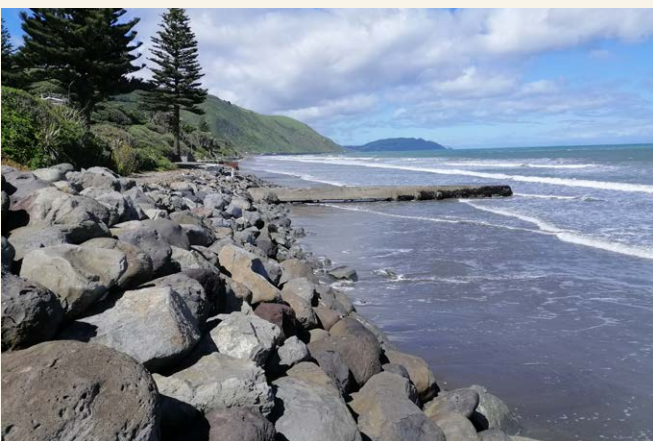
C. Paekākāriki seawall at Beach Road.

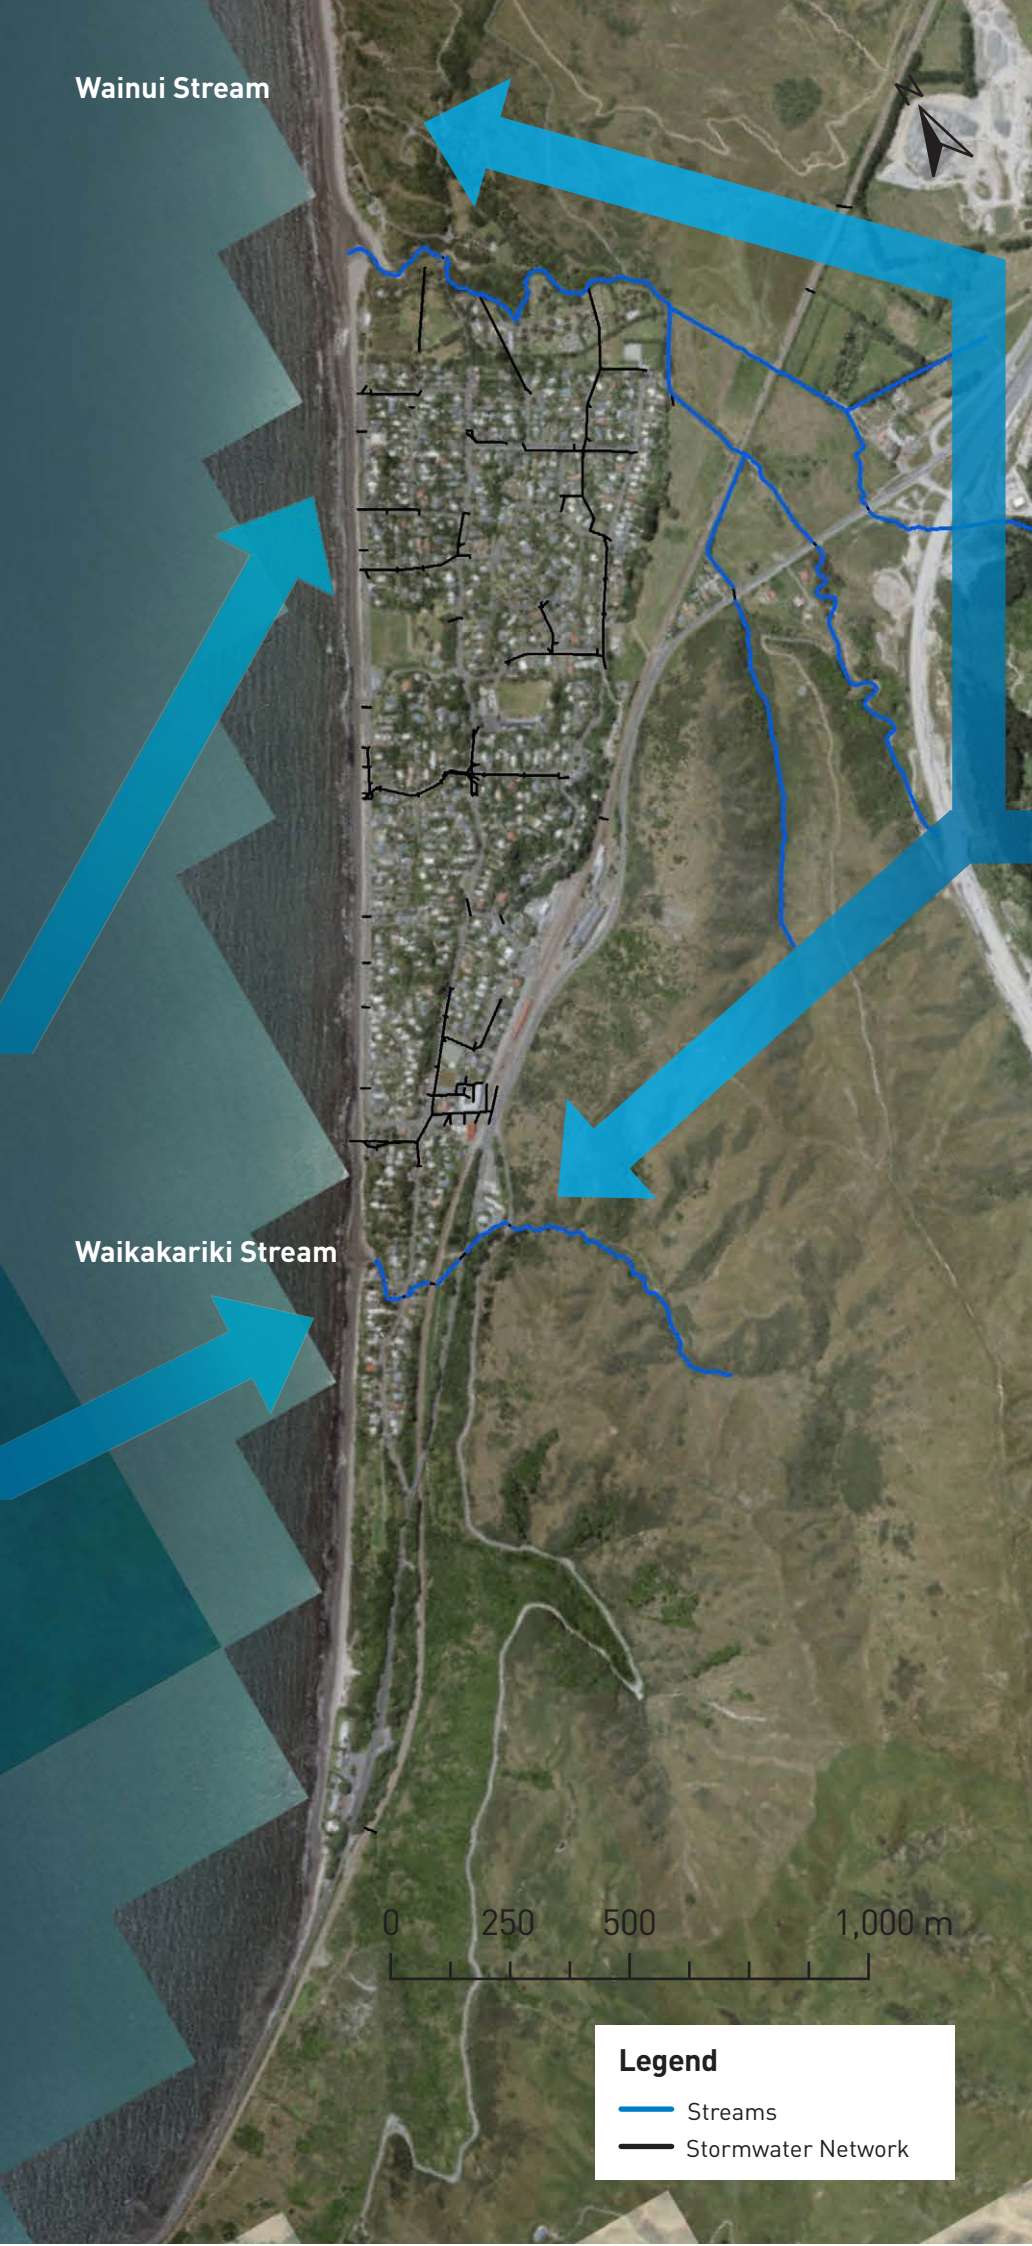
0.35 m and 0.45 m RSLR (~2070)

Future flood hazard under lower RSLR scenarios is around the mouths of the Wainui and Waikakariki Streams.

0.85 m and 1.25 m RSLR (~2130)

Flooding is still mostly localized around the two stream mouths. The mapping shows some localized depressions within the Paekākāriki settlement, which could be susceptible to flooding from stormwater outfalls, but are generally protected by higher surrounding ground levels.

There is a small area around both stream mouths where there could be additional flooding caused by wave run-up.

Pathways to coastal flooding in Paekākāriki are along the Wainui and Waikakariki Streams. The stormwater drainage network in Paekākāriki is generally raised well above the highest extreme sea level considered in this assessment.
