**Project Number 18634.000.001**

**Geotechnical Investigation**

234 Rangiuuru Road, Ōtaki, Kāpiti Coast

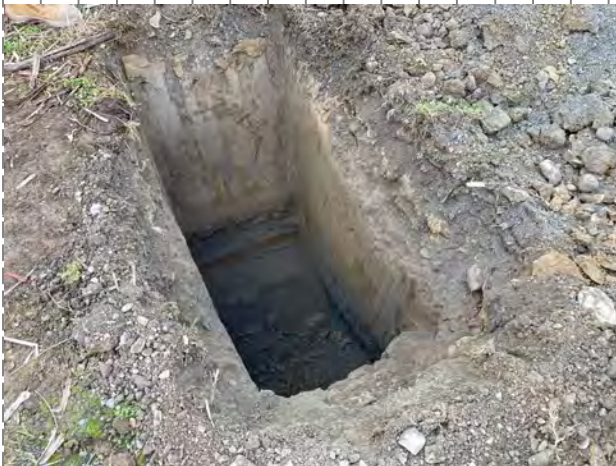
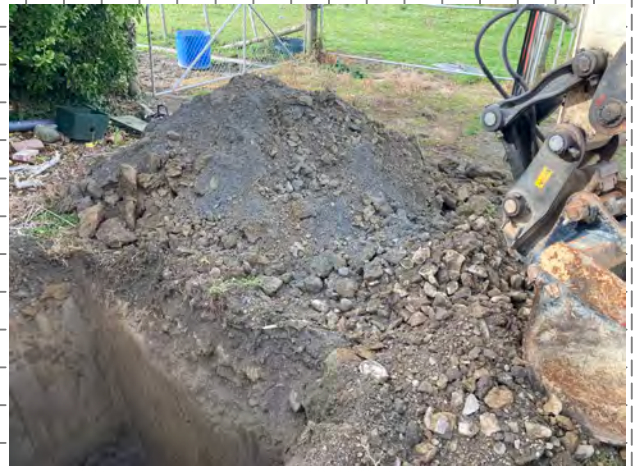
Bucket excavator met practical refusal. at 1.8 m depth .  
Scala Penetrometer met practical refusal at 1.8 m depth.  
Standing groundwater was not encountered.

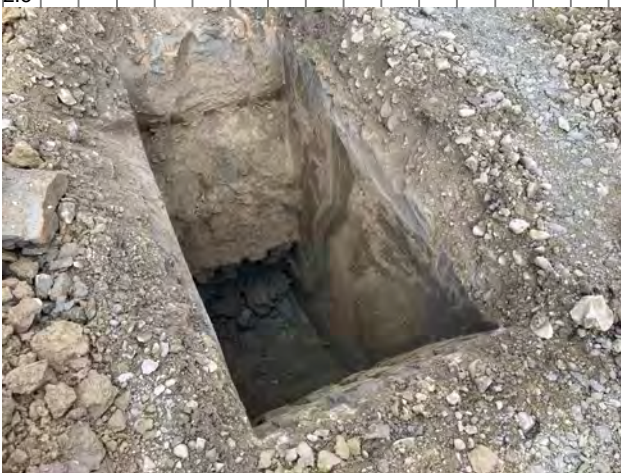
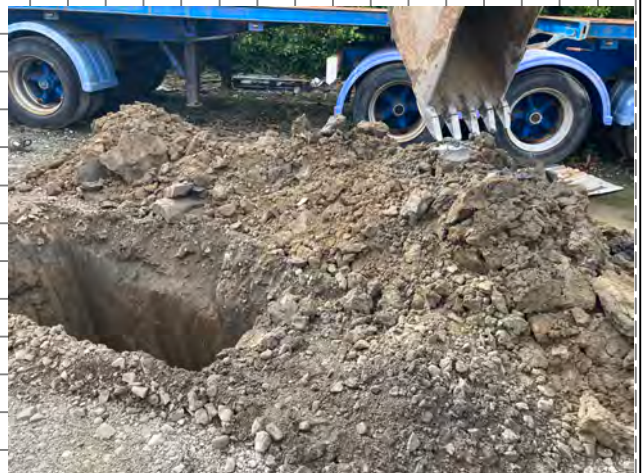
# LOG OF TEST PIT TP02

Bucket excavator met practical refusal. at 2.3 m depth .  
Scala Penetrometer met practical refusal at 2.1 m depth.  
Standing groundwater was not encountered.

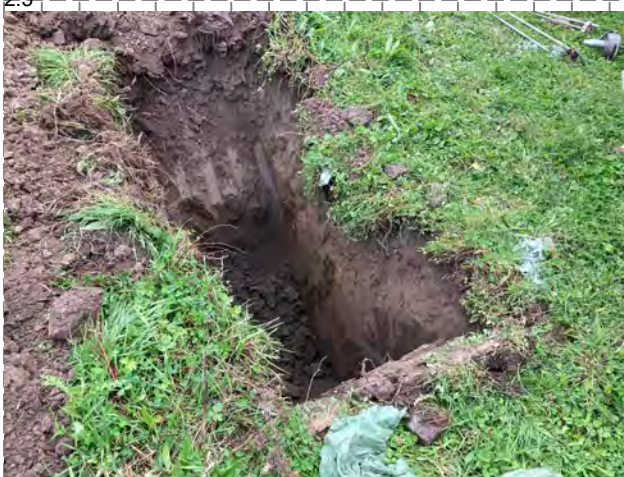
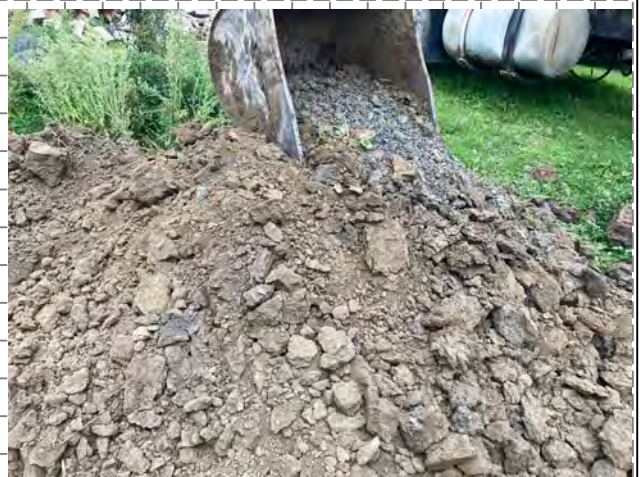
# LOG OF TEST PIT TP03

Bucket excavator met practical refusal. at 1.8 m depth .  
Scala Penetrometer met practical refusal at 1.7 m depth.  
Standing groundwater was encountered at 1.7 m.

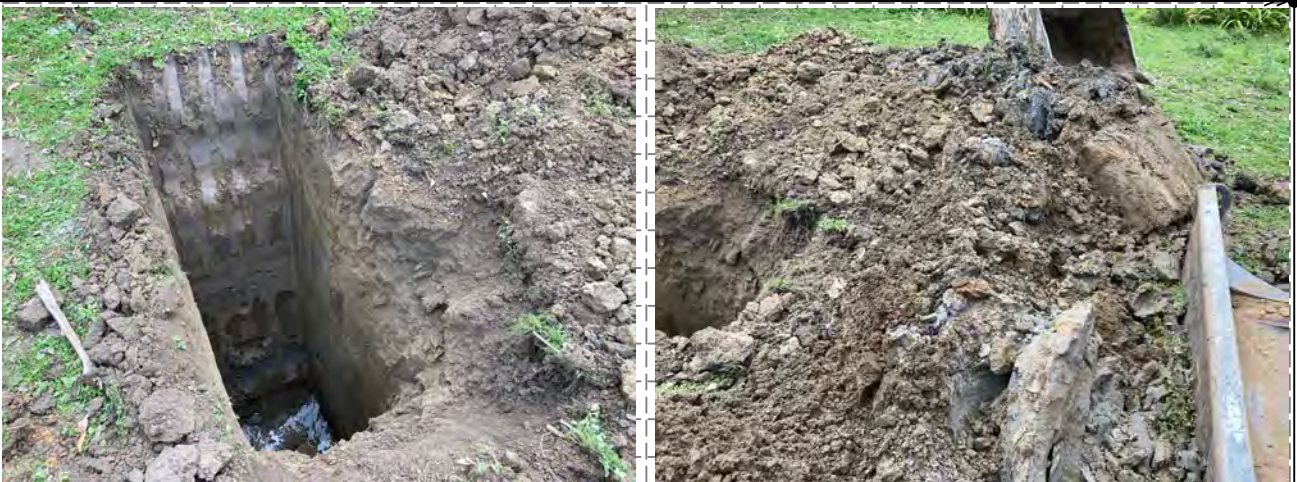
# LOG OF TEST PIT TP05

Bucket excavator met practical refusal. at 2.3 m depth .  
Scala Penetrometer met practical refusal at 3.1 m depth.  
Standing groundwater was encountered at 2.1 m.

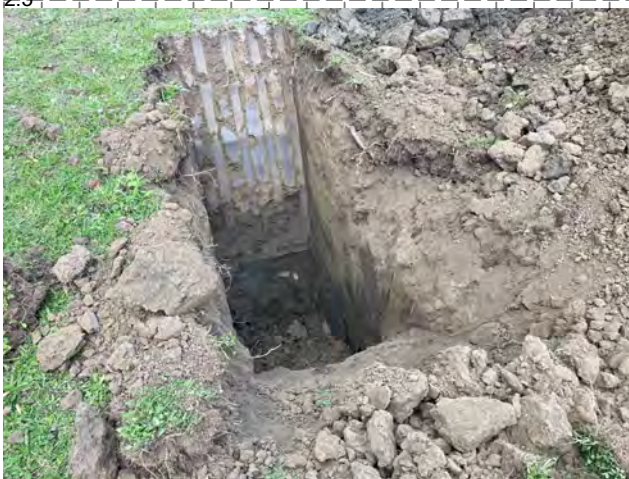
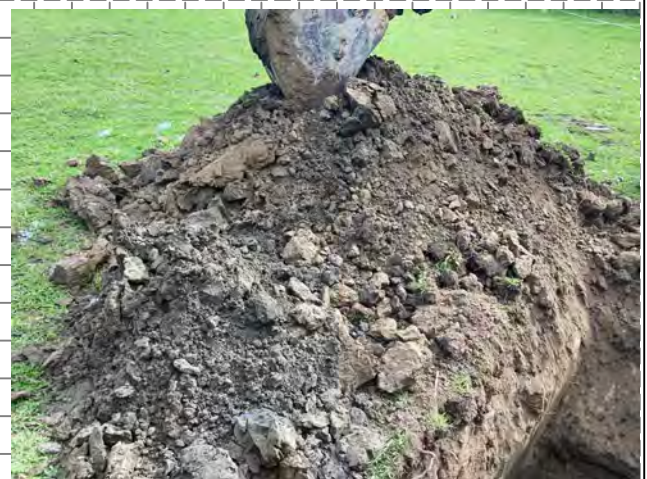
Bucket excavator met practical refusal. at 1.8 m depth .  
Scala Penetrometer met practical refusal at 2 m depth.  
Standing groundwater was encountered at 1.7 m.

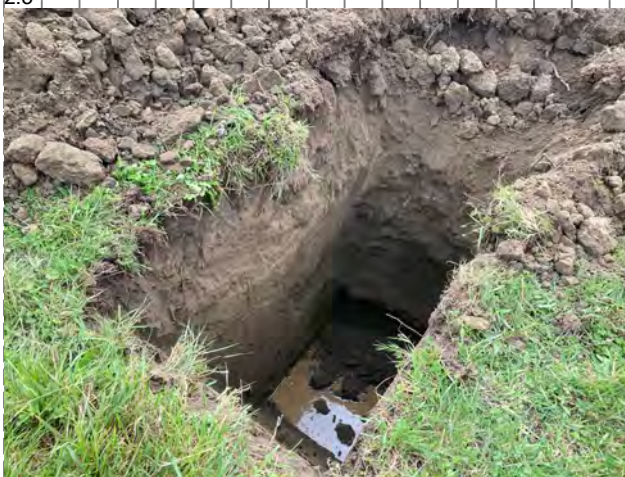
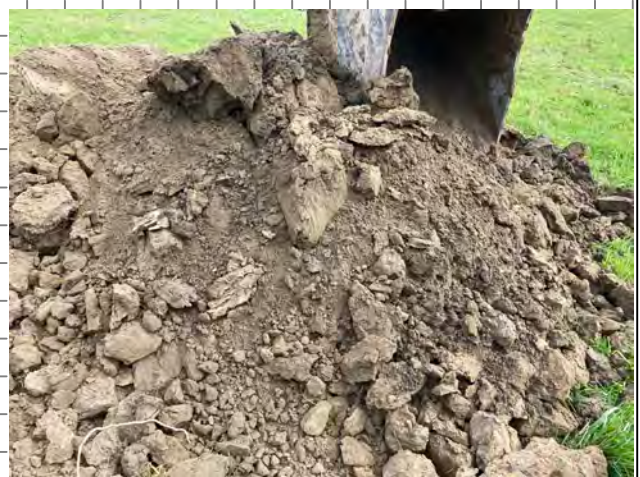
Bucket excavator met practical refusal. at 2.1 m depth .  
Scala Penetrometer met practical refusal at 2.1 m depth.  
Standing groundwater was encountered at 2 m.

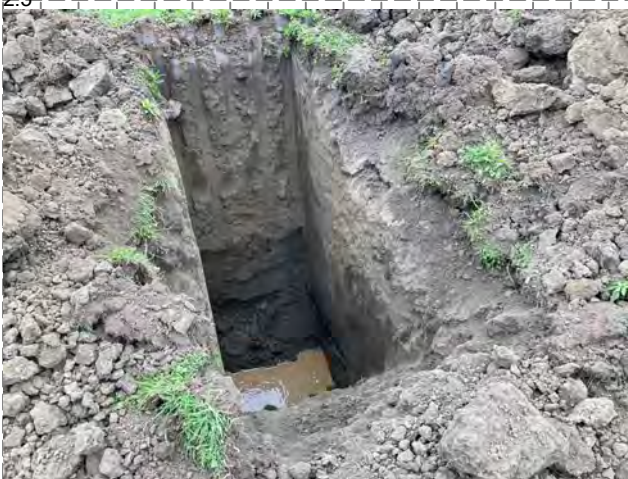
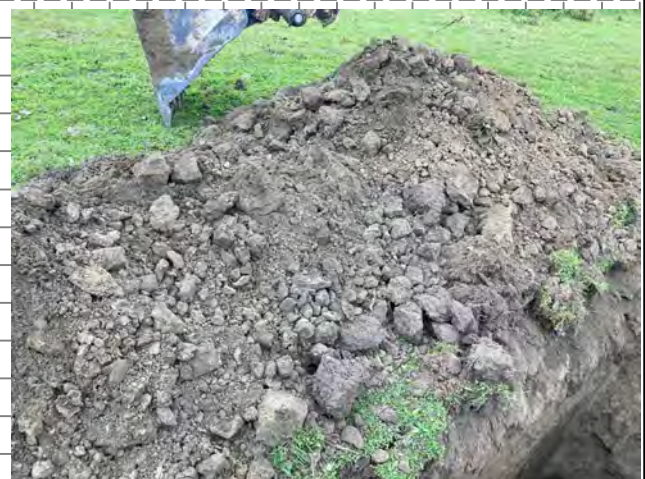
Bucket excavator met practical refusal. at 2.2 m depth .  
Scala Penetrometer met practical refusal at 1.7 m depth.  
Standing groundwater was encountered at 1.9 m.

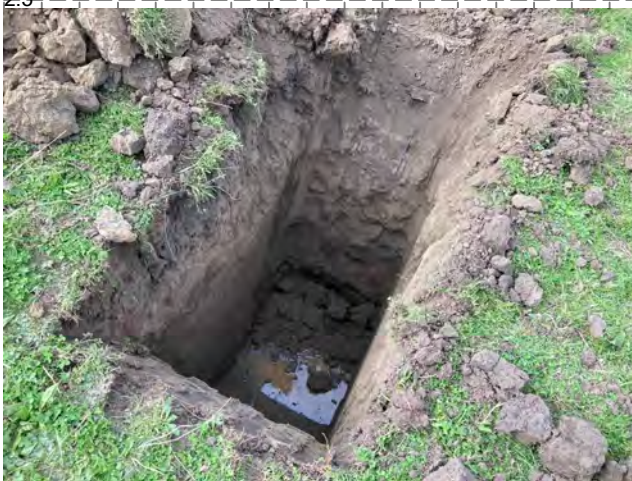
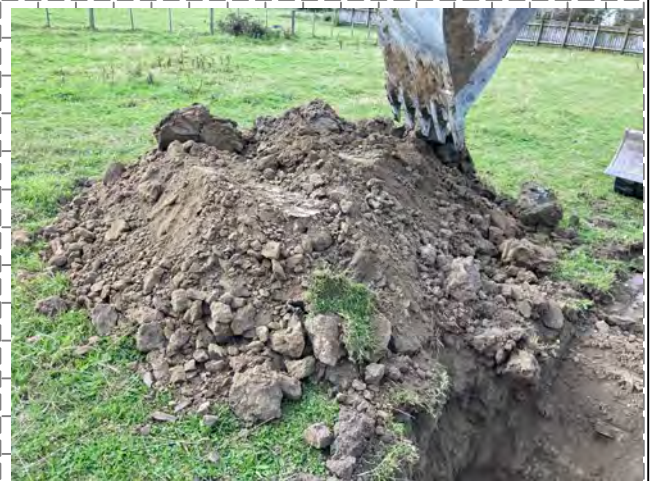
Bucket excavator met practical refusal. at 2.1 m depth .  
Scala Penetrometer met practical refusal at 2.1 m depth.  
Standing groundwater was encountered at 2 m.

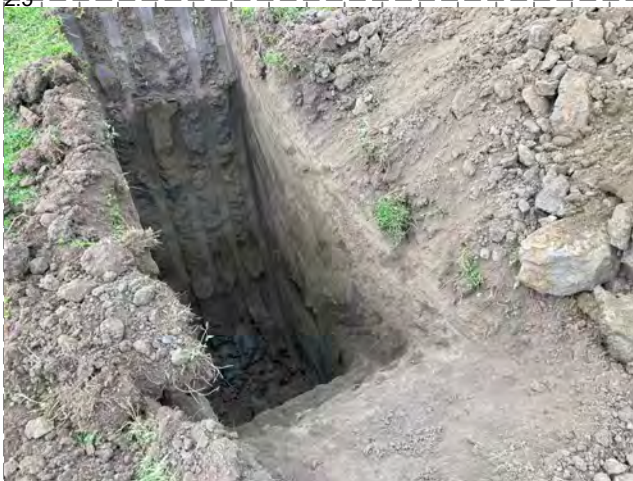
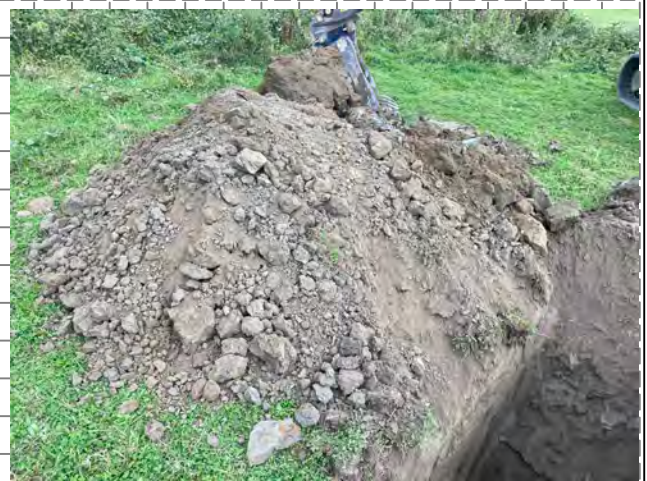
Bucket excavator met practical refusal. at 2.1 m depth .  
Scala Penetrometer met practical refusal at 2 m depth.  
Standing groundwater was encountered at 2 m.

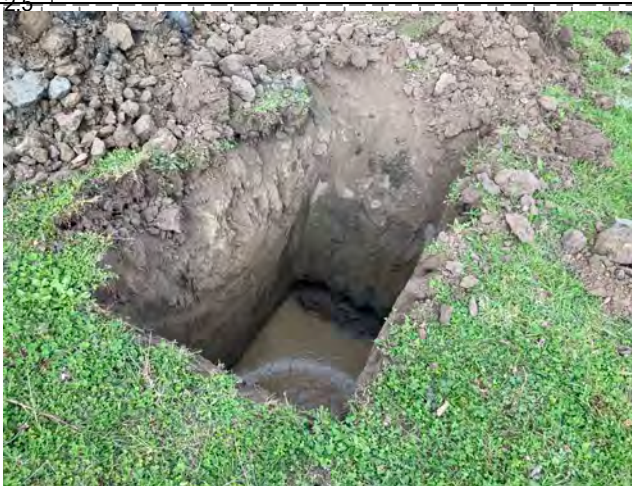
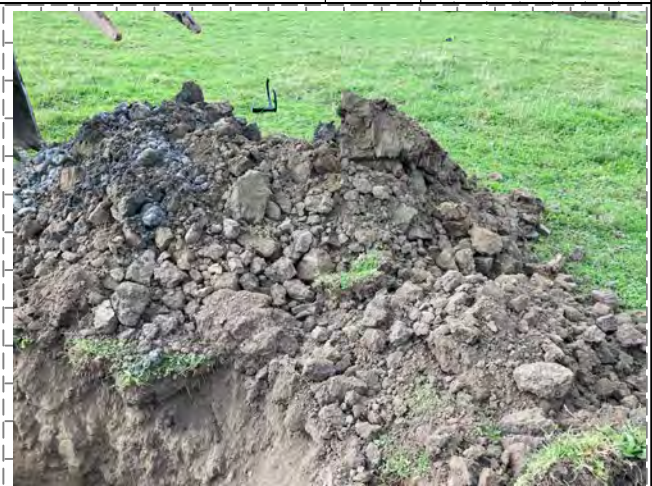
Bucket excavator met practical refusal. at 1.7 m depth .  
Scala Penetrometer met practical refusal at 1.5 m depth.  
Standing groundwater was encountered at 1.5 m.

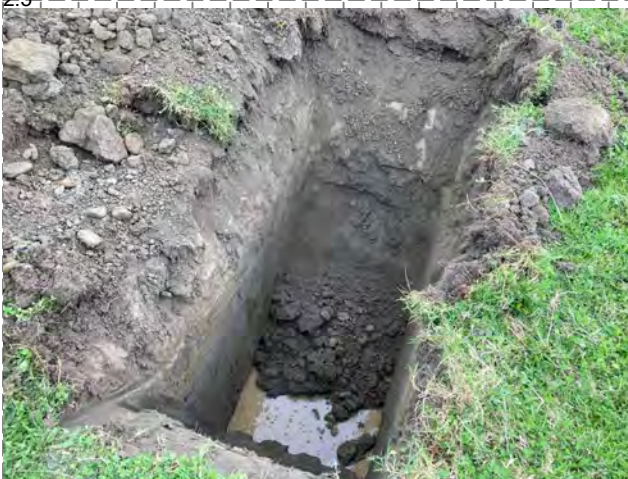
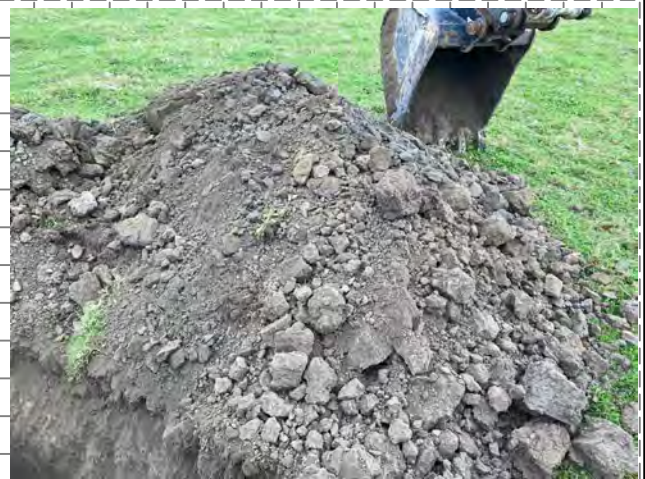
Bucket excavator met practical refusal. at 1.7 m depth .  
Scala Penetrometer met practical refusal at 1.6 m depth.  
Standing groundwater was encountered at 1.6 m.

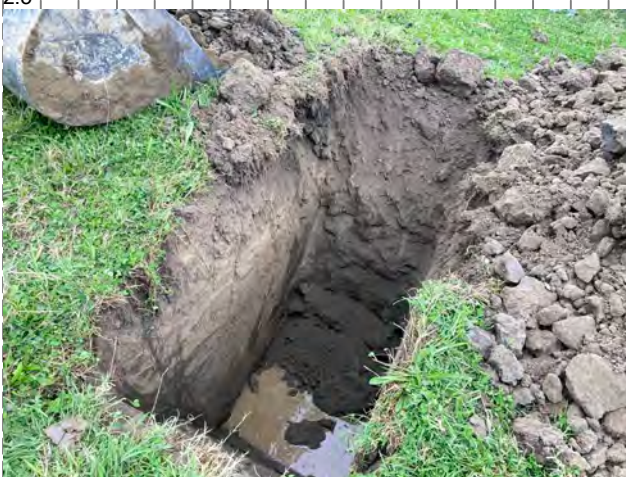
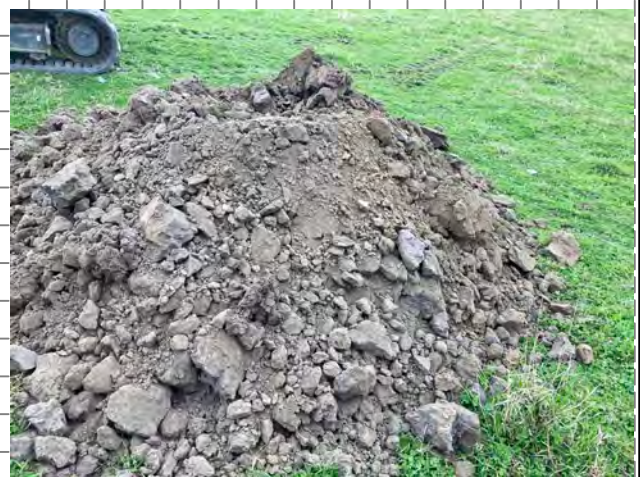
Bucket excavator met practical refusal. at 1.7 m depth .  
Scala Penetrometer met practical refusal at 1.5 m depth.  
Standing groundwater was encountered at 1.6 m.
