Annual Waikanae Borefield Report 2015/16 (Consent WGN130103 [33759])

Prepared for Greater Wellington Regional Council

On behalf of Kāpiti Coast District Council

Prepared by CH2M Beca Ltd

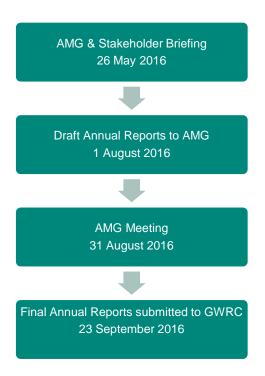
Figure 6: AMG activities associated with this year's annual report

Adaptive Management Observations and Opportunities	Consideration with AMG Recommendations
Small Coastal Streams	
Ngarara Small Coastal stream site was challenging to maintain due to high sediment movement which buried the instruments on a number of occasions. The Kakariki site is on the same stream also provides data on the stream health and is considered a better indicator of potential effects.	 Remove Ngarara SCSs monitoring site from further monitoring AMG Agreed

Recommendations made by the AMG and included in the final annual reports still require the approval of GWRC before implementation.

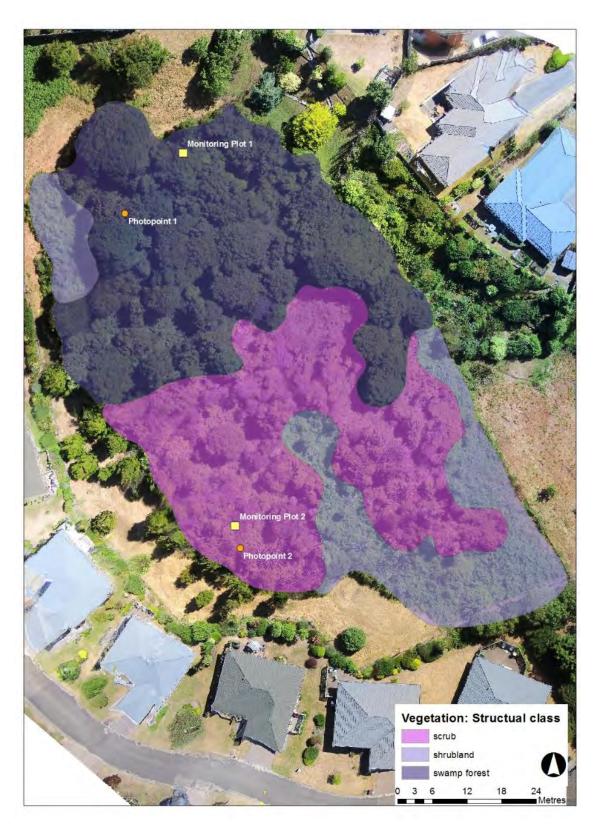
Figure 5. Local wetland vegetation communities at Crown Hill Manuka Bush Wetland (based on March 2015 aerial photograph).

The baseline map of Crown Hill Manuka Bush wetland, consisting of an aerial map and overlaid vegetation communities, both recorded during surveys undertaken in 2015 is presented as Figure 5. The community boundaries are indicative only. They change seasonally to a small degree but where hydrology is stable the boundaries should also be relatively stable.

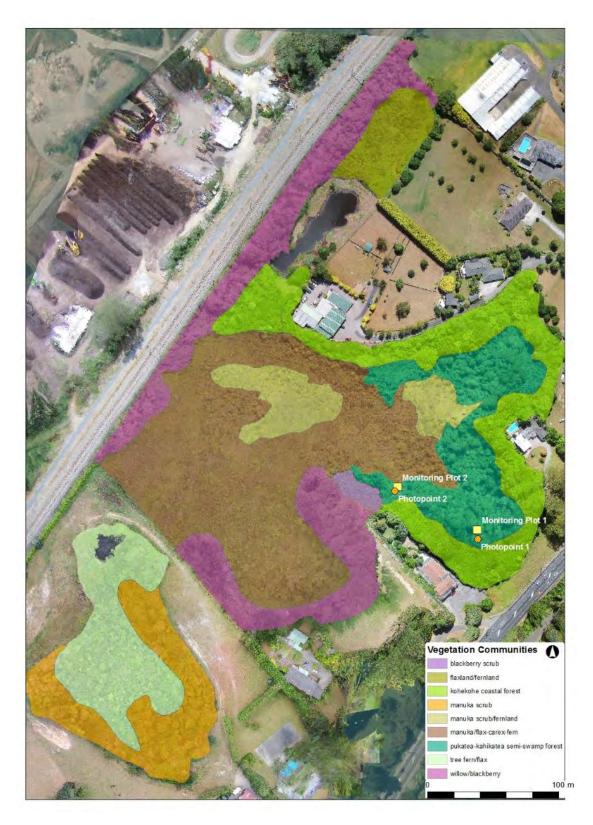
Figure 7: Local wetland vegetation communities at Muaupoko Swamp forest with position of permanent monitoring plots and photopoints (March 2015 aerial photograph).

The baseline map of Muaupoko Swamp wetland, consisting of an aerial map and overlaid vegetation communities, both recorded during surveys undertaken in 2015 is presented as Figure 7. The community boundaries are indicative only. They change seasonally to a small degree but where hydrology is stable the boundaries should also be relatively stable.

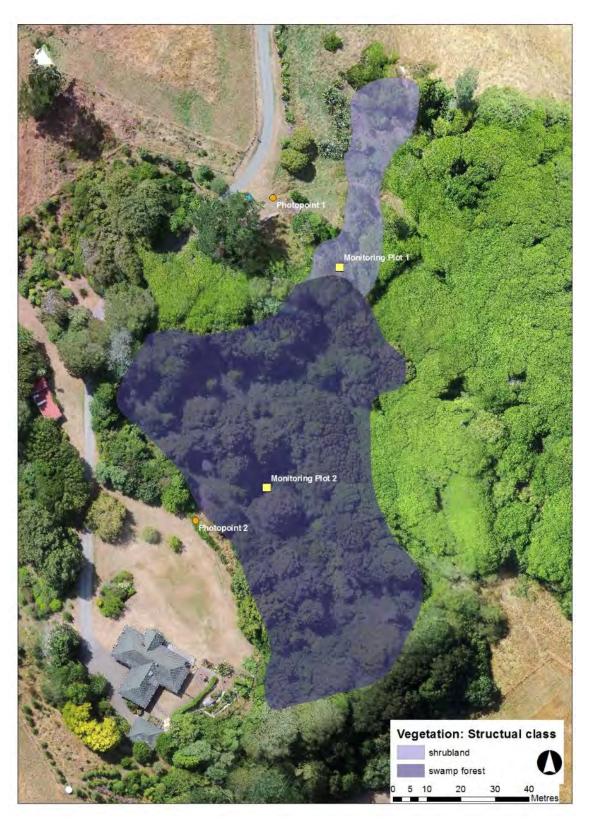
Figure 24. Local wetland vegetation communities at Ngarara Bush wetland over the March 2015 aerial photograph.

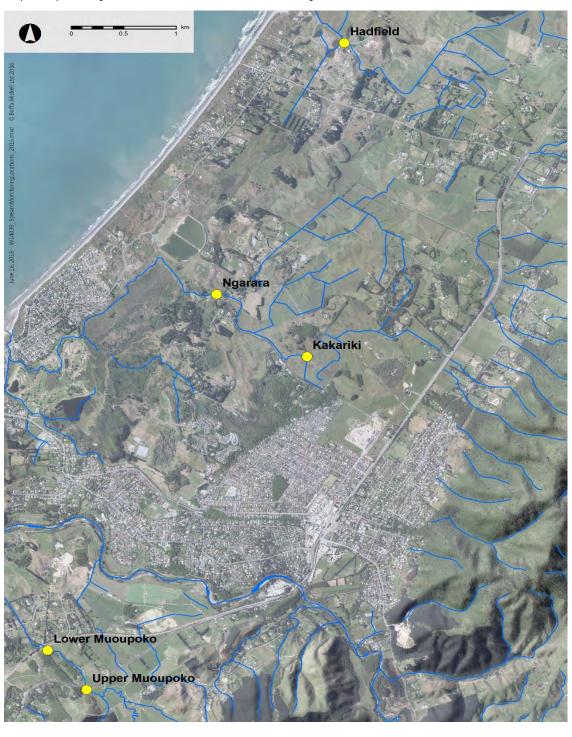
Map 1: Map showing locations of small coastal stream monitoring sites

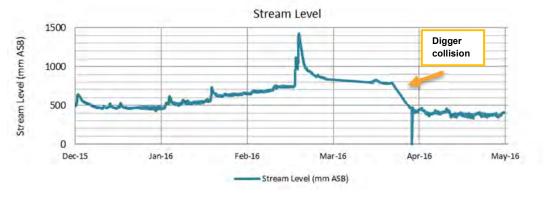
Figure 3: Stream levels at Hadfield Stream throughout the monitoring period December 2015 to May 2016

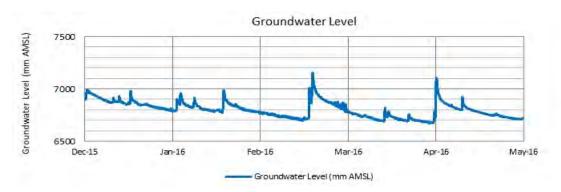
Figure 10: Ground water levels, Kakariki Stream through the monitoring period December 2015 to May 2016

Groundwater levels stayed within 6700 – 7000 mm AMSL for the whole season. The stream level sensor became buried within sediment and was not taking accurate readings until the sensor was re-calibrated in February. Dissolved oxygen levels were consistently between 8-10mg/L up until mid-January to mid-February where DO dropped to 6-8mg/L. Temperature increased gradually throughout the season until mid-February where temperatures declined.
