To:	Susan Jones, Mitchell Daysh	Job No:	2375.200
From:	Graham Ussher, RMA Ecology Ltd	Date:	23 July 2025
cc:	Holly Madden, RMA Ecology Ltd		
Subject:	100 & 110 Te Moana Road PPC: FRI response regarding ecological matters; July 2025

Attachment A – wetland investigations July 2025

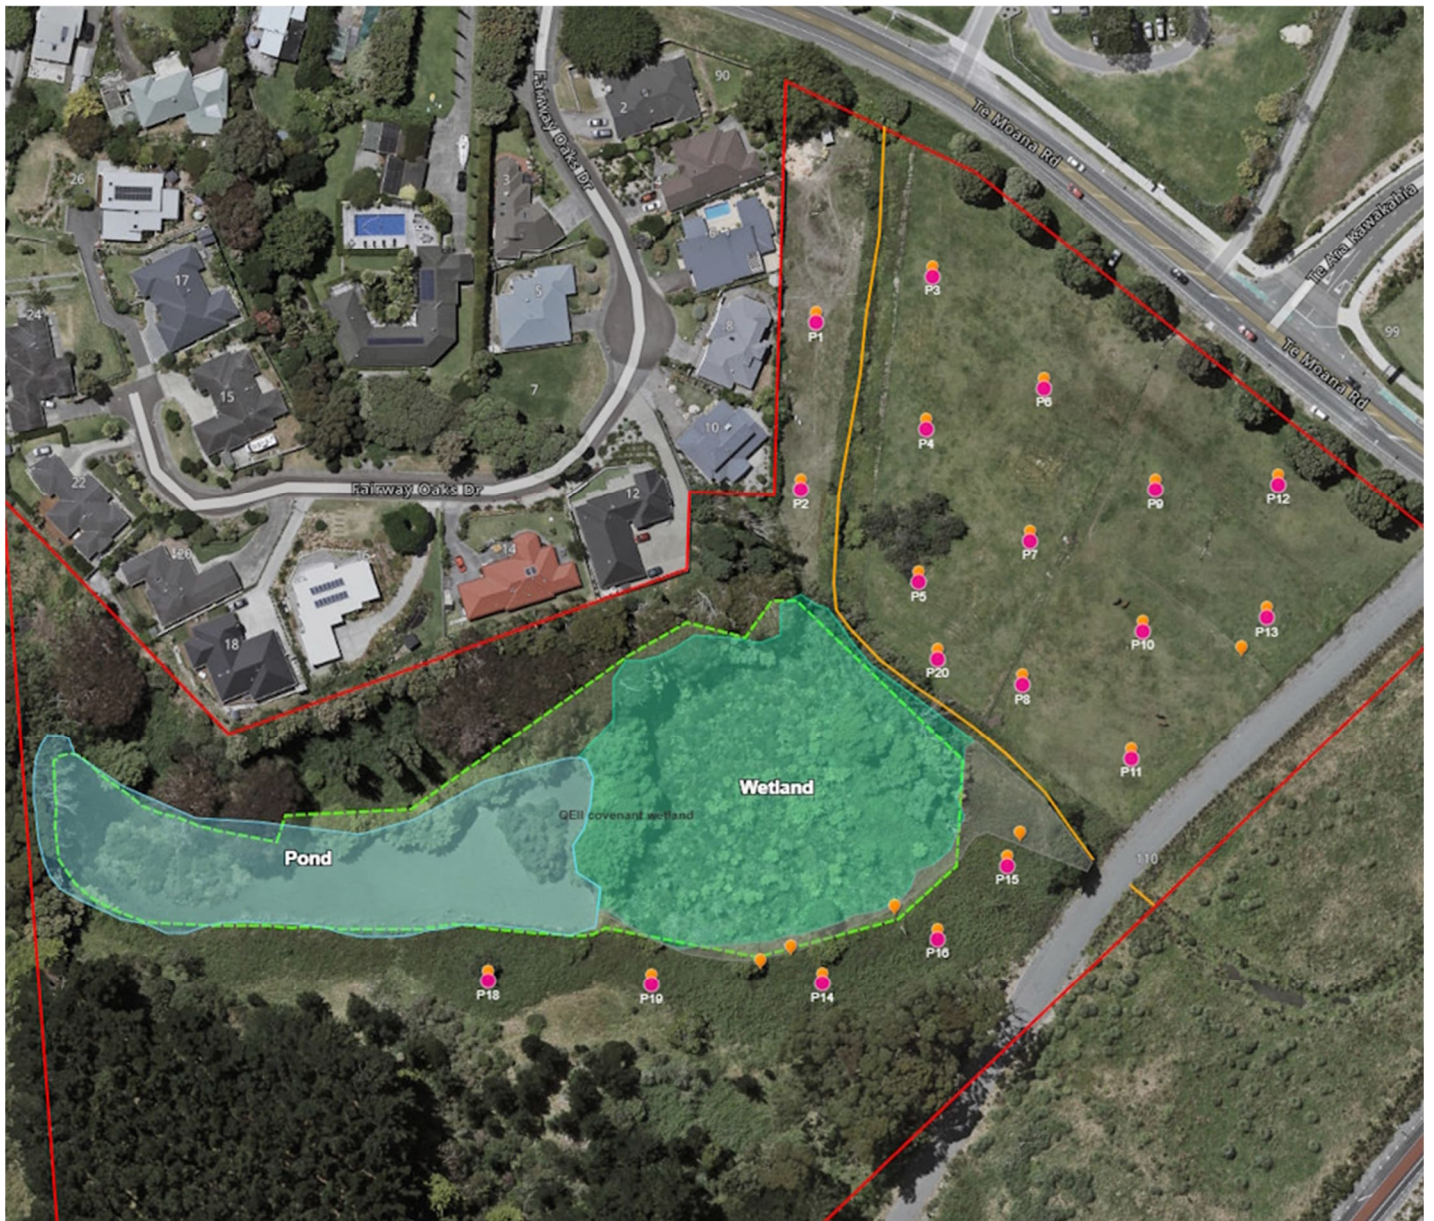
The map below shows the location of wetland vegetation plots (red dots) and soil cores (orange dots) taken in July 2025 (numbered 1-20) as well as previous samples taken during prior investigations.

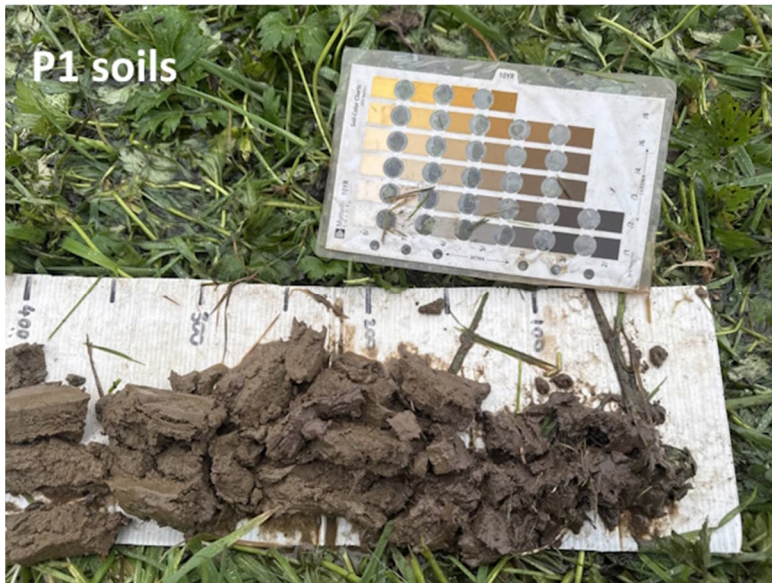
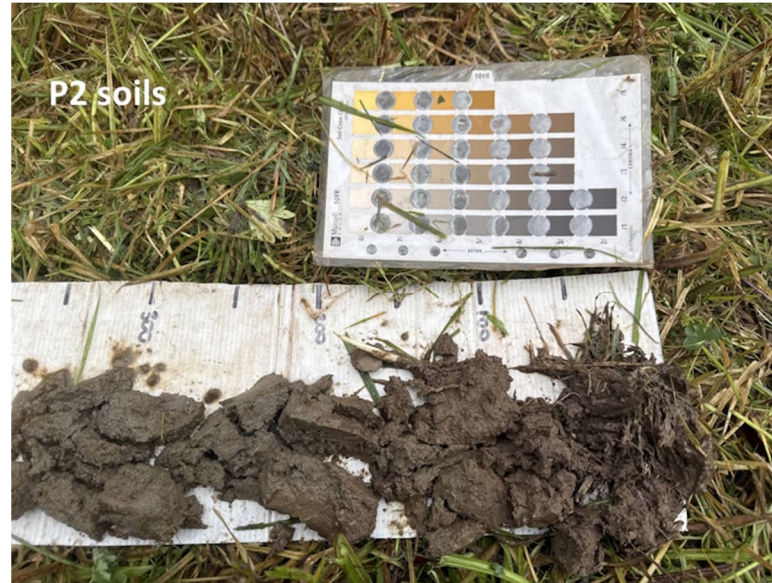
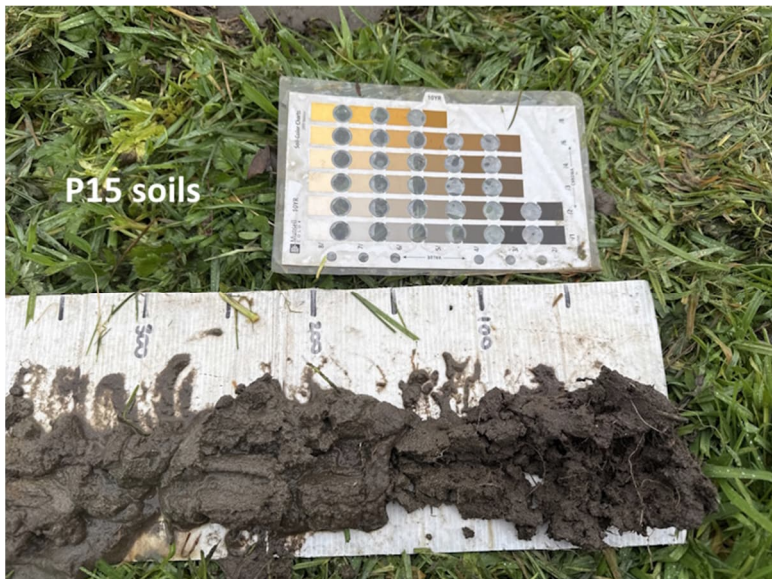
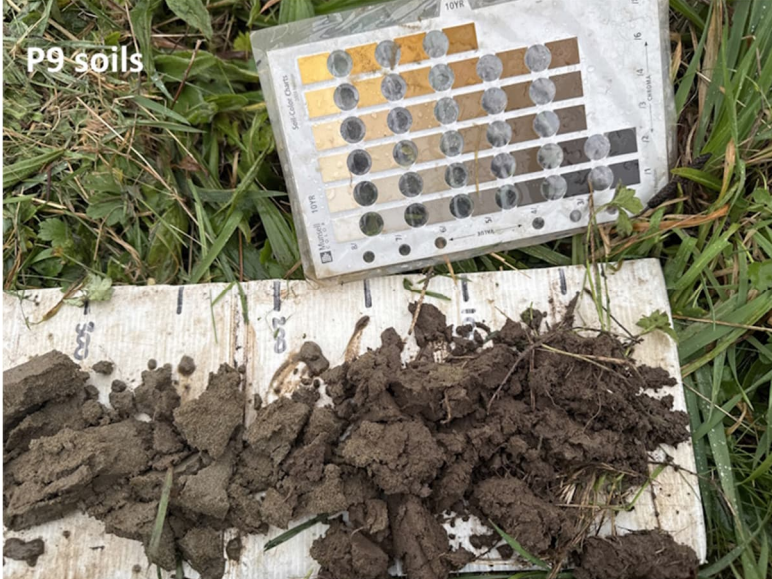
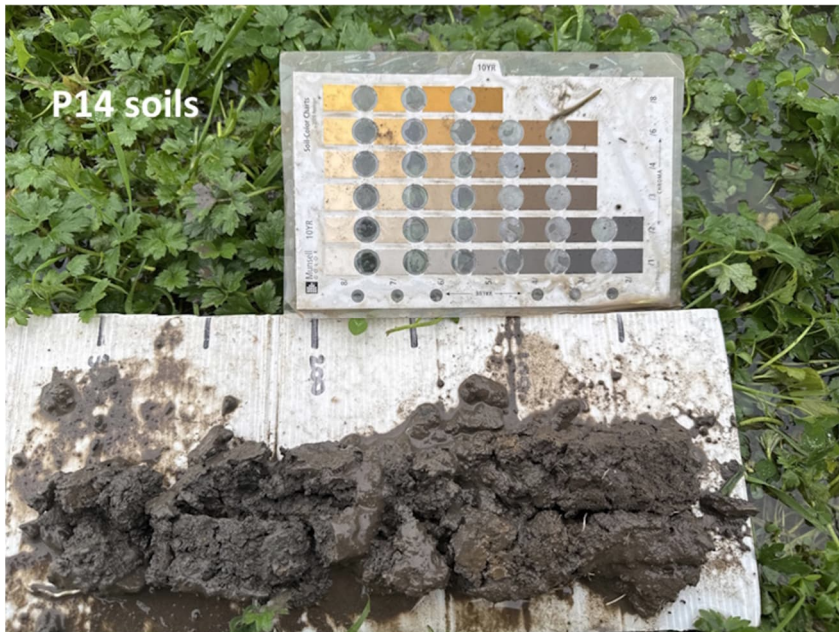
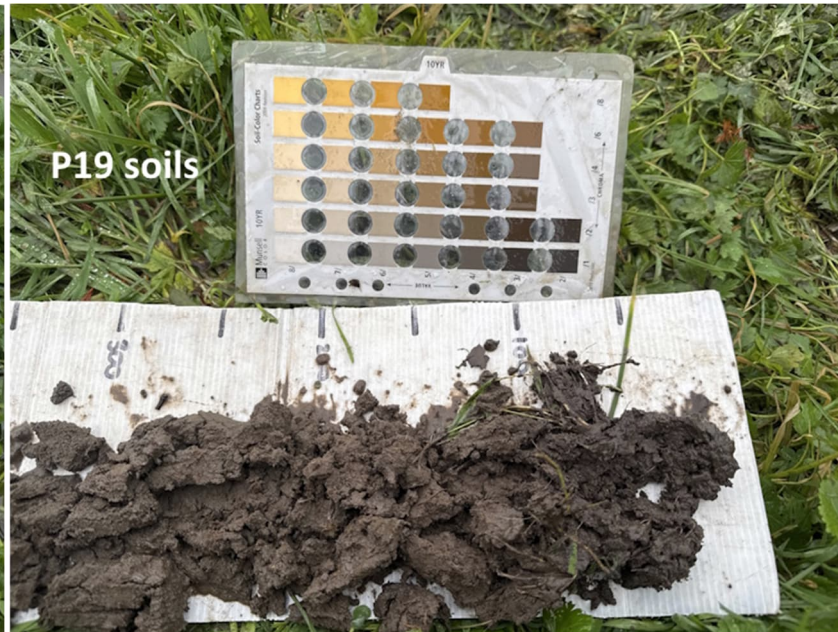
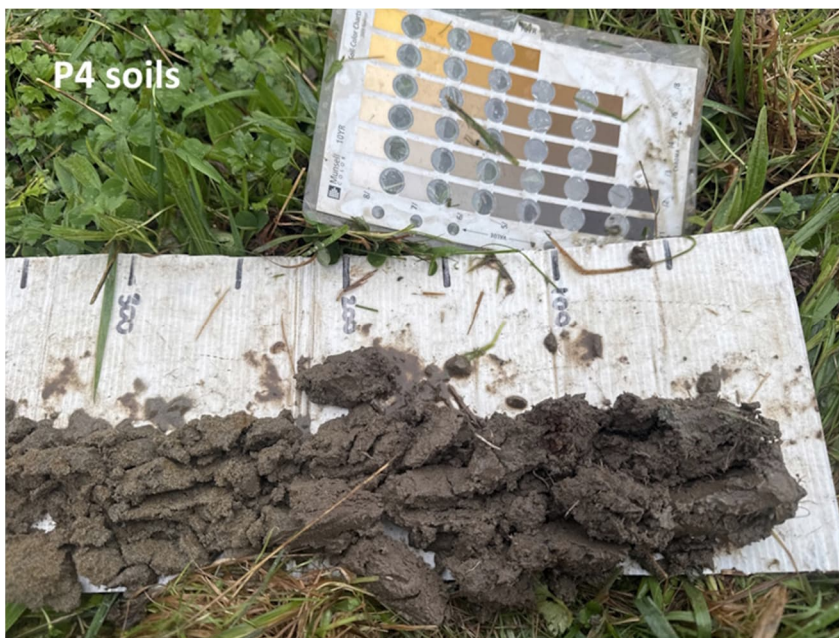
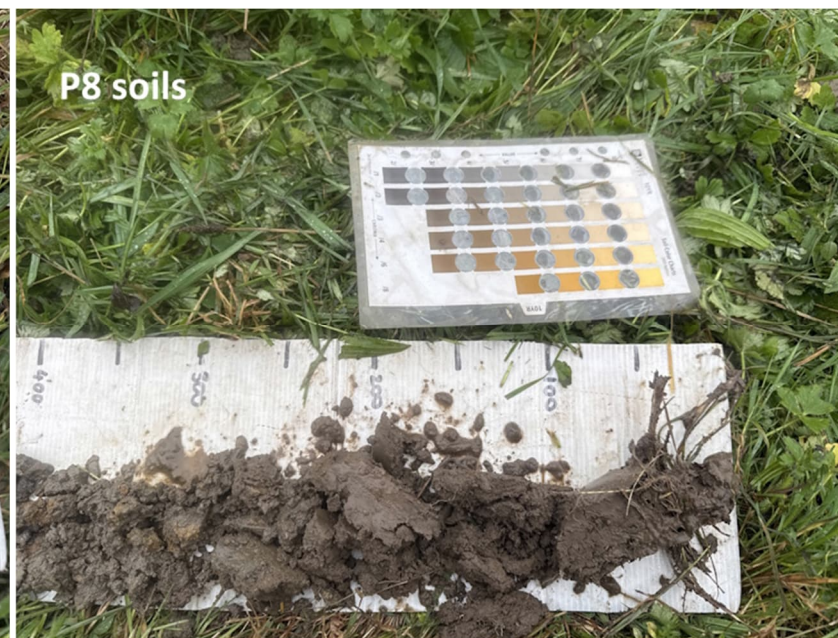
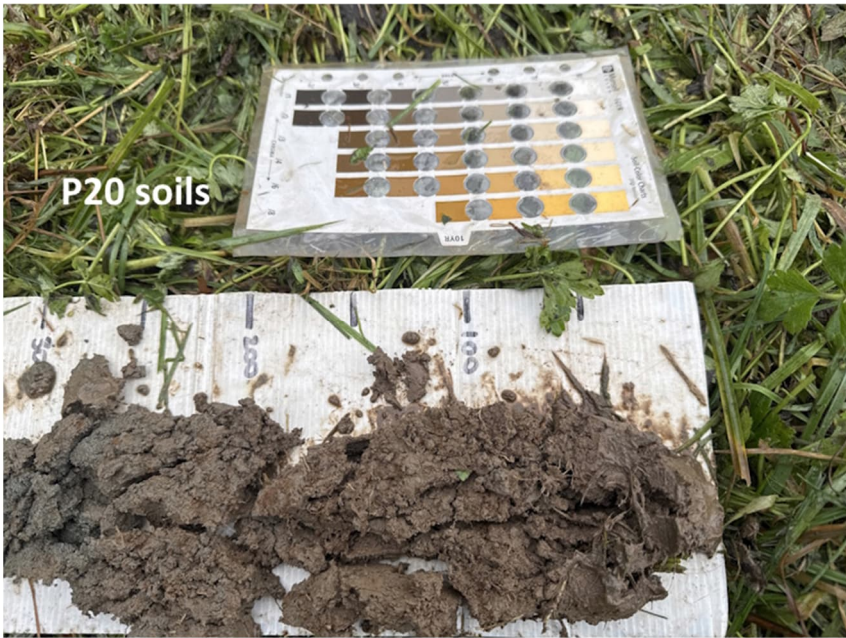
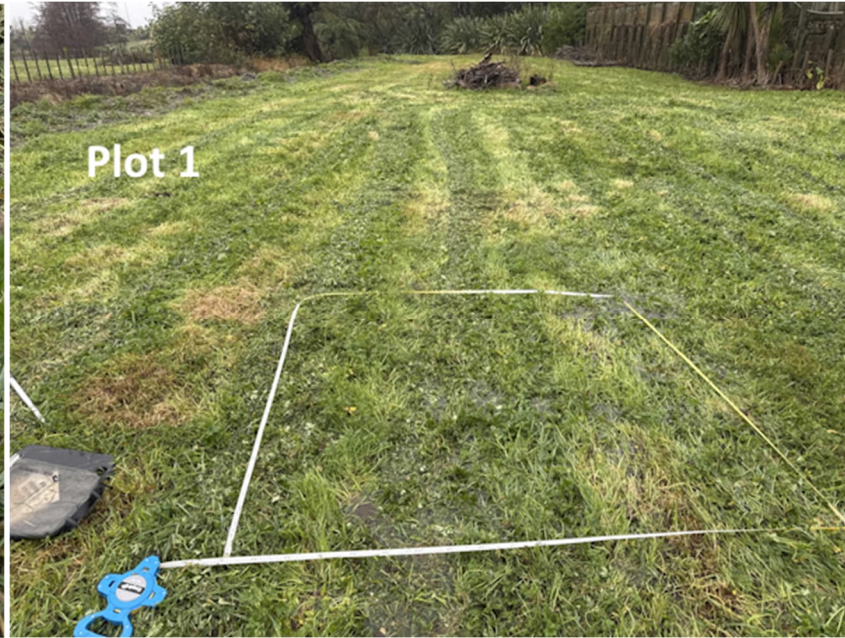
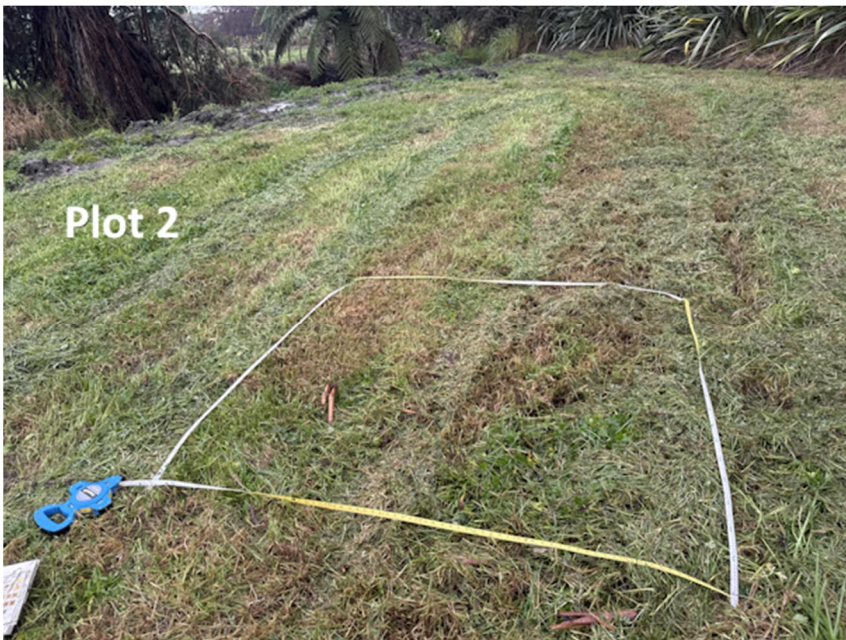
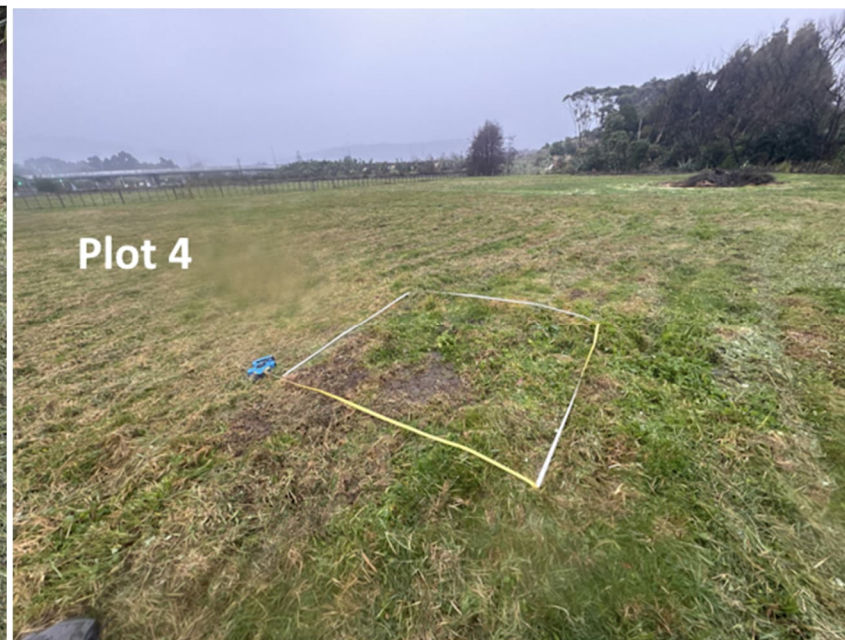
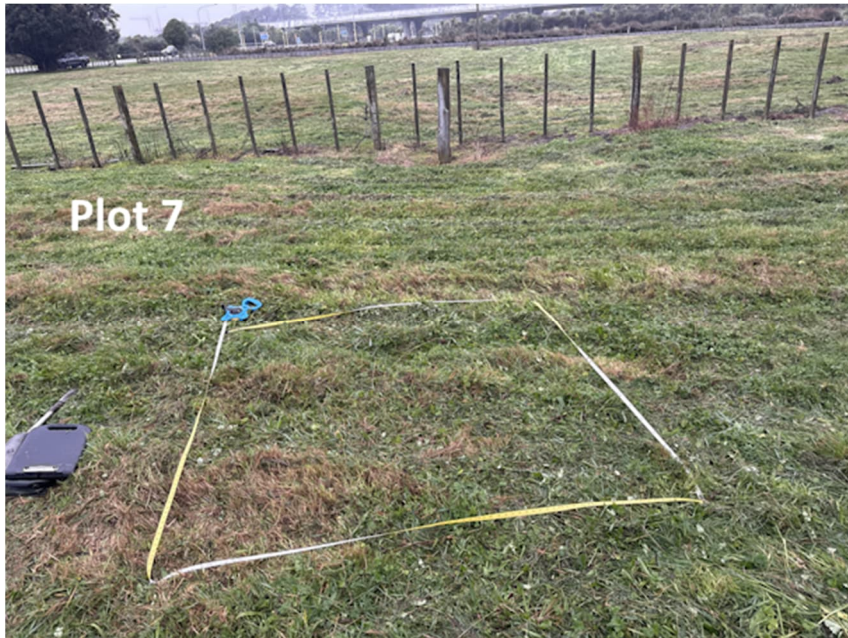
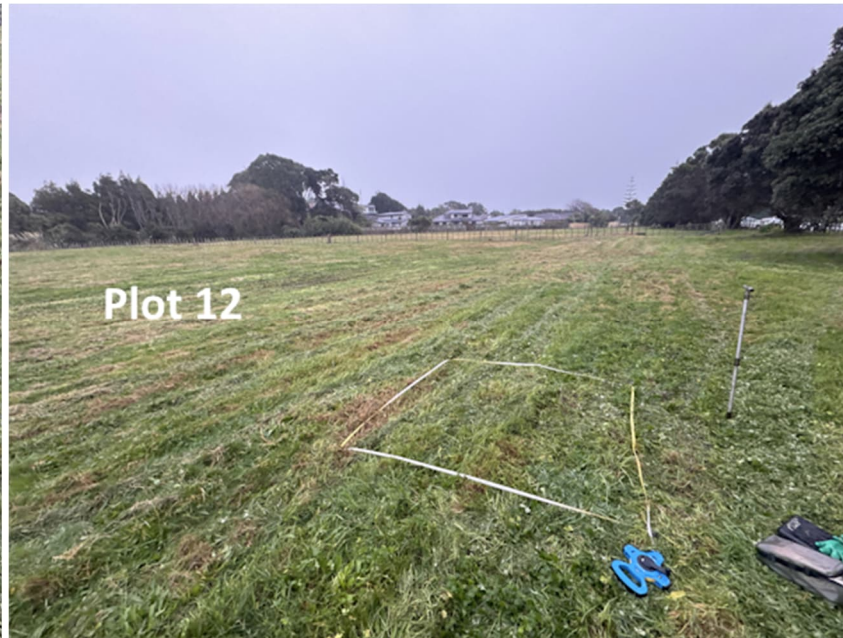
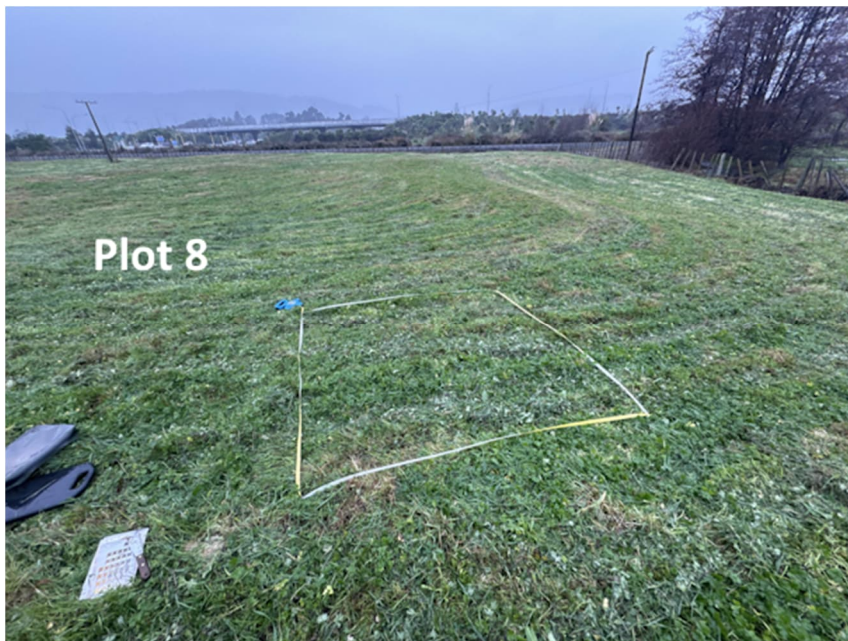
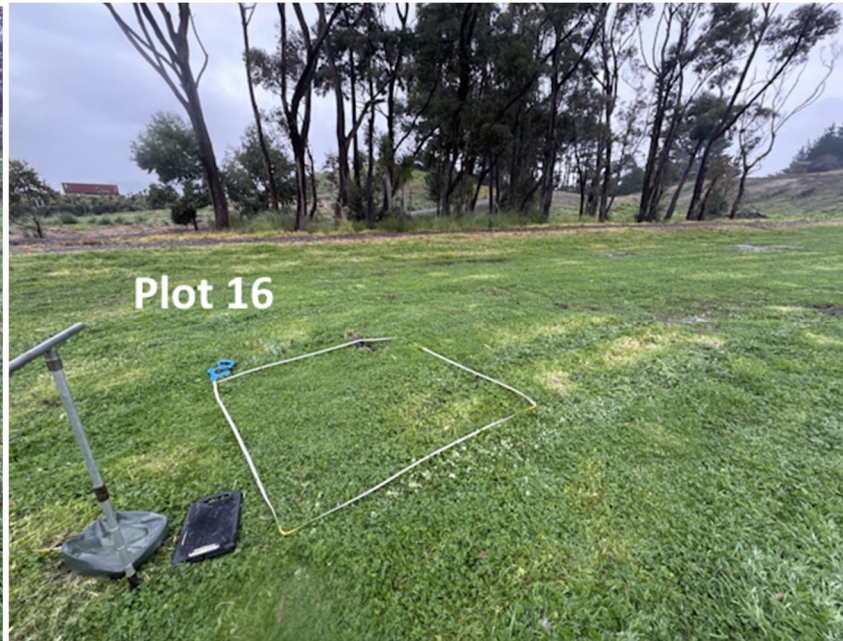
Soil core photos and site photos from plots (selection). This was taken immediately after heavy rain and after a prolonged period of weeks of periodic rain, and the site shows no water ponding. Plot locations were determined by laying down a grid over the site at a set spacing as a desktop exercise. On site plots were located within 0.5 m (accuracy of GPS) of the desktop randomly selected points.
