Northern Ohariu Fault

**Review of geomorphologic
evidence for an active fault
trace**

**Report for
Kapiti Coast District Council**

Project Number 996

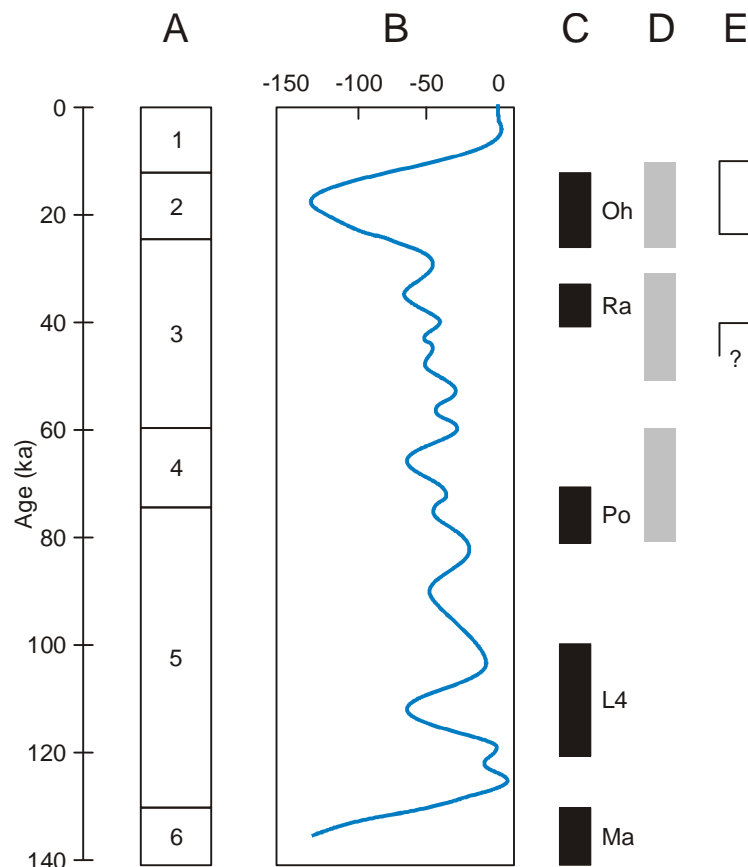
Figure 2. Quaternary stratigraphy, New Zealand. A = Oxygen Isotope stages, B = Relative Sea Level curve (metres relative to present day), C = Loess stratigraphy Oh = Ohakean, Ra = rattan, Po = Porewan, Ma = Marton. D = loess units from Palmer et al. (1998), E = Koputaroa Dune deposition. From Hawke & McConchie (2005).

In contrast to south of the Otaki River, most of the area north of the river and along Ringawhata Rd comprises an older terrace surface, the Marton Terrace. This was deposited during an older interglacial period, and is mantled with three loess units deposited in subsequent glacial events (Palmer et al. 1988). The age of the surface is 140–150 kA and the overlying loess units are approximately 15–25, 30–50 and 65–75 kA respectively (Palmer & Van Dissen 2002, see Figure 2).

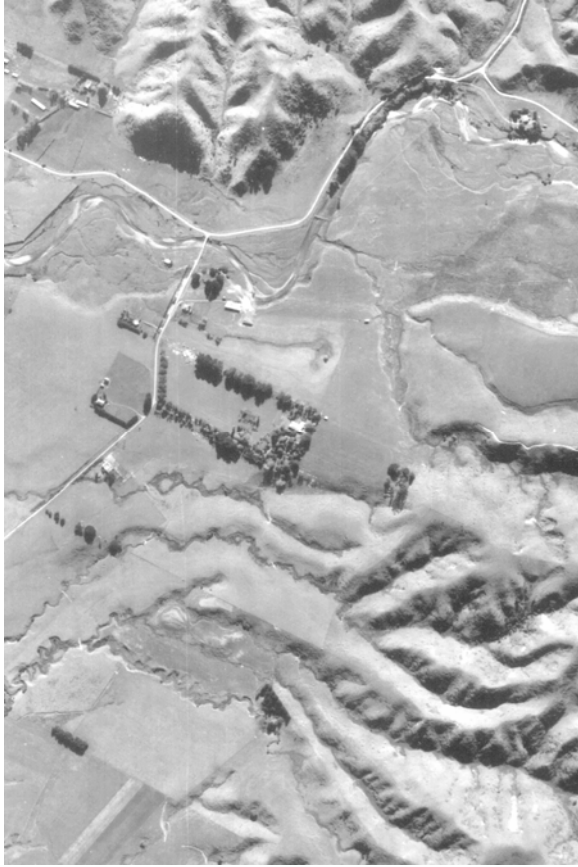
Figure 7. 1948 vertical aerial photograph (SN 198 Run 306/9) of northern Ringawhata Rd area.

On the “Older Recent Alluvium” surface adjacent to Waitohu Stream (Figure 6B, Section 10), there is a clear fault trace evident in aerial photographs and the LIDAR data, though the vertical offset appears to be less than 0.3m. A distinct change in vegetation across the fault trace indicates drainage from the western (upstream) side is impeded by the fault. GNS state there is clear evidence on the 1949 aerial photographs for right lateral offset at this locality. We were unable to detect such evidence on the photographs, or on the ground (Figure 7).

Where the fault crosses Waitohu Stream, GNS describe clear evidence (on the 1948 aerial photographs) for right lateral offset (though no details are given). We are unable to confirm these observations from our inspection of the same aerial photographs and the LIDAR data, or on the ground.

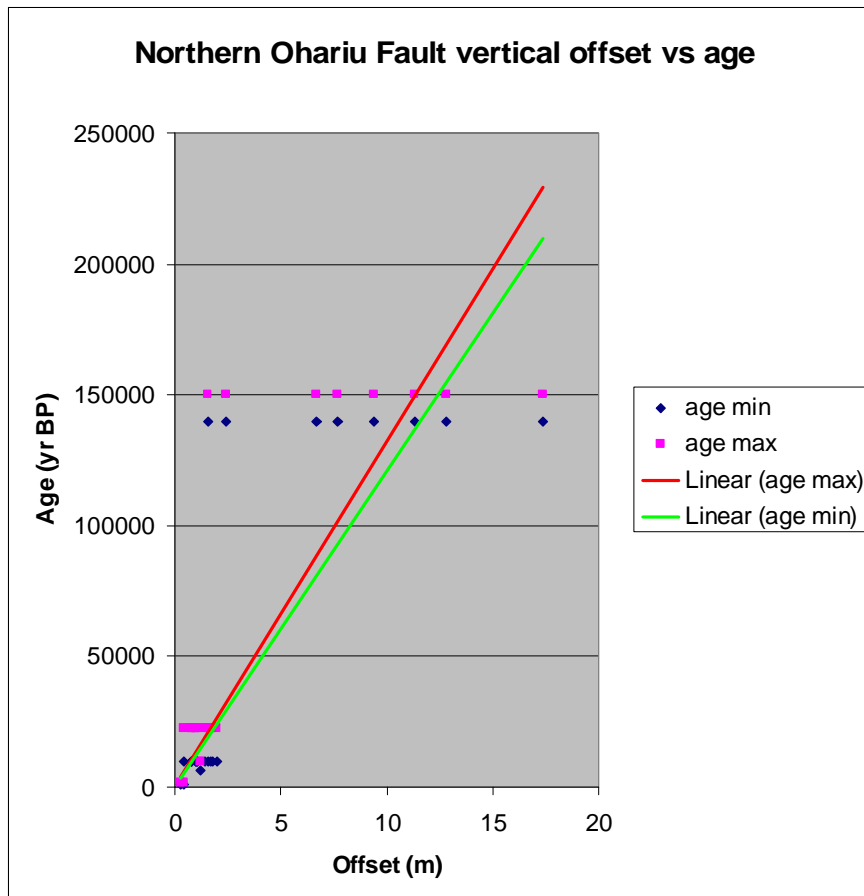
Figure 9. Plot of total vertical offset versus age, with linear best fits for minimum and maximum surface ages.

Vertical offsets up to 2 m are present on the Ohakea II (OI2) surface, and up to 17.5 m on the Marton Terrace (OI6) surface which is 8 times older. A plot of age versus offset (Figure 9) indicates that the fault is characterised by an average vertical offset rate of 10m in about 120,000 yrs (0.08 mm per year). A maximum vertical offset rate for the fault (calculated from 17.5 m in 140,000 yrs, which includes all vertical movements) is about 0.12 mm per year. On the Ohakea II surface, the vertical offset rate is 0.09 mm per year (assuming the surface is c. 22000 yrs old), which is consistent with the rate seen on the older Marton surface. Rates of subsidence adjacent to the fault trace along Ringawhata Rd are 0.03–0.07 mm per year, and the rate of uplift is 0.03–0.05 mm per year.

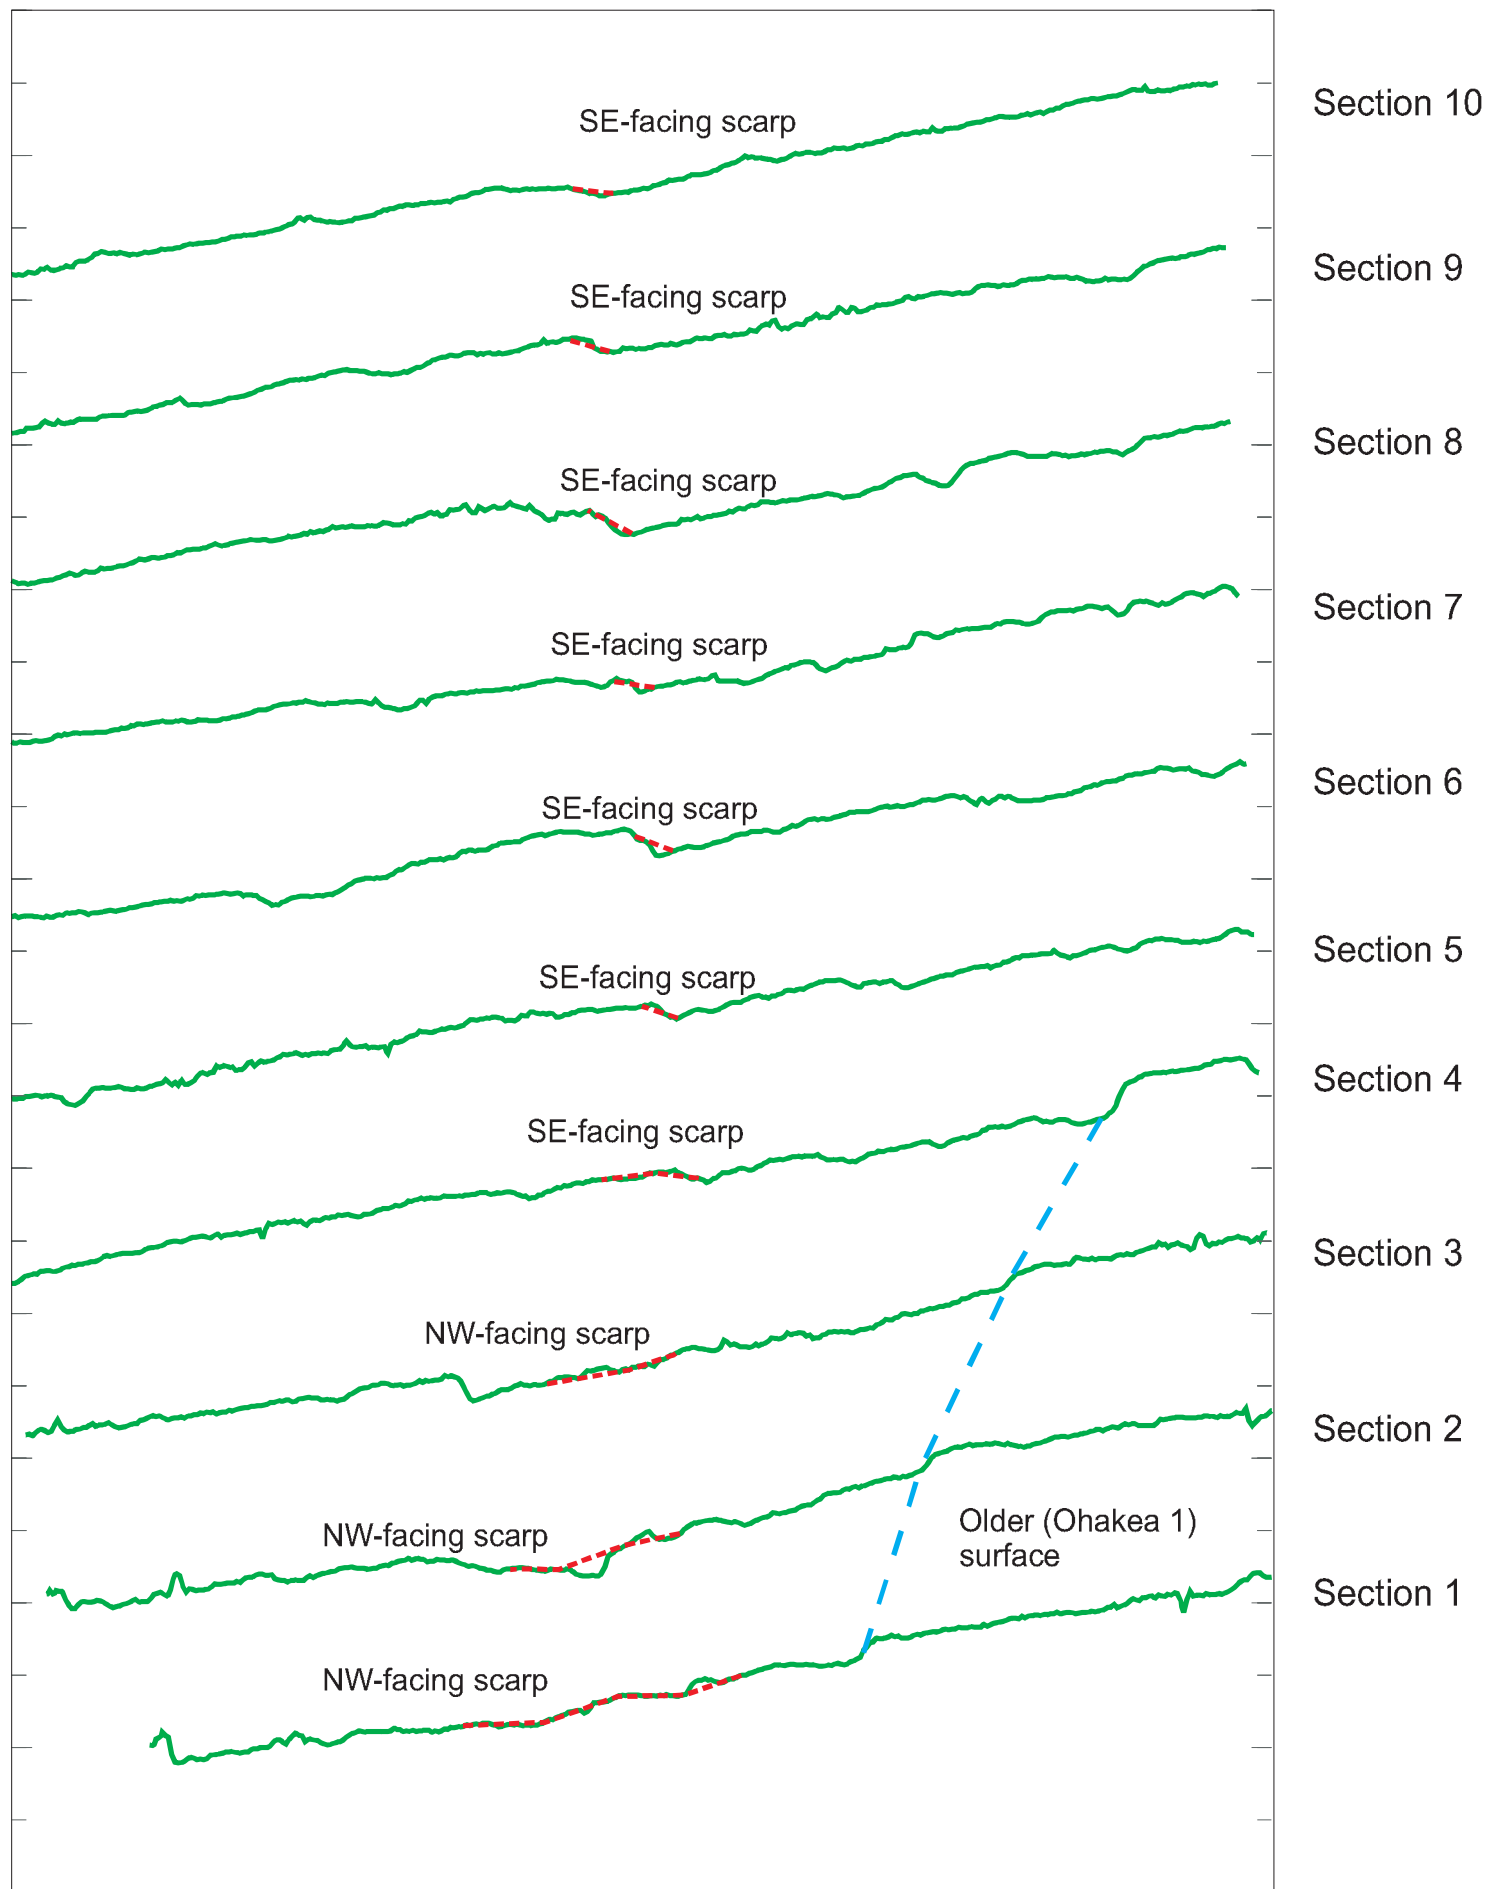
DRAWN	SDW	FIGURE	5A
APPROVED	IRB	DATE	11-Dec-2008

Cross sections 1-10
South of Otaki River

South of the Otaki River, the Northern Ohariu Fault is expressed as a generally continuous low linear scarp which can be clearly seen on the ground, on aerial photographs and in the LIDAR data. We have generated a series of 15 cross sections across the fault scarp at a spacing of 250m to enable the vertical offset across the scarp to be measured (Figure 5A/B).

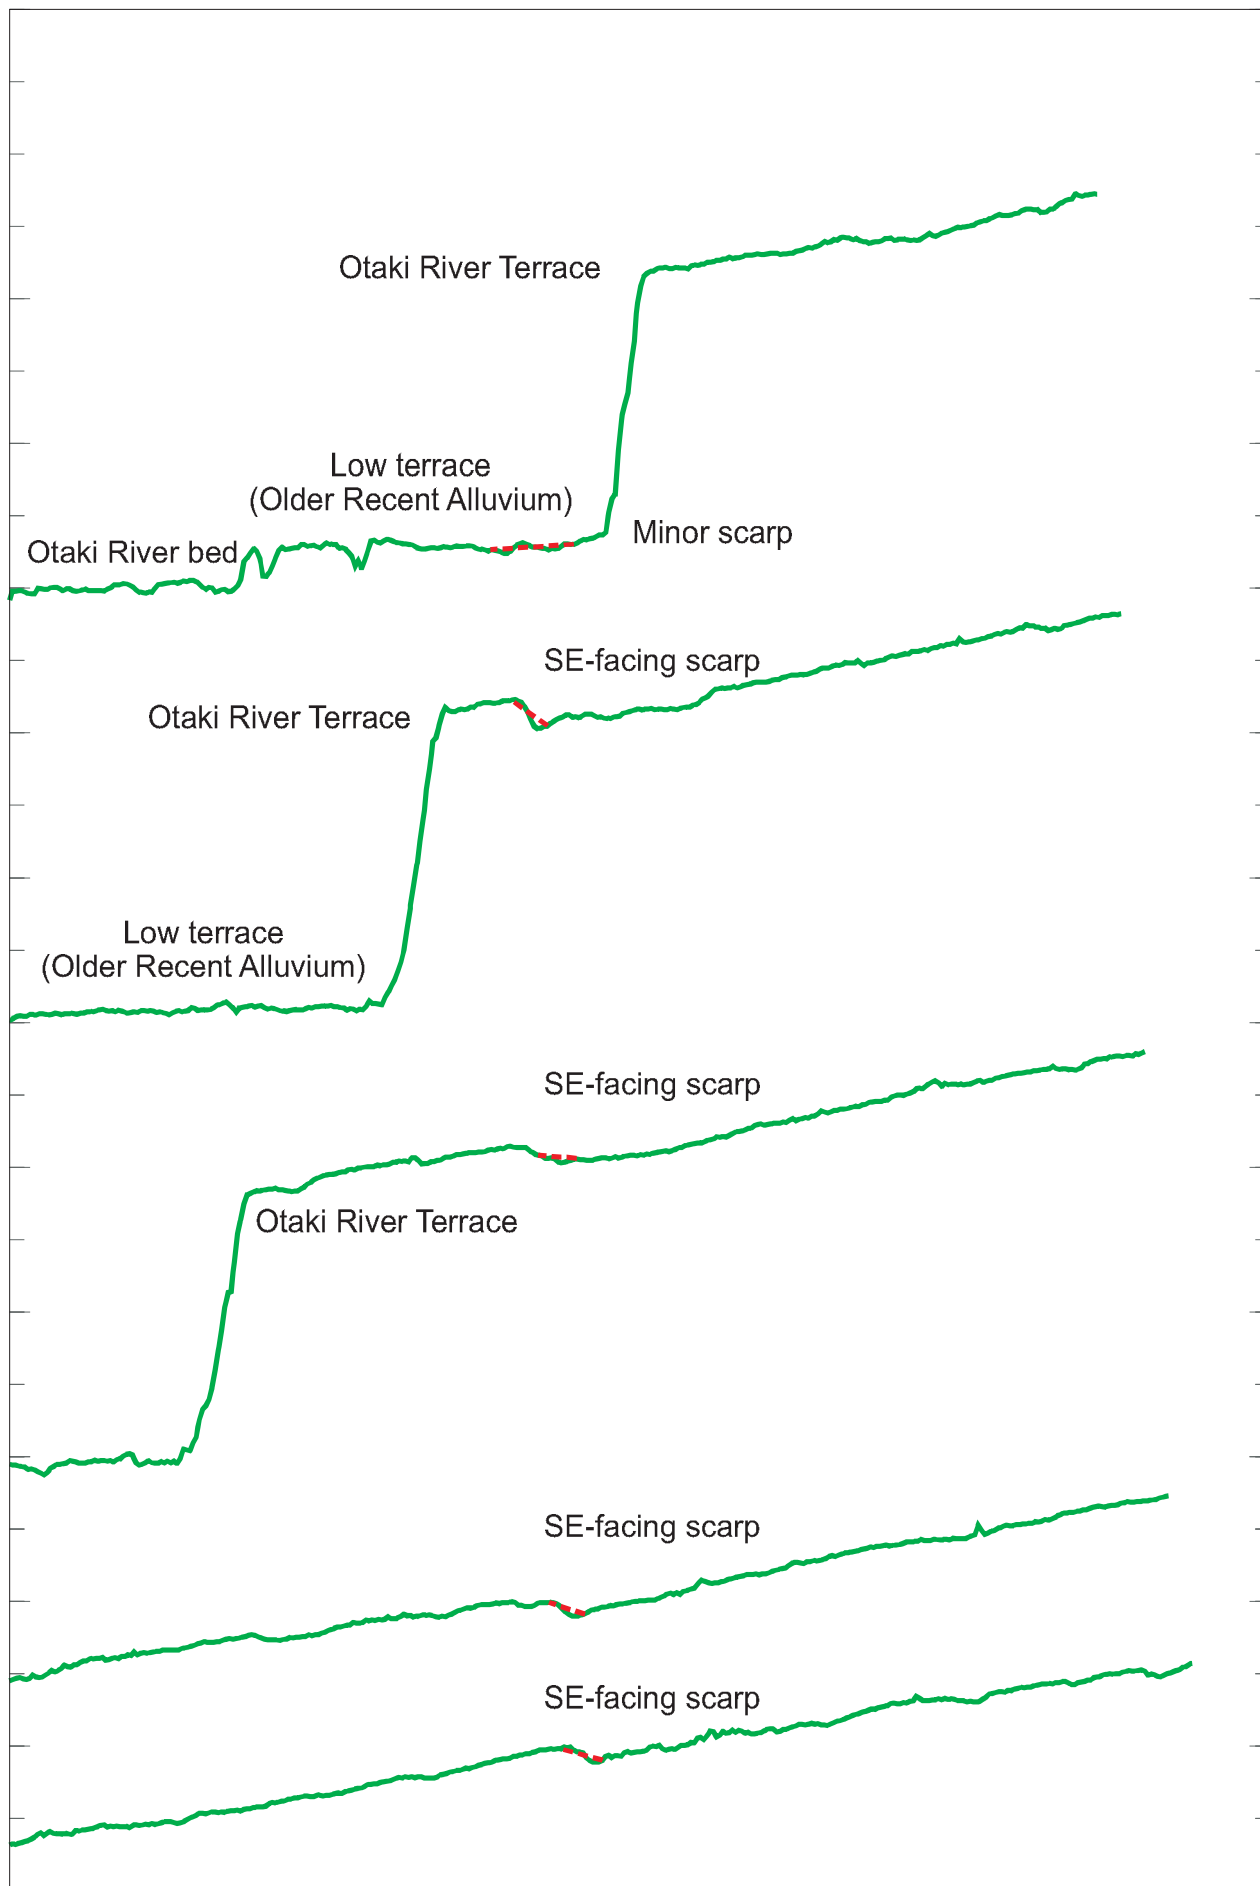
DRAWN	SDW	FIGURE	5B
APPROVED	IRB	DATE	11-Dec-2008

Cross sections 11-15
 South of Otaki River

Adjacent to the Otaki River, the fault location can be clearly identified on the Ohakea II surface extending to its eroded edge. On the lower terrace, GNS indicate that the fault can be clearly seen on the 1948 aerial photographs, at a position slightly offset to the NW from the position on the high terrace, which is inferred to indicate dip on the fault plane. Due to orchard development in the area, the feature is not visible on current photographs. The LIDAR data also shows a subtle feature on the inboard (cliff) side of the low terrace, extending for a distance of c.85 m from the base of the cliff, though no lateral offset is evident (Figure 3). The vertical fault offset determined from our cross section through this area is 0.4m, which is similar to variation in elevation for adjacent parts of the low terrace surface (Figure 5B, Section 15). In contrast, the fault offset on the adjacent upper, older surface is 2.0m (Figure 5B, Section 14).

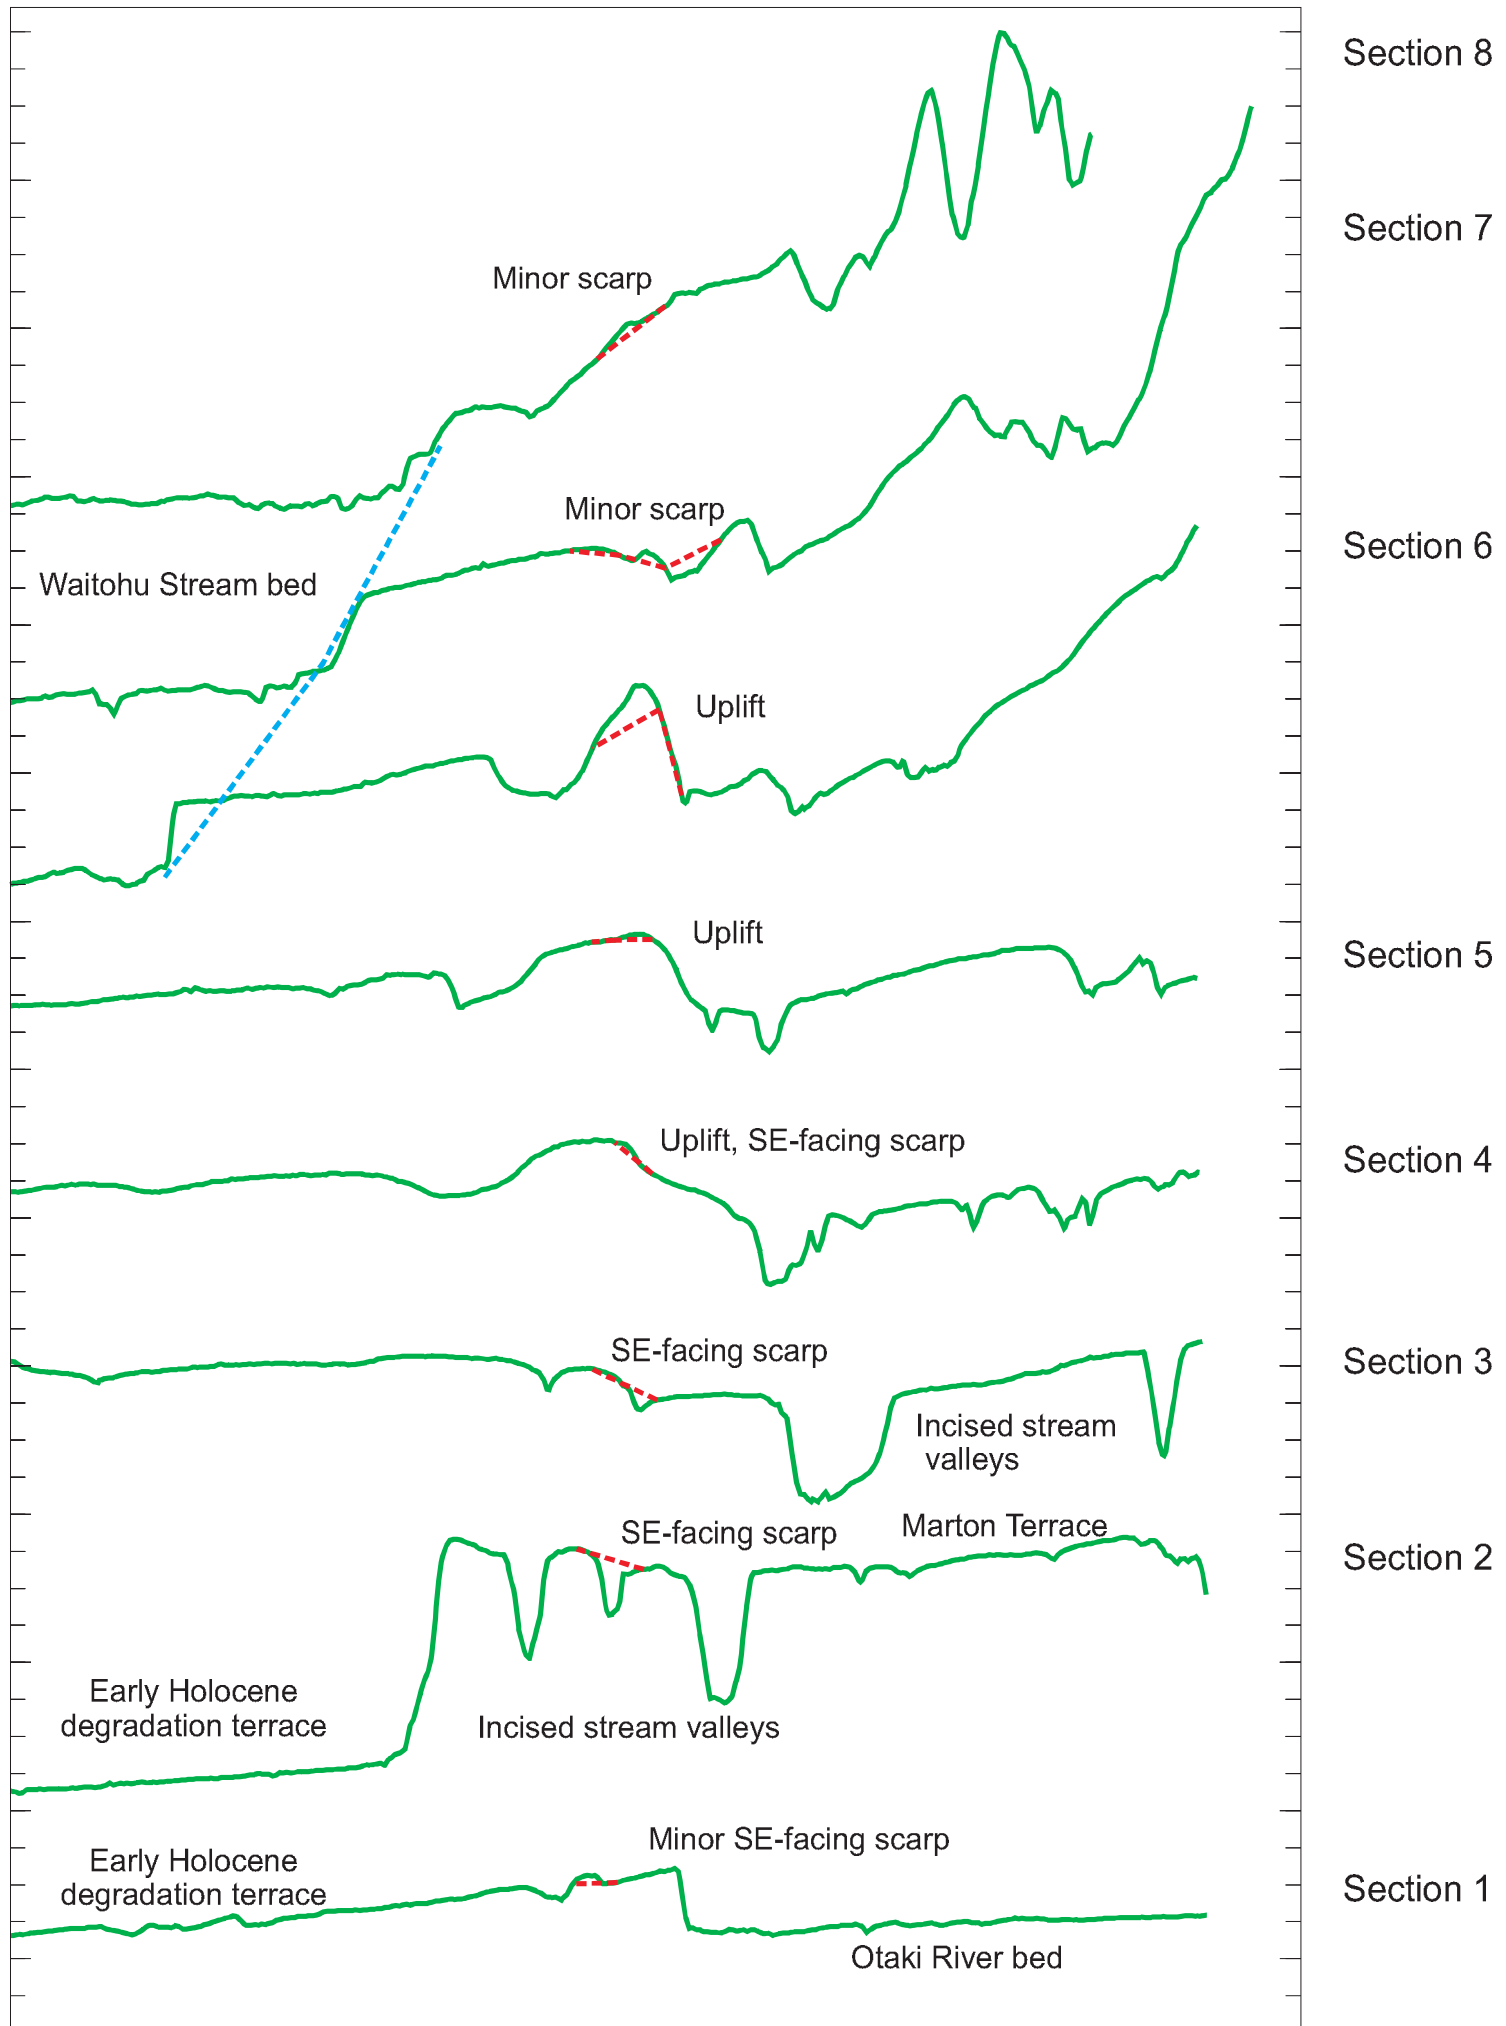
DRAWN	SDW	FIGURE	6A
APPROVED	IRB	DATE	11-Dec-2008

Cross sections 1-8
North of Otaki River

In contrast to the southern section, the fault character across the area from the Otaki River to Waitohu Stream is complicated by extensive fluvial erosion of the Marton Terrace surface, and uplift or subsidence adjacent to parts of the fault trace (Figure 4). Drainage appears to be diverted around the areas of uplift and through the areas of subsidence. Measured vertical offsets determined from cross sections are listed in Table 2, and cross section locations are shown in Figure 4. Cross sections are shown in Figure 6A, B.

The GNS mapped fault polygons adequately capture the position and / or likely position of the fault trace. However, between Sections 5 and 9 (Figure 6A), deformation is “Distributed” (comprising multiple fault traces and/or folds) and not “Well Defined” as indicated (Ministry for the Environment 2003, Table 8.1).

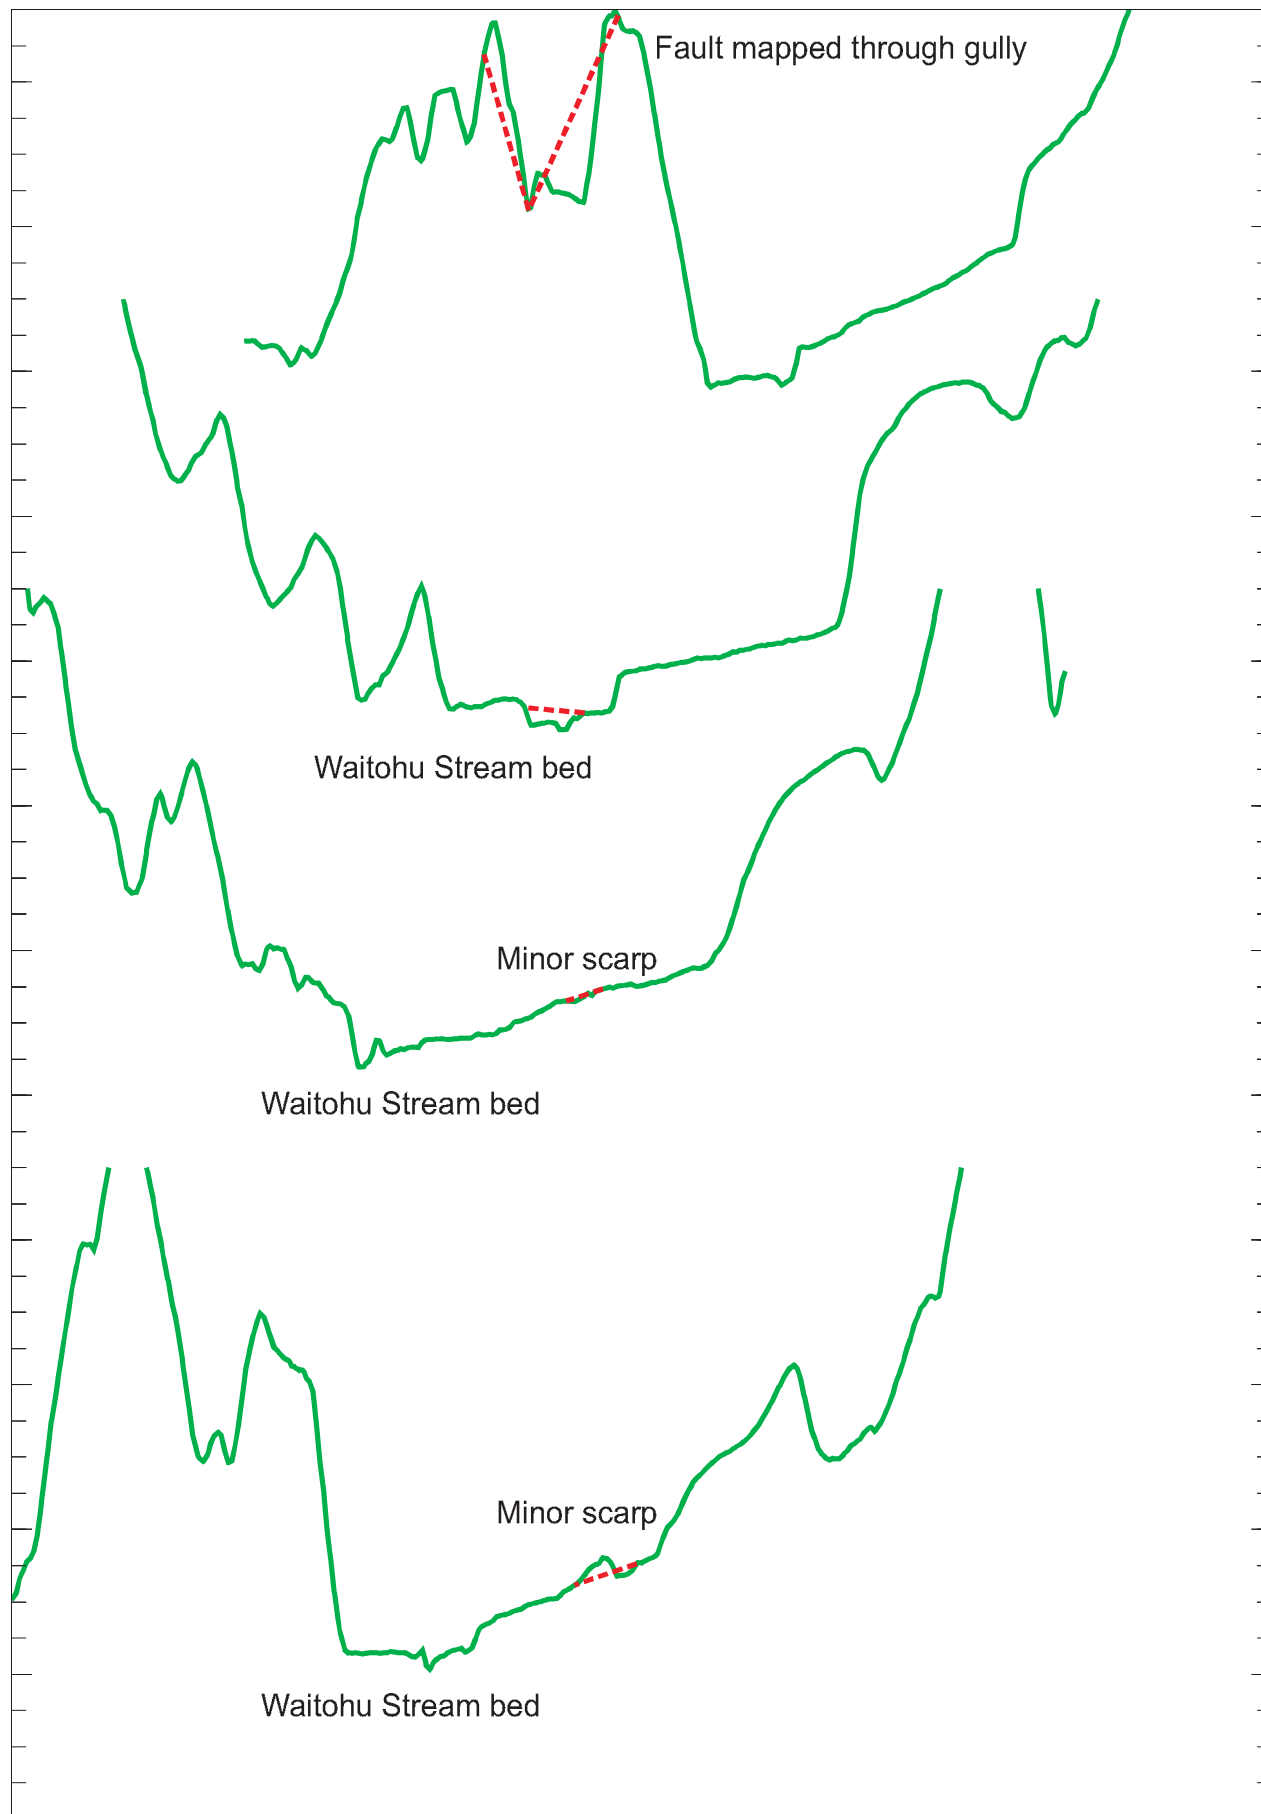
DRAWN	SDW	FIGURE	6B
APPROVED	IRB	DATE	11-Dec-2008

Cross sections 9 -12
 South of Otaki River
