# Lower Maungakotukutuku Geotech Feasibility

**Lower Maungakotukutuku Dam  
Factual Geotechnical Report**

July 2010

Kapiti Coast District Council

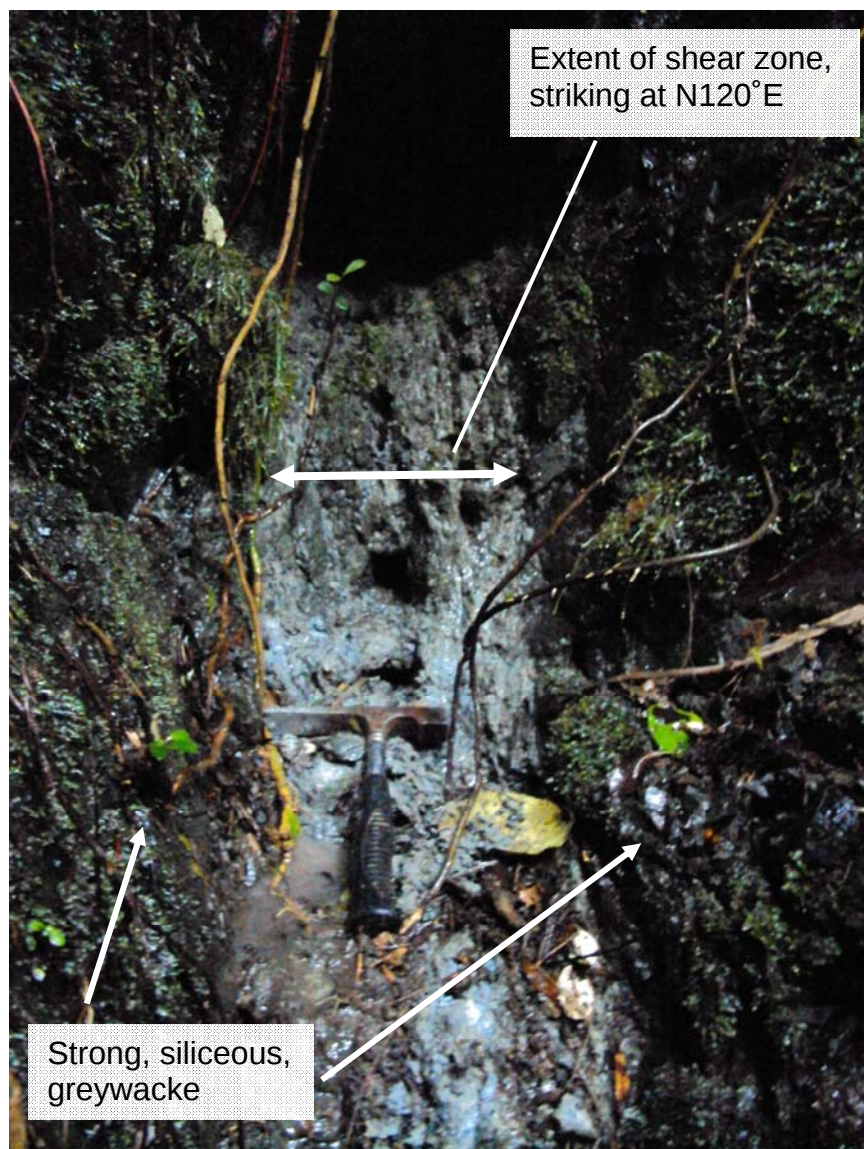
**Figure 3.1. Shear Zone**
