Raumati Pool Building Seismic Strengthening Project

Background

Details of Stage 1

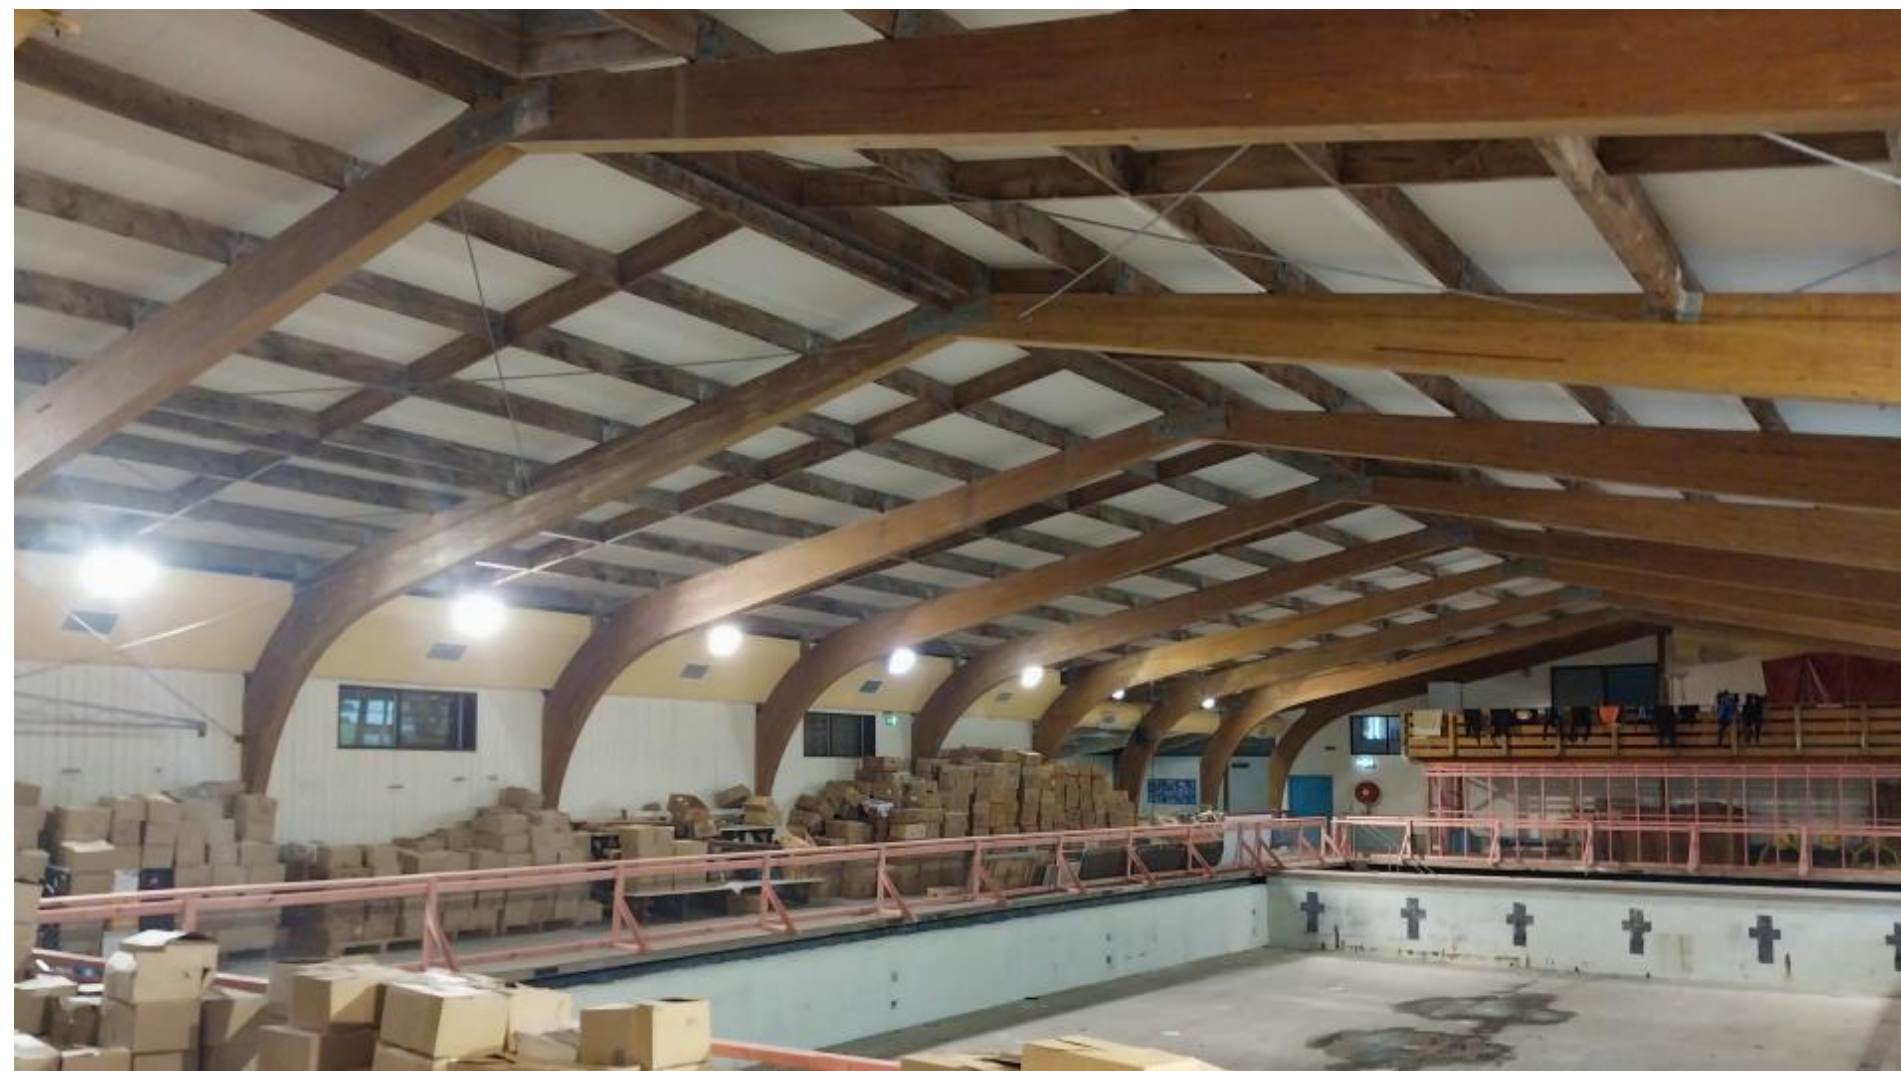
Stage 2 Main Pool & Southern End of Building

Stage 2: Strengthen the remainder of the building, which includes the structural beams over the open pool area, the eastern and western walls, and the southern end of the building formally known as the “Raptors Swim Club”. Work is planned for the next LTP

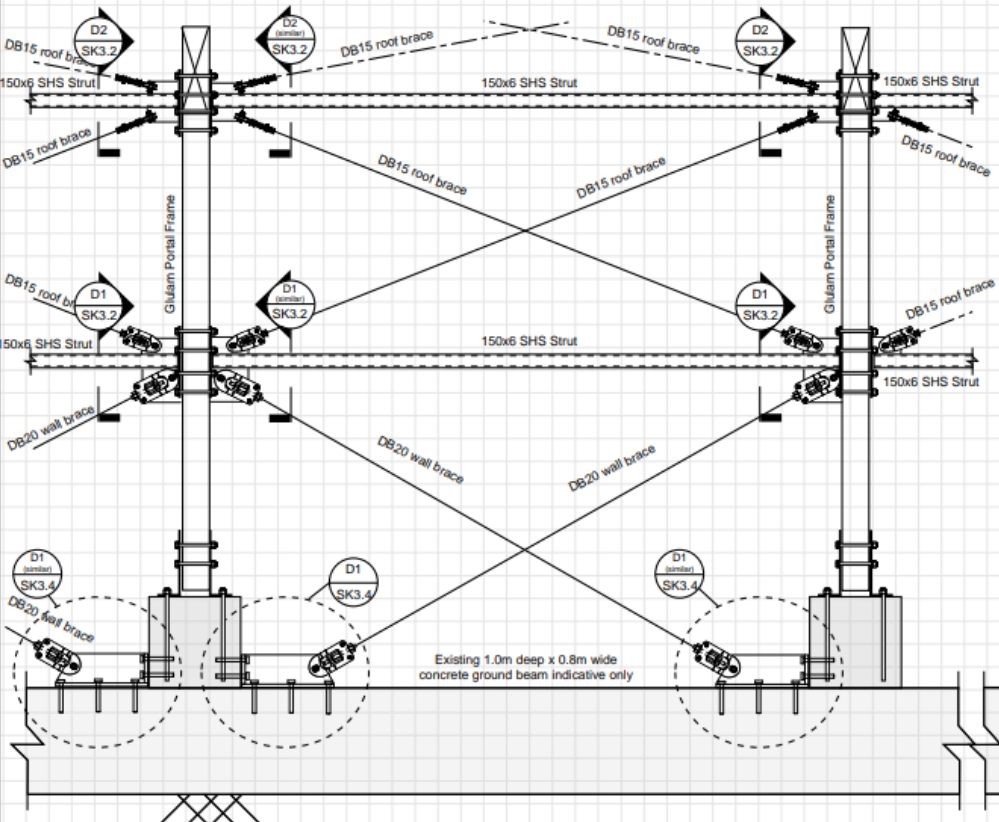
Section 1 Typical Portal Frame Wall Bracing Elevation

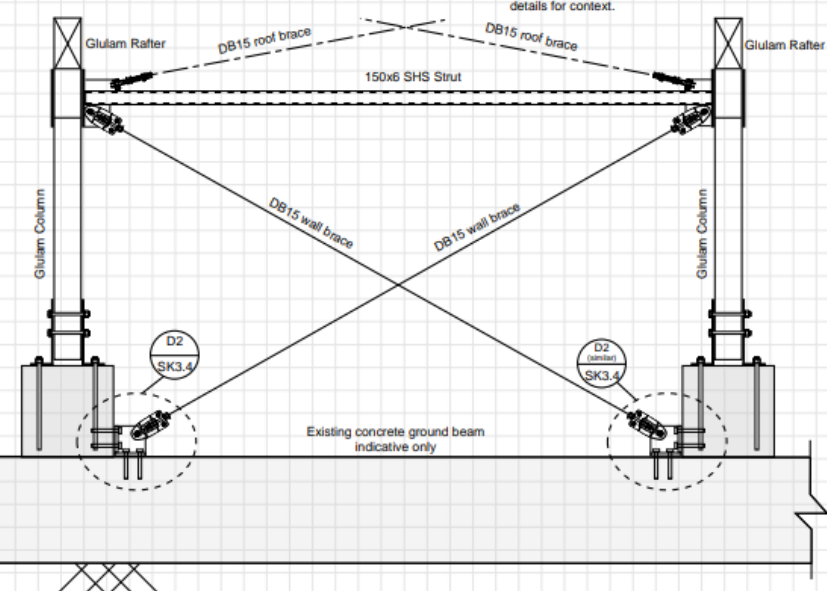
Section 2 Extension Wall Bracing Elevation
