254 RANGIURU ROAD, OTAKI

28 April 2021

ASBESTOS DEMOLITION SURVEY REPORT

254 RANGIURU ROAD, OTAKI DETAILED SITE INVESTIGATION

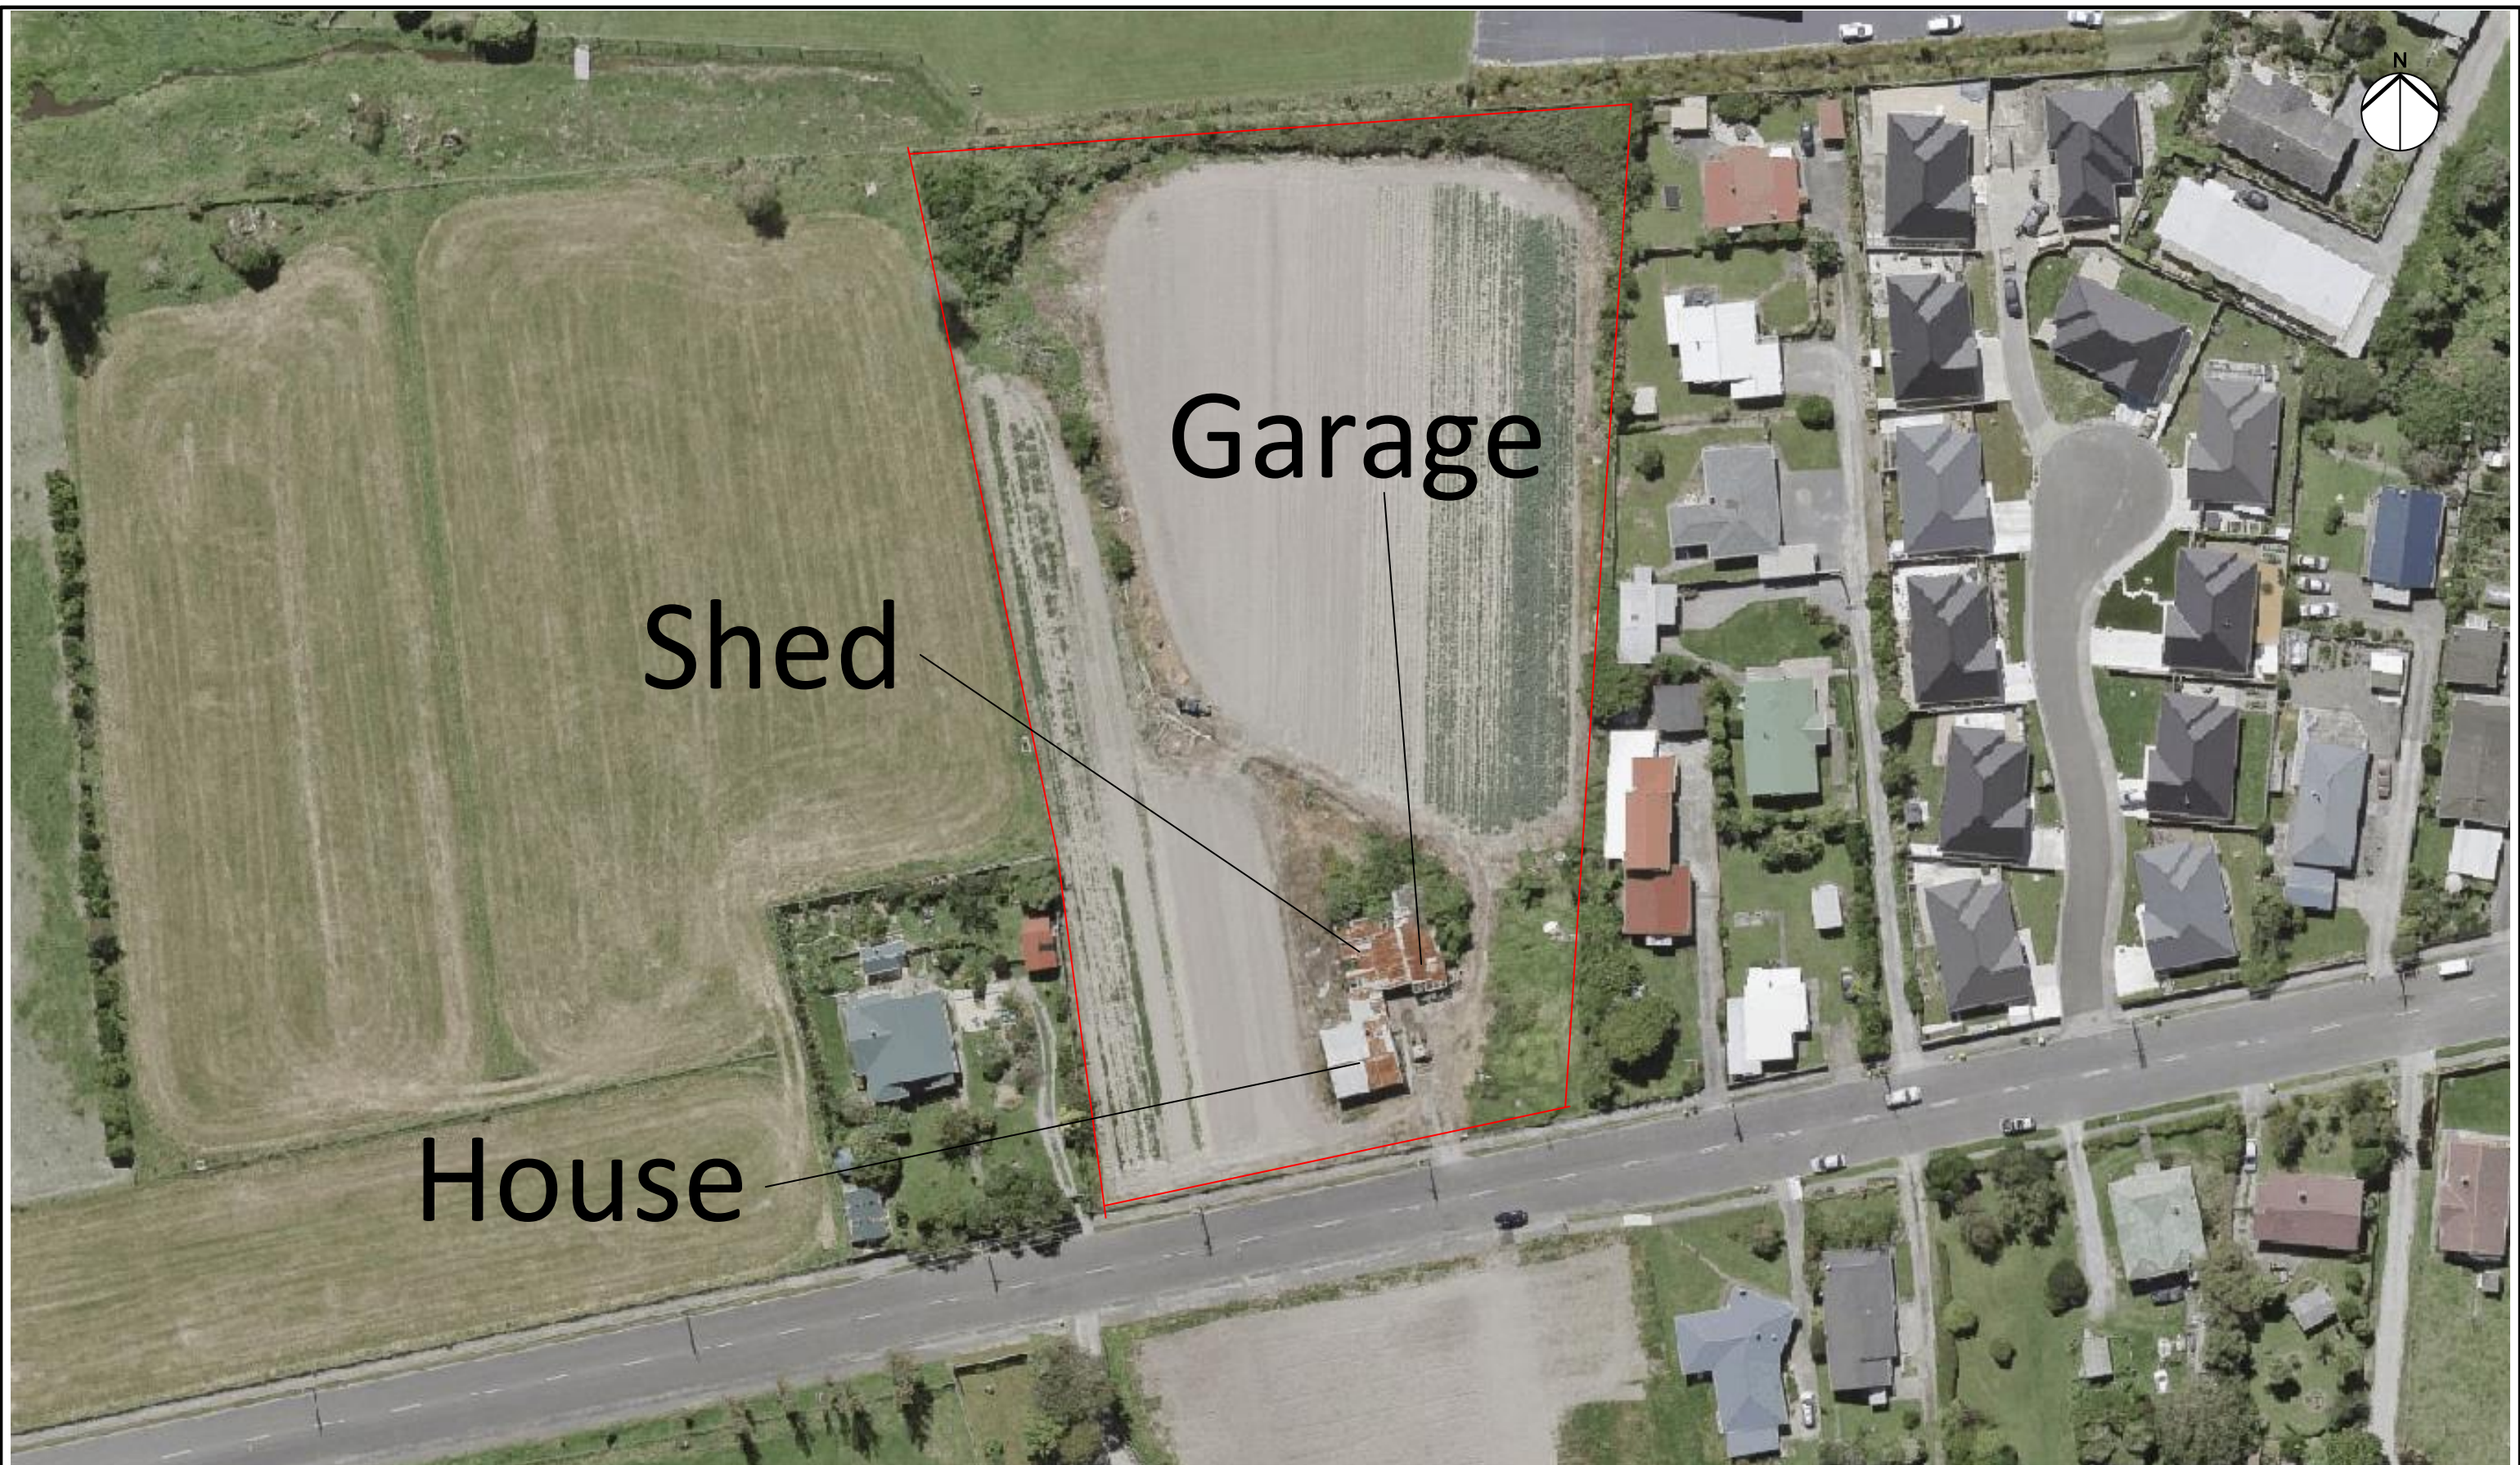
Figure 1: Site overview

Site location:
254 Rangiora Road, Otaki

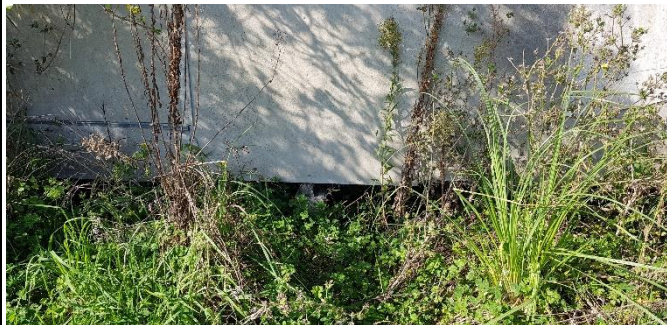
ASBESTOS - Confirmed				House		Risk:	Medium
Photo Ref	84139	Sample ID	WSP-134500	Room	Windows		
Application	Putty			Material	Mastic sealant

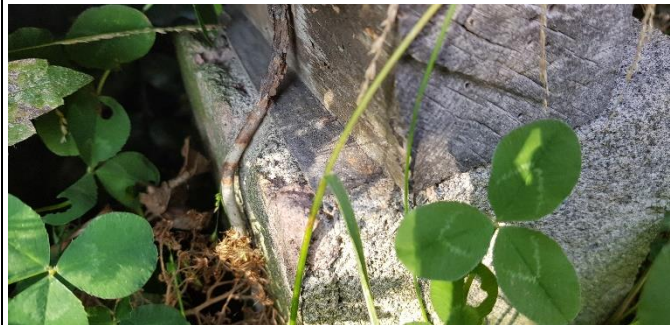
ASBESTOS - Confirmed				House		Risk:	Low
Photo Ref	84140	Sample ID	WSP-134500.1	Room	House piles		
Application	Packer			Material	Bituminous material

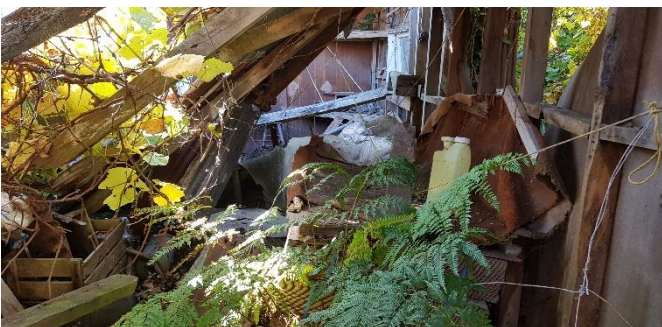
ASBESTOS - Confirmed				Shed		Risk:	Low
Photo Ref	84141	Sample ID	WSP-134499	Room	Southern wall		
Application	Electrical fuse board			Material	Resinous board

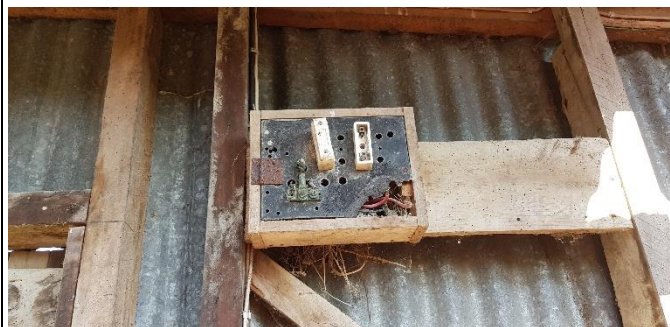
ASBESTOS - Strongly presumed				House	Risk: Low
Photo Ref	84142	Sample ID	Strongly presumed	Room	Living room 1
Application	Electrical fuse board			Material	Resinous board

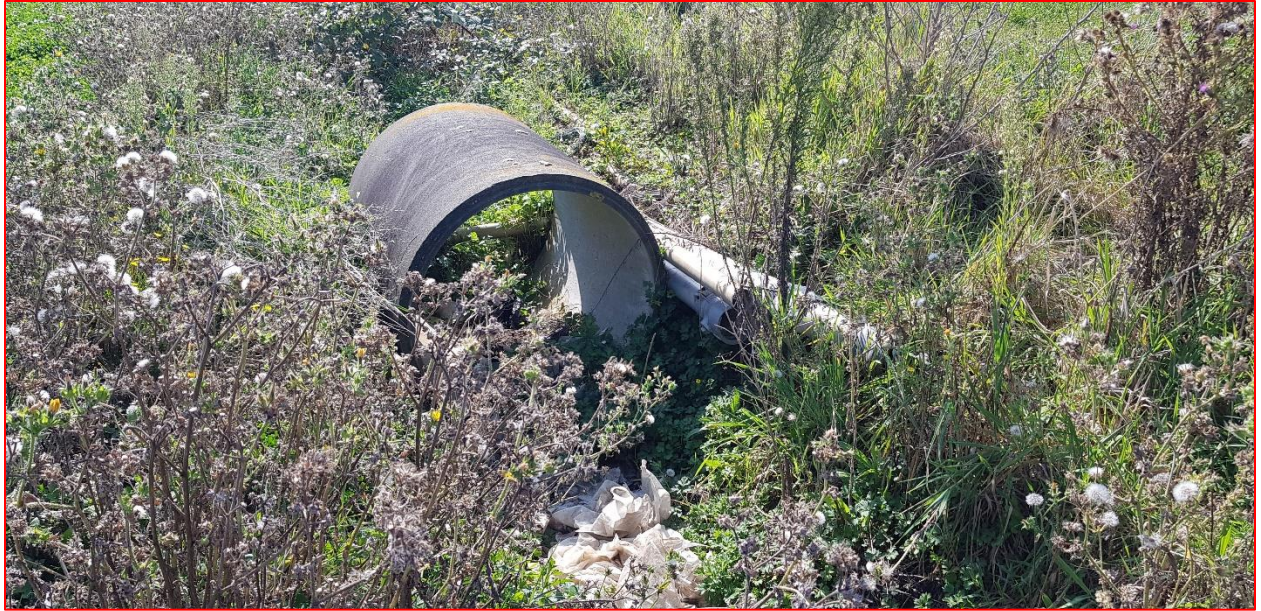
Photo 9: Pipes and plastic in the central area of the drainage ditch

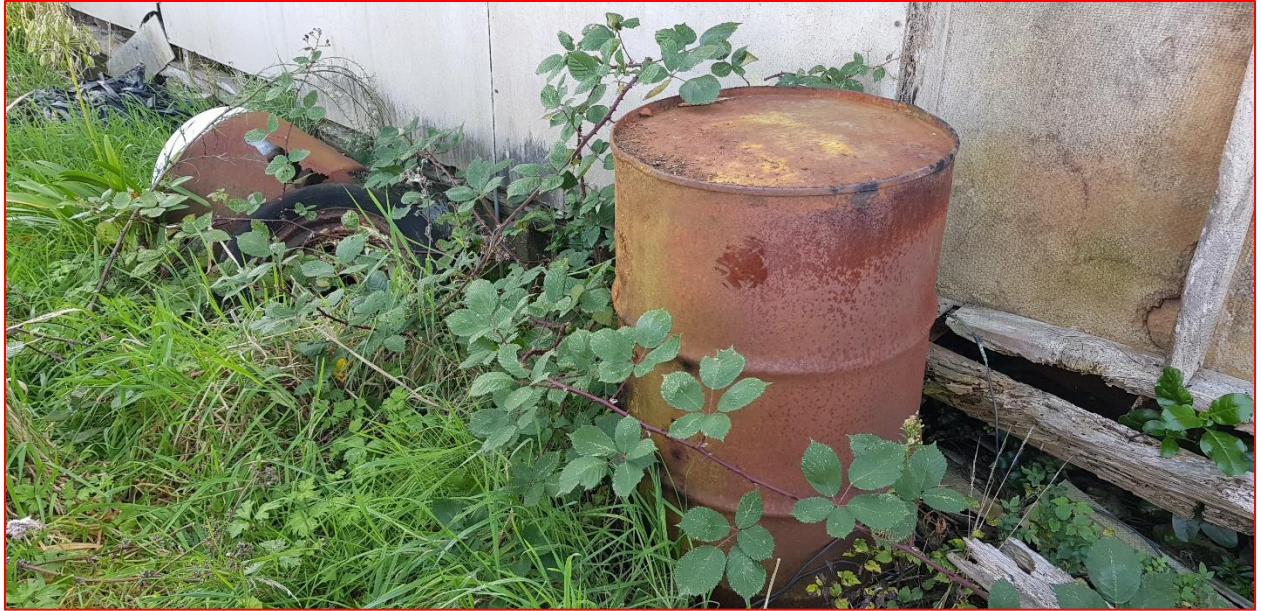
Photo 11: Corroded metal drum on the south side of the house

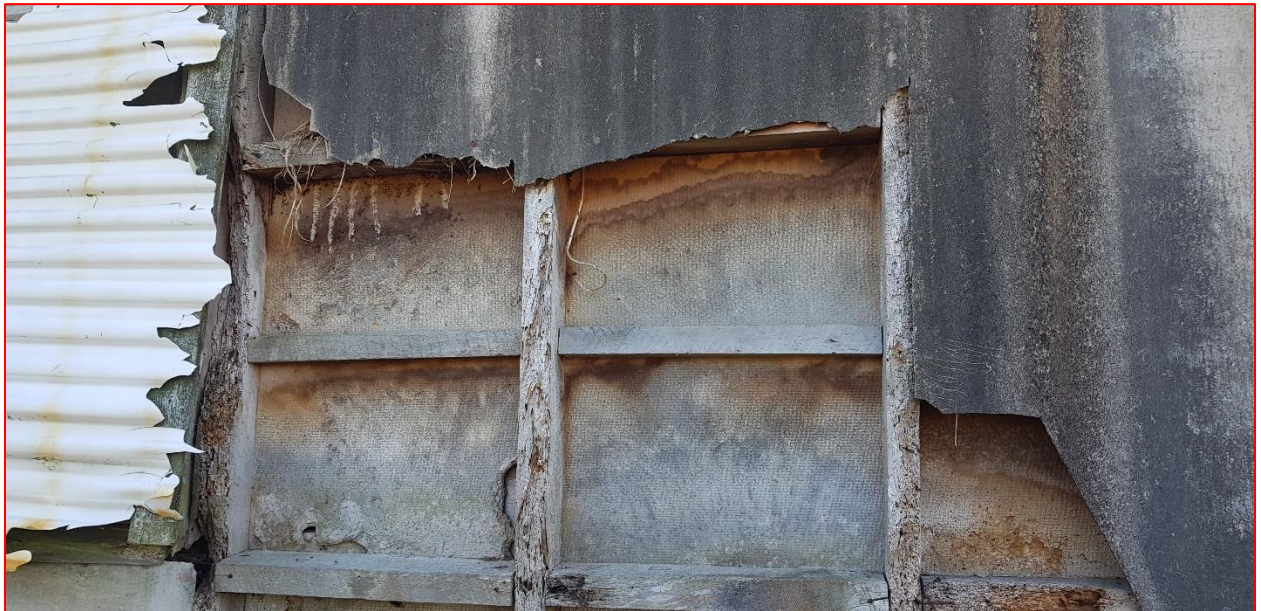
The house, in the south-east corner of the site, is clad in deteriorated, unpainted, asbestos containing, fibre cement sheeting. This has resulted in low levels of asbestos in soil on the north side of the shed. The extent of this is unknown.

Photo 12: Damaged asbestos containing fibre cement sheet external wall cladding

- The asbestos containing fibre cement sheet wall cladding of the house is in a deteriorated condition with debris on the surrounding surface soils which may extend further under the house itself. This cladding should be removed as Class B licensed asbestos removal works prior to the demolition of the residence. As part of the removal, the debris in the surrounding soils should be handpicked for removal. A surface soil scrape may be required. Refer to the report titled *254 Rangioru Road, Otaki – Detailed Site Investigation* (WSP, April 2021) for further information regarding soils. Until this material can be appropriately removed, it is recommended that access to the house and immediate surrounding area is restricted in order to minimise any further disturbance of the asbestos.

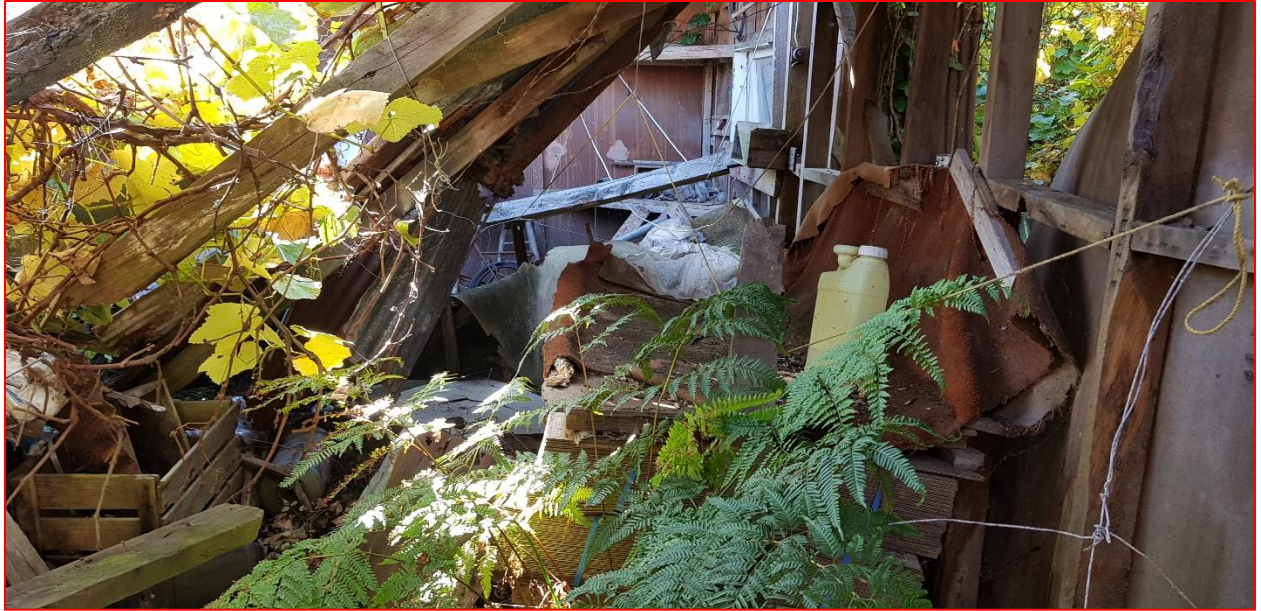
Photo 13: Collapsed section of the shed

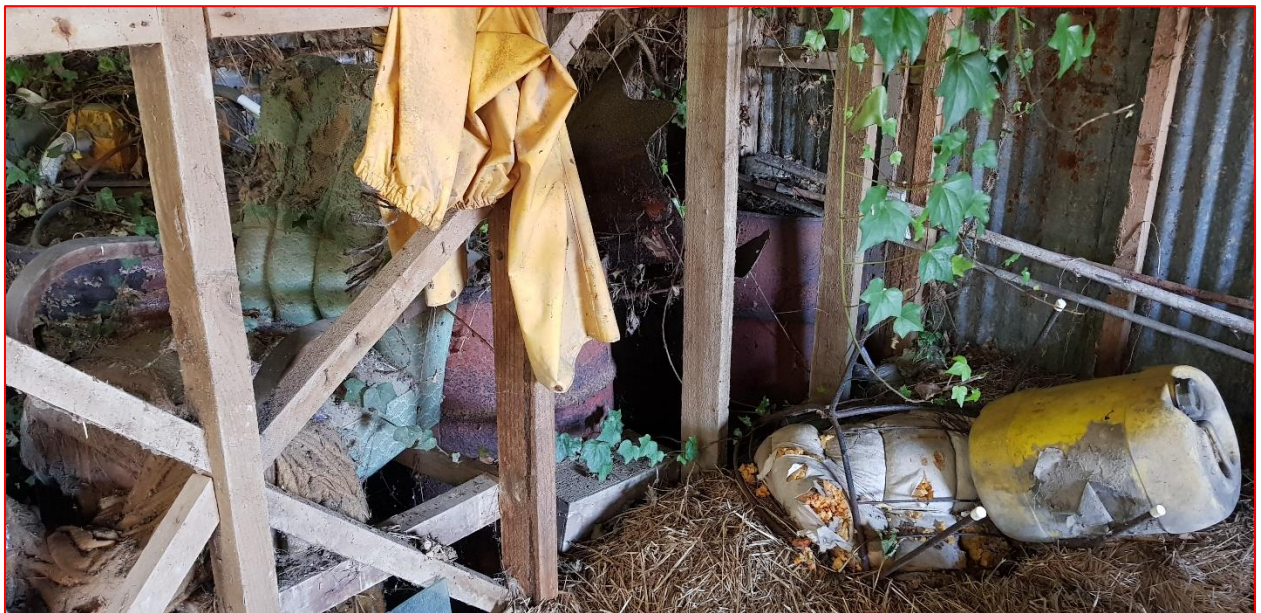
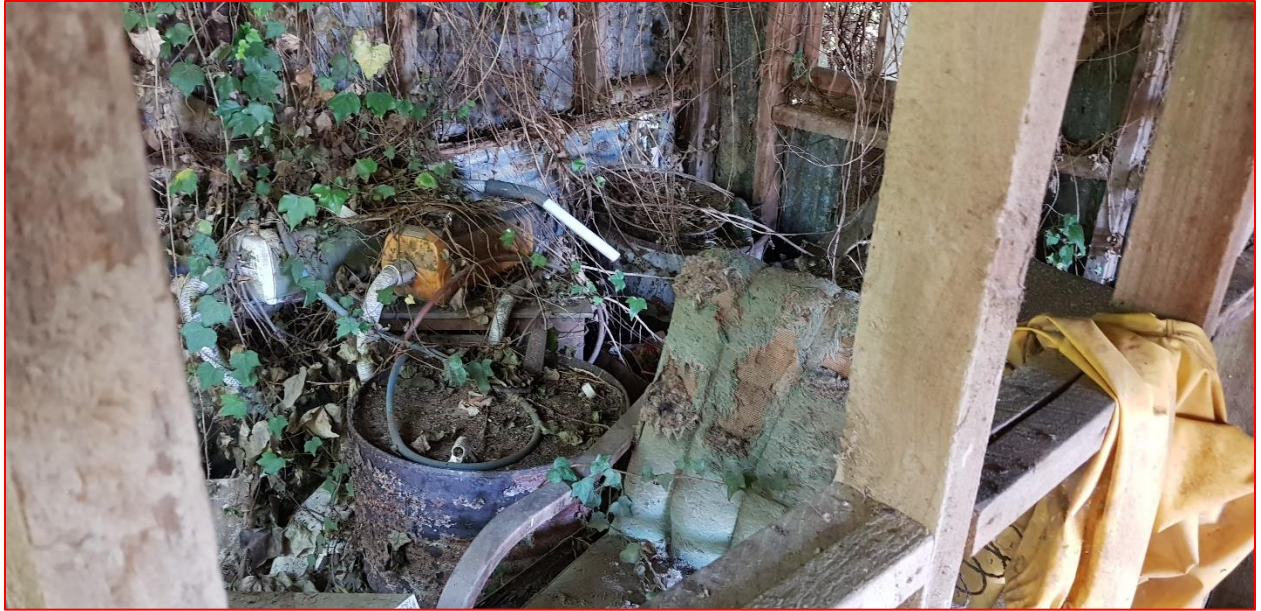
Photo 14: Looking through the back wall of the garage at the corroded metal drums in the lean-to

Photo 15: Looking through the back wall of the garage at the corroded metal drums in the lean-to

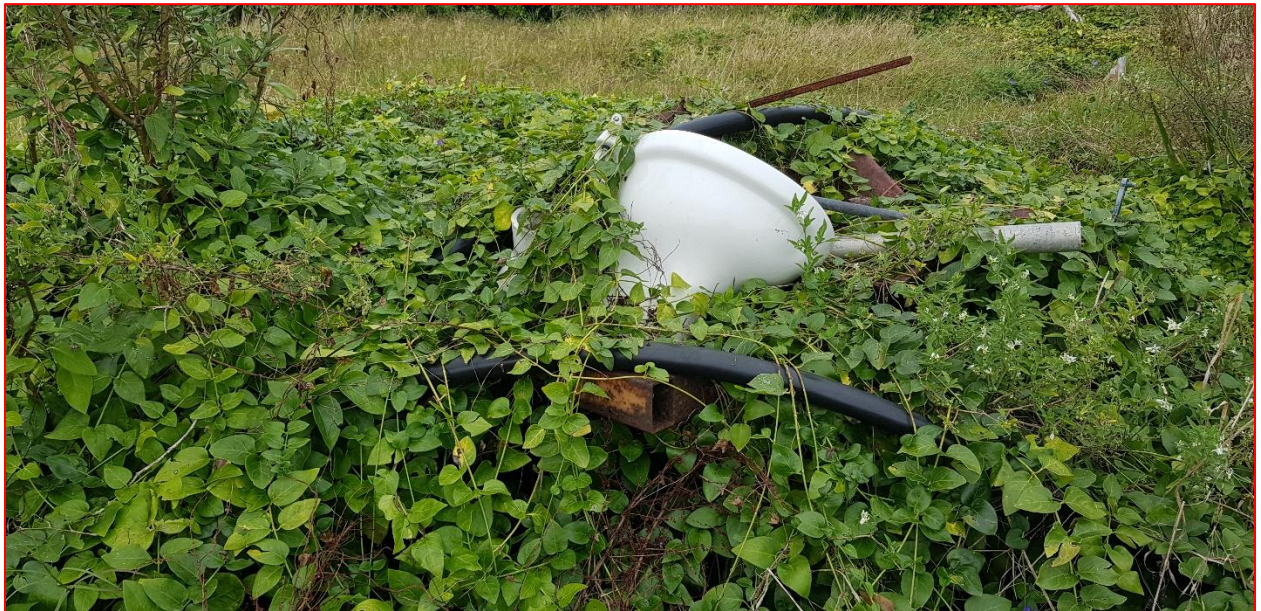
Photo 23: Rubble in the south-east corner of the site overgrown with weeds

Photo 24: Rubble in the south-east corner of the site overgrown with weeds
