FACILITY MANAGEMENT

PAEKAKARIKI SKATEPARK

CONDITION ASSESSMENT - SKATE SURFACE

MACLEAN SKATEPARK

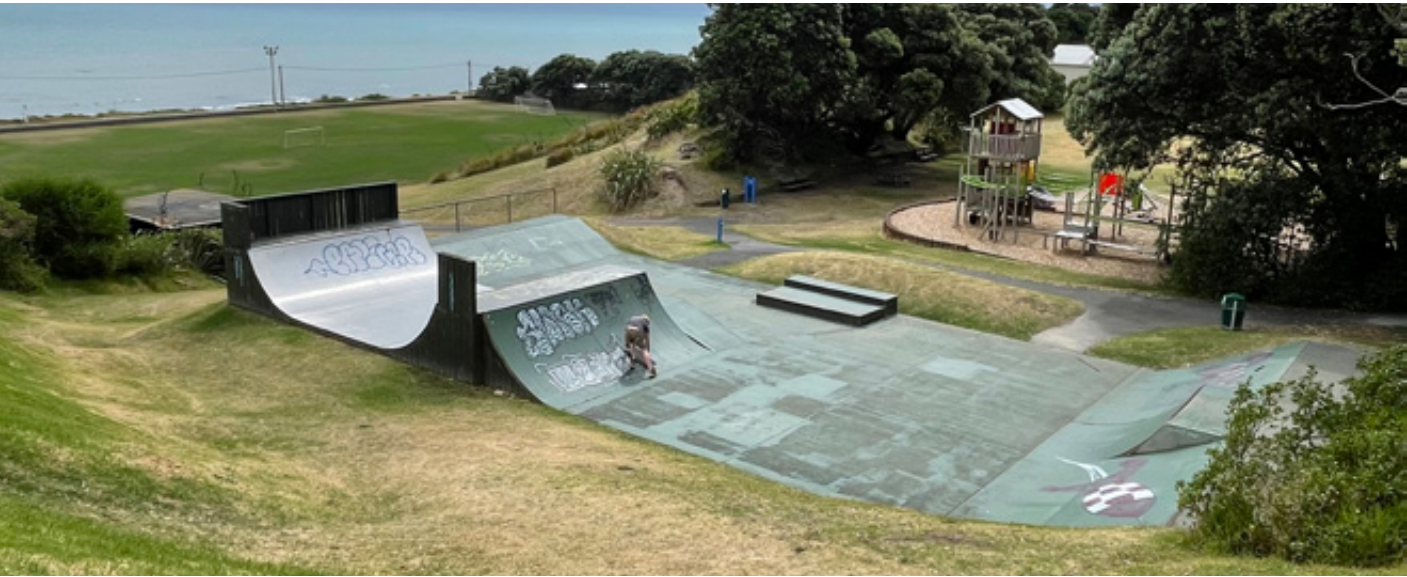
CONDITION + FUNCTION PLAN

The current condition of the park is fair, however there is a major joint that has opened up and requires immediate attention.

- Crack repair to construction joint
- Chip repair
- Landscape erosion maintenance and tidy up
- Safety signage

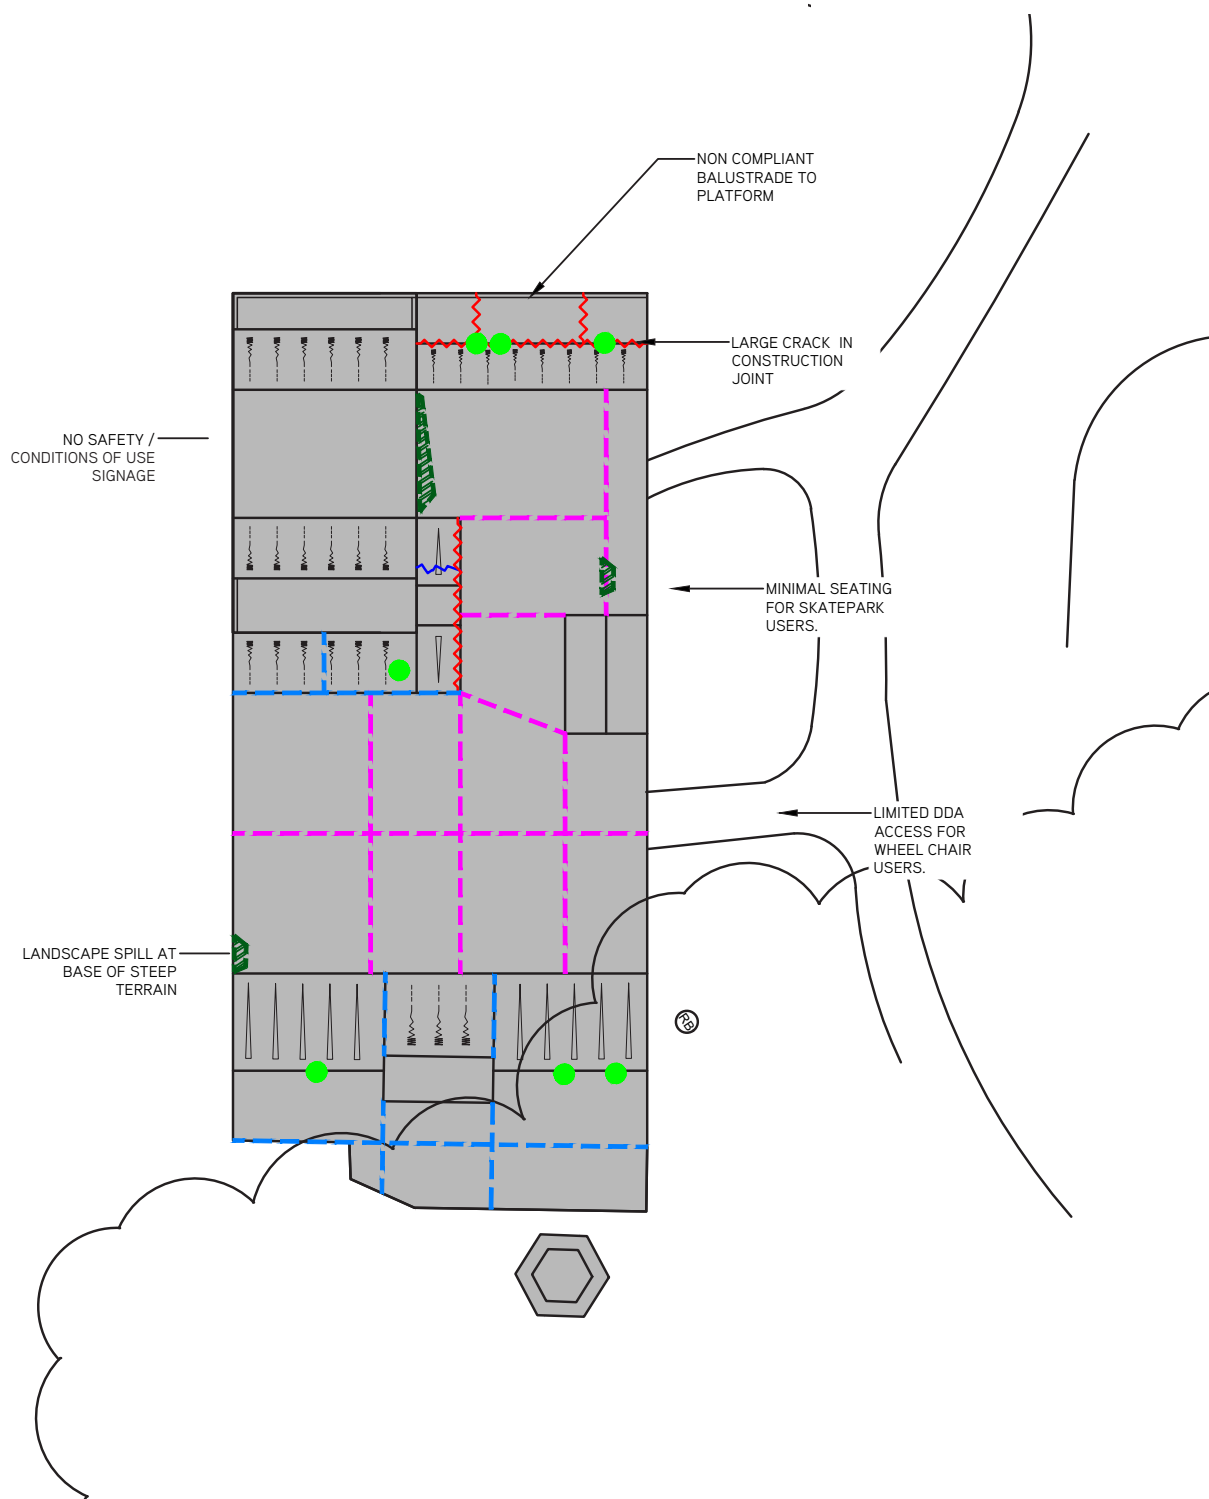
Some construction joints within the skatepark are of poor quality and are widening. Wide joints and saw cuts create a hazard for small scooter and skateboard riders as their wheels can become trapped causing the rider to fall unexpectedly creating a safety hazard. Further, wide joints are at risk of widening further and creating holes within the concrete surface.

Chipping has formed along some concrete joints and on obstacles. If left unattended chips will continue to develop, creating a greater hazard. These chipped areas are hazardous to riders as they can catch small wheels causing users to fall creating a safety hazard.

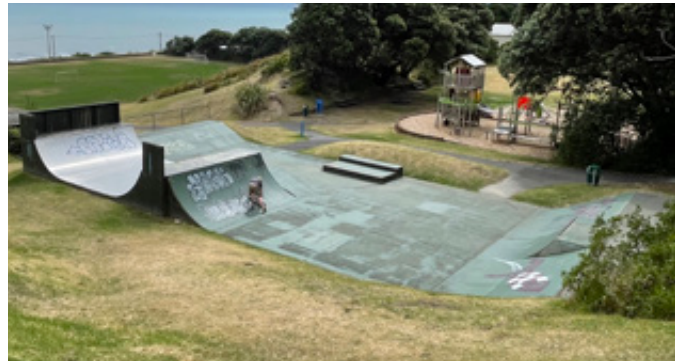
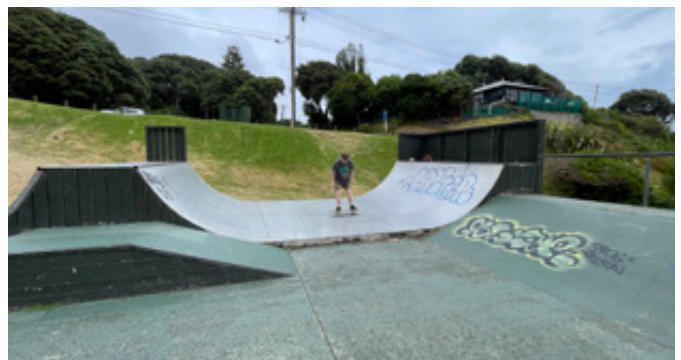
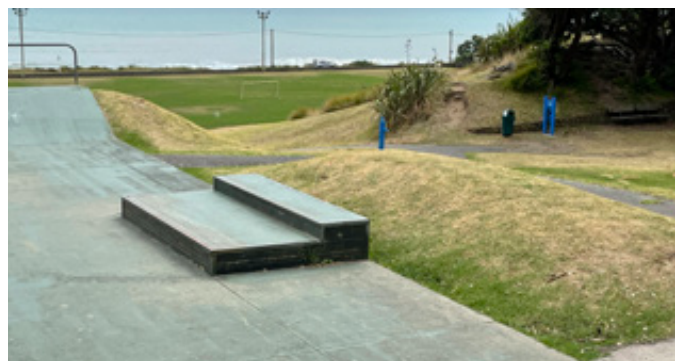
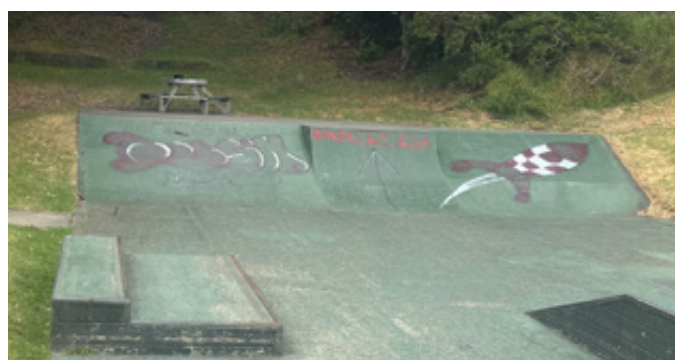
Value contribution: Overall, the skatepark is fun and functional for a Neighbourhood Level facility and contributes positively to the Paekakariki community as well a good edition to the Regional frame work of skateparks.

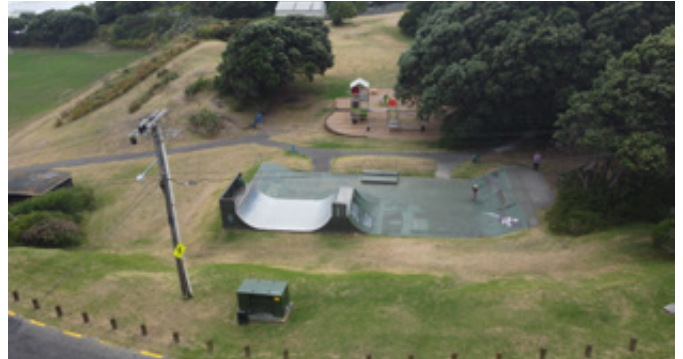
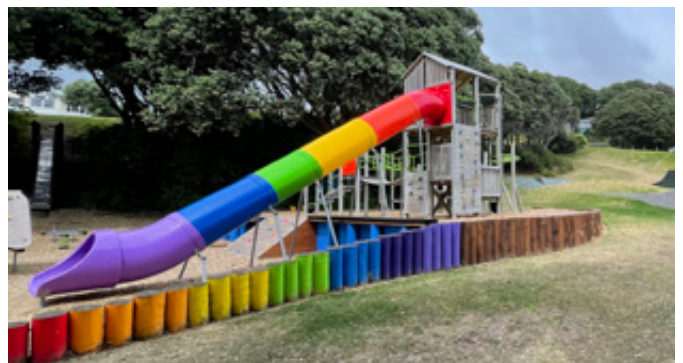
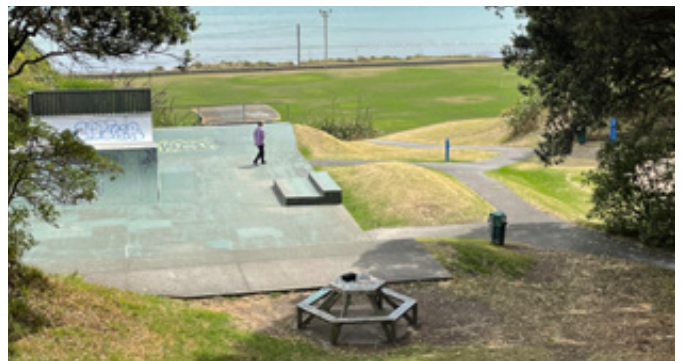
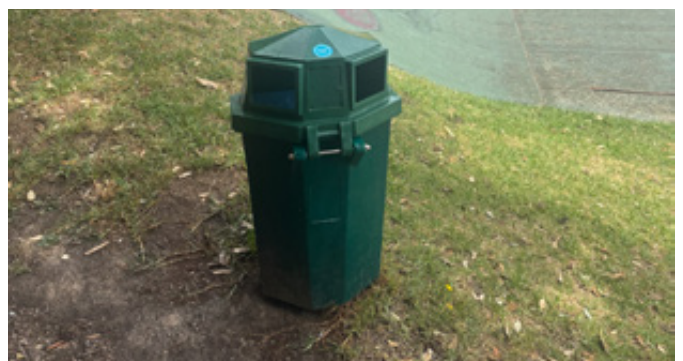
LANDSCAPE AND AMENITY

Signage: There is currently no safety signage or conditions of use signage accompanying the facility.

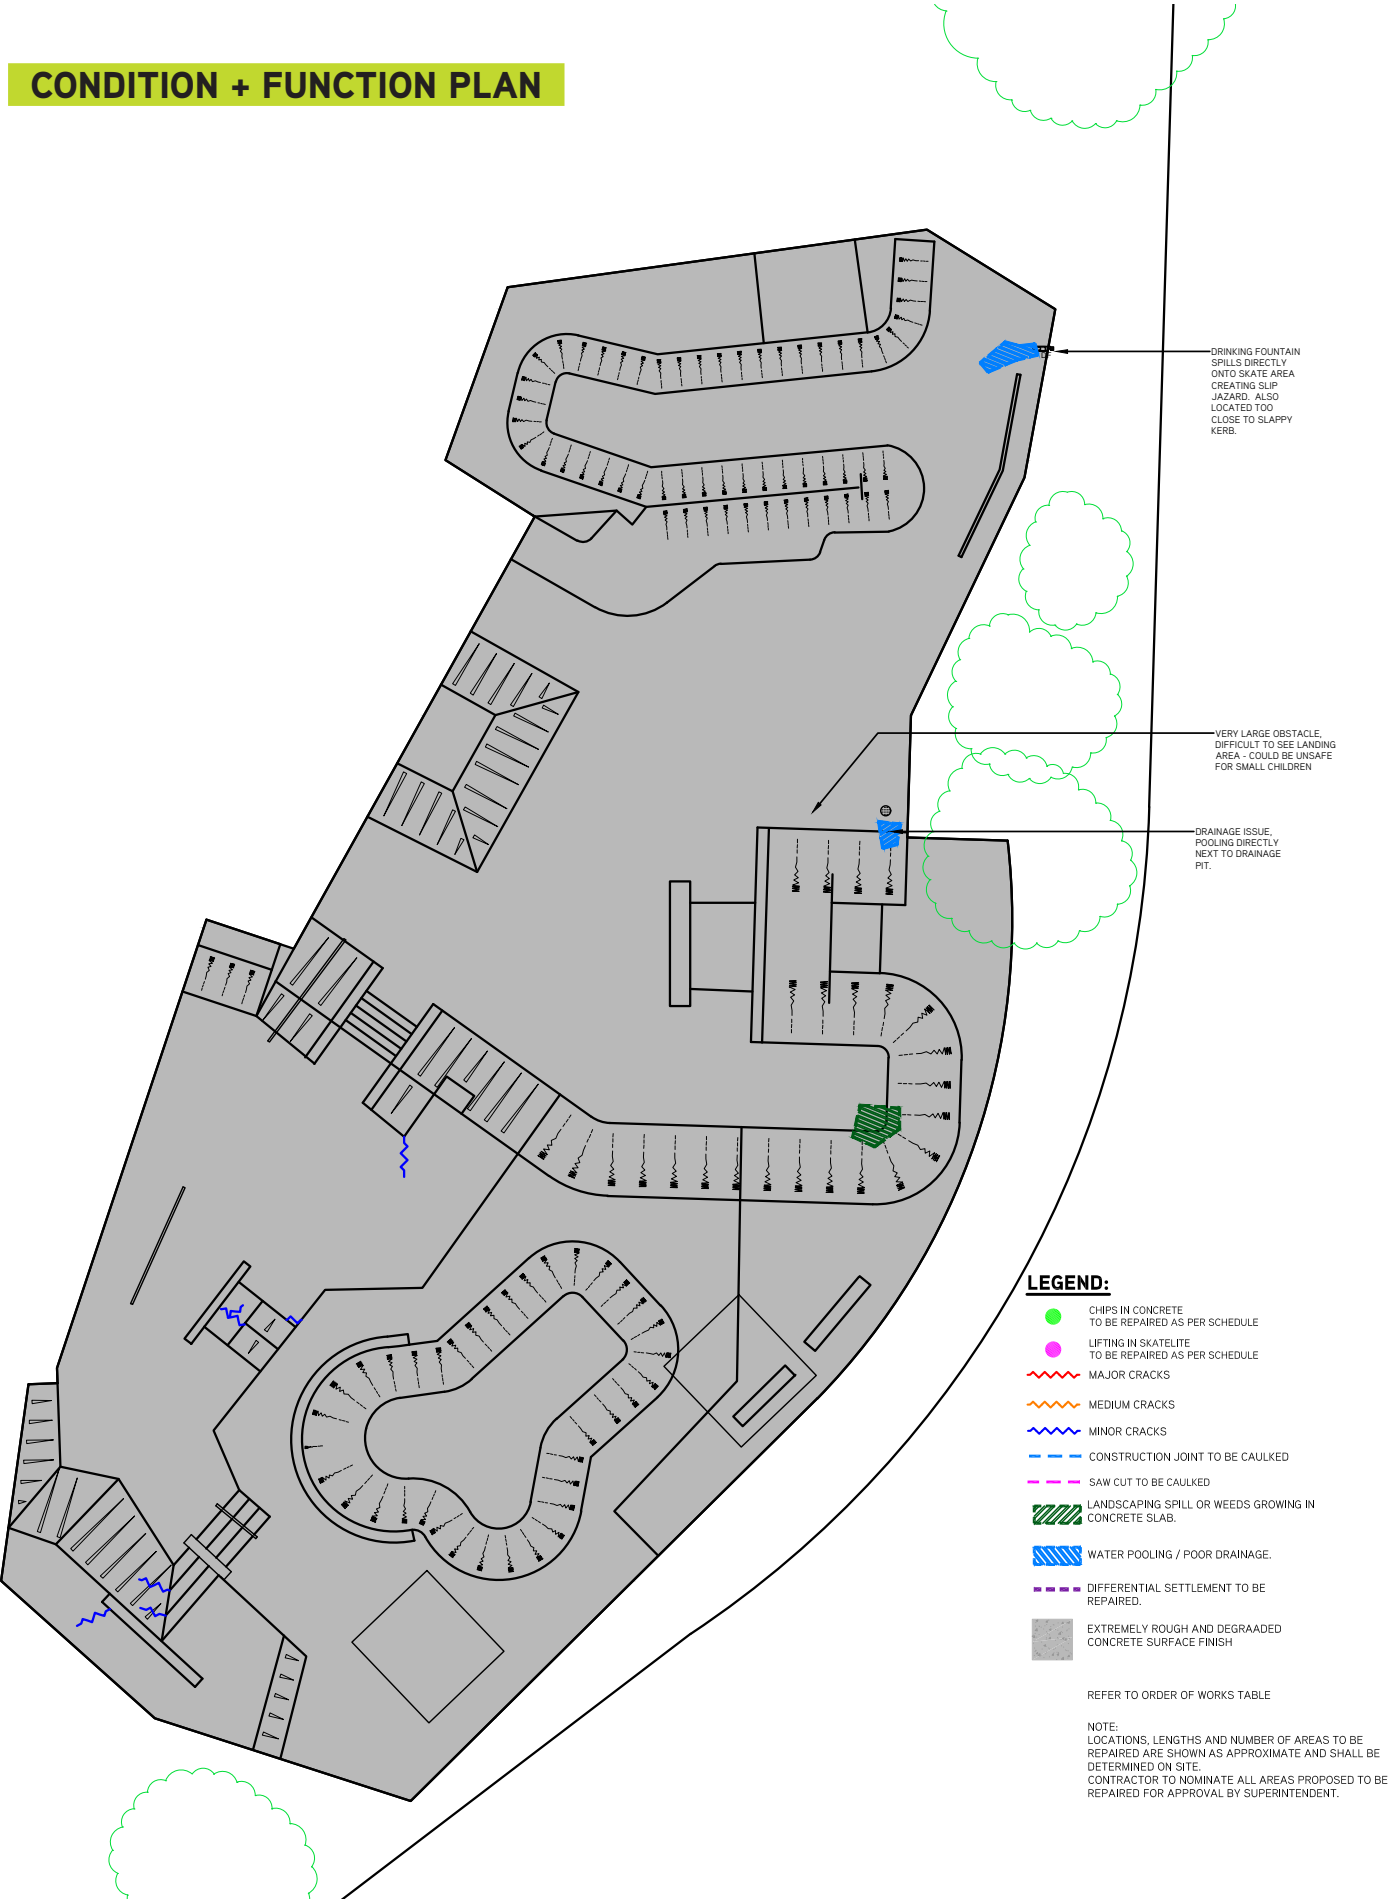
CONDITION ASSESSMENT - SKATE SURFACE

01. FINE TO MEDIUM CRACKING:

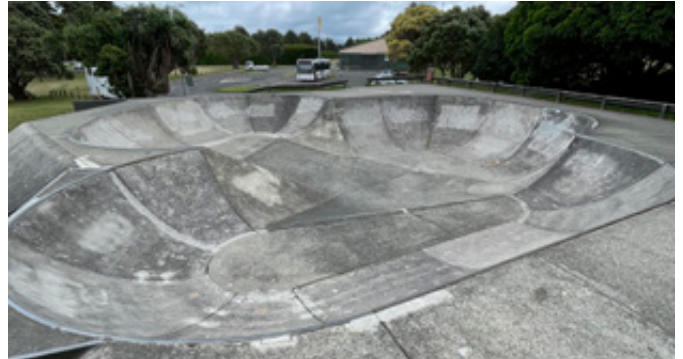
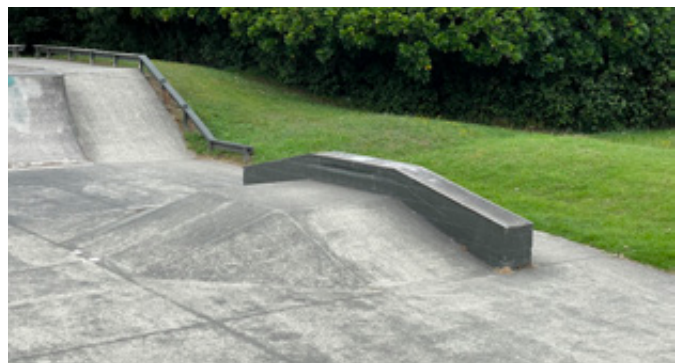
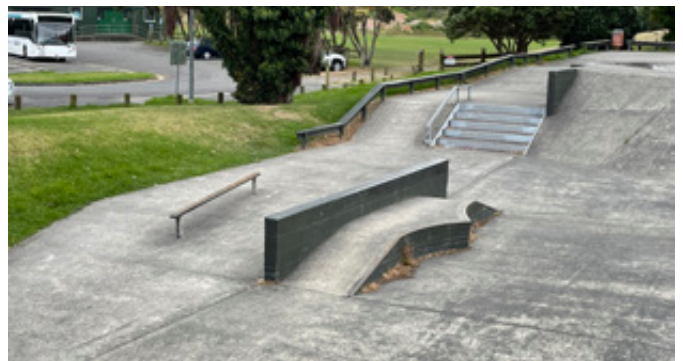
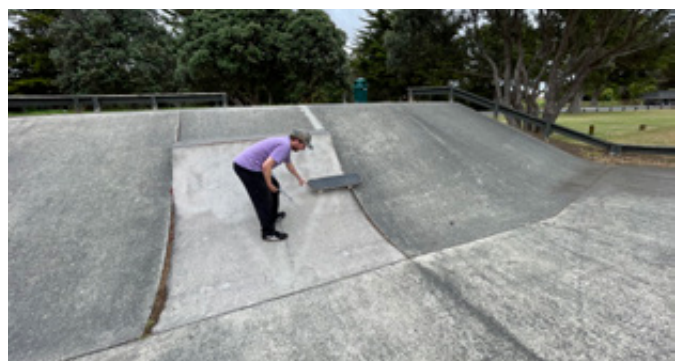
Value contribution: Overall, although the facility is defined as a 'Community Level' skatepark, it contributes very little to the Kapiti Coast skate network due to the poor quality, hazardous unsafe nature of features and surface, outdated style and limited functionality.

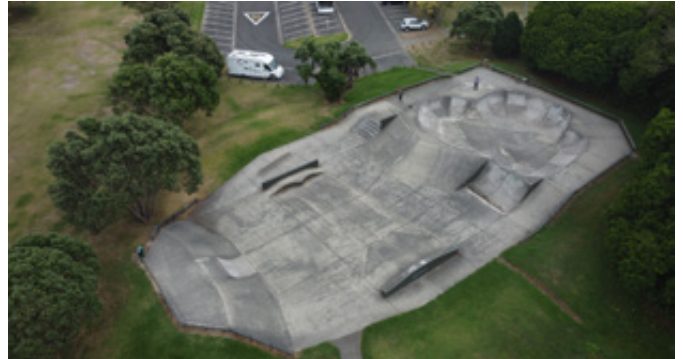
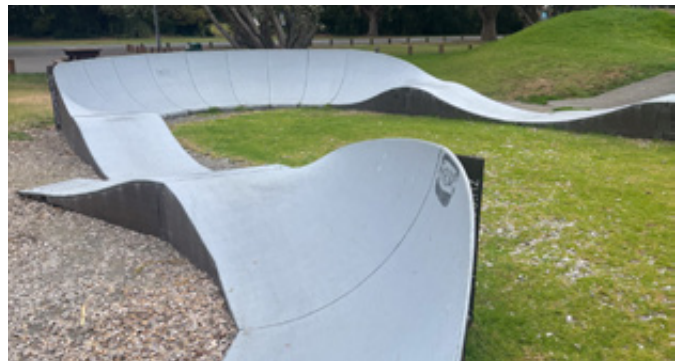
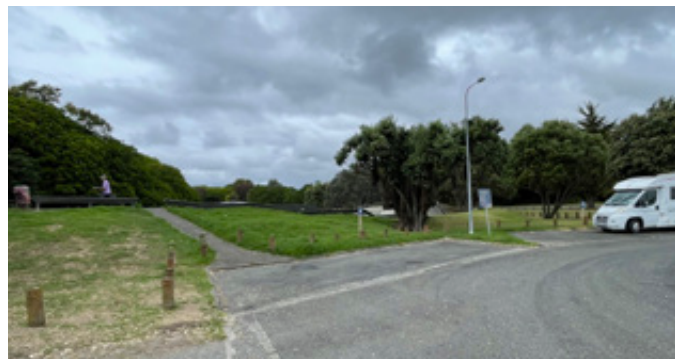
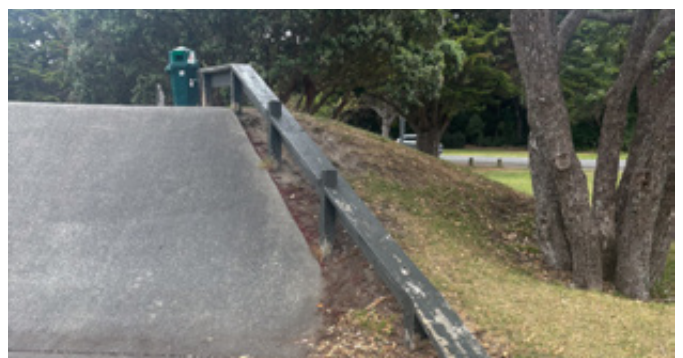
LANDSCAPE AND AMENITY

Signage: There is currently no safety signage or conditions of use signage accompanying the facility.

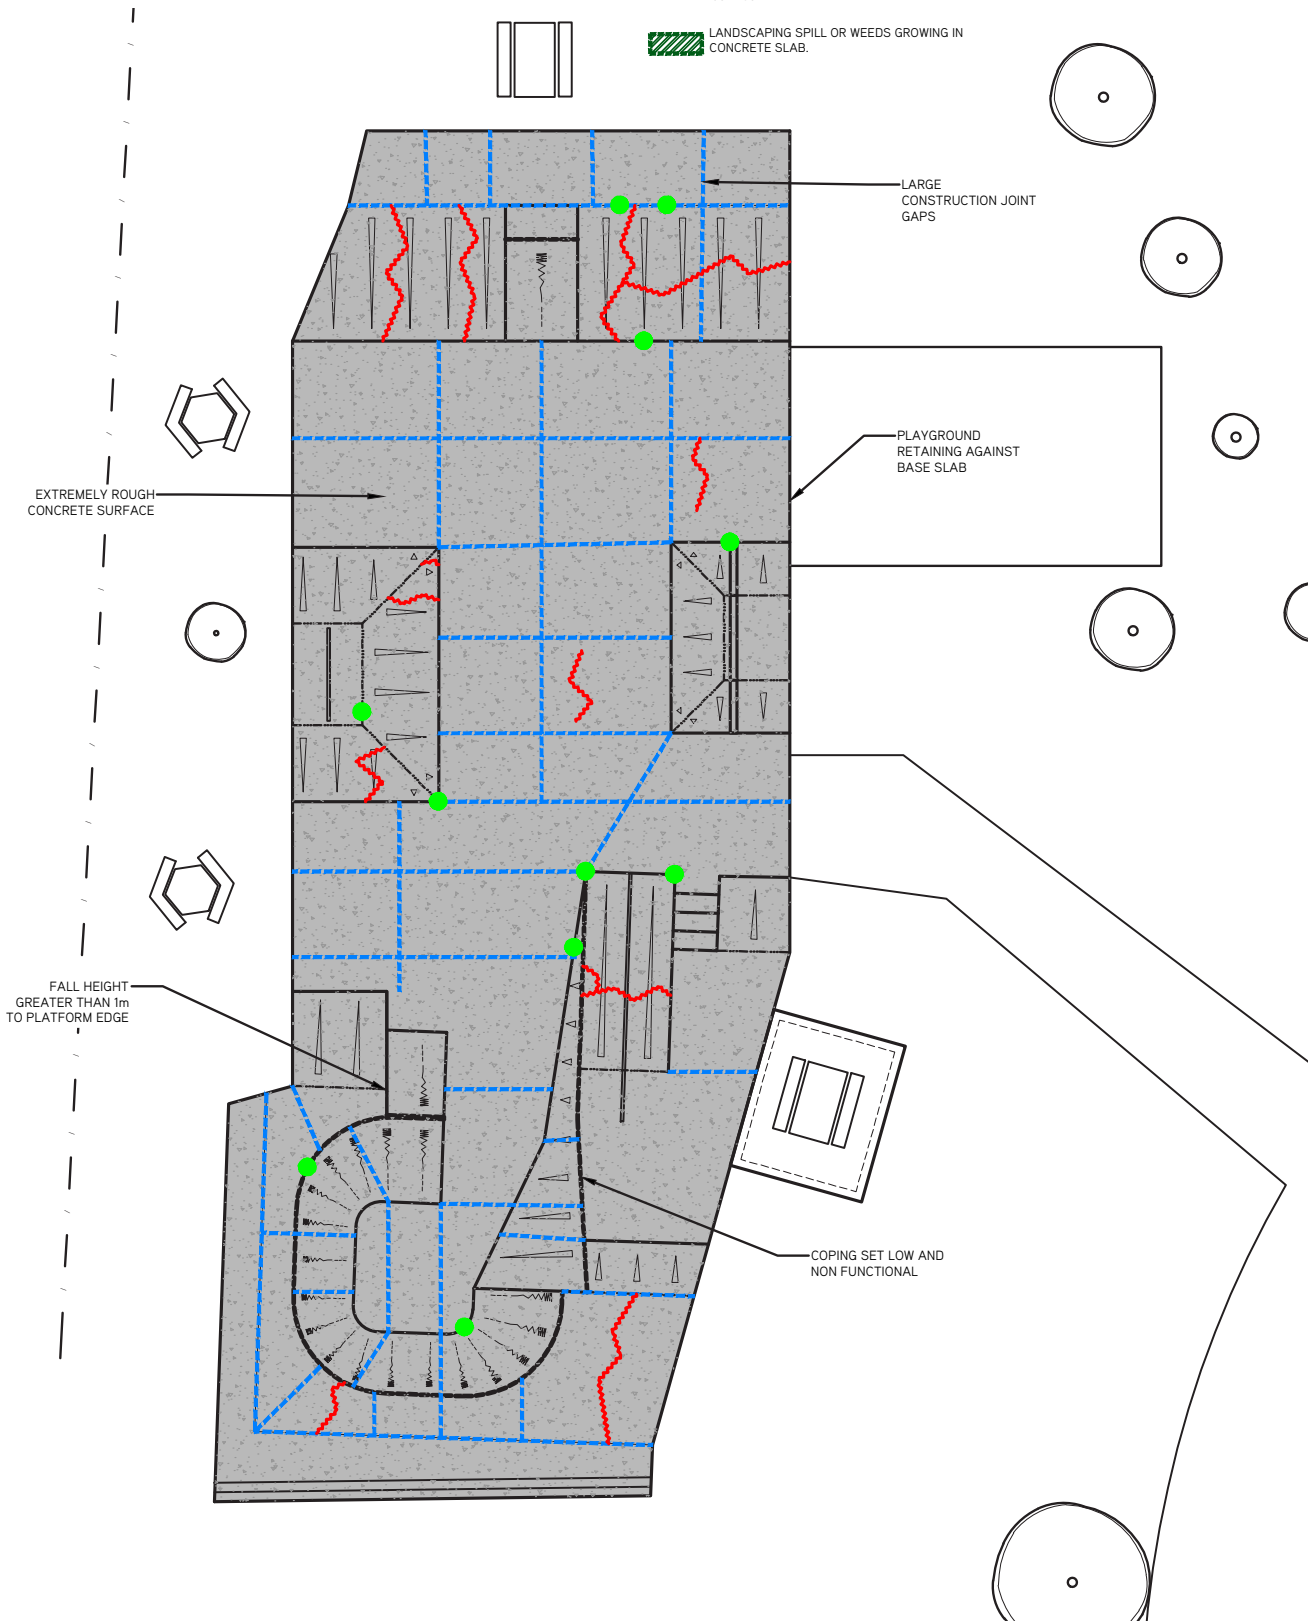
- CHIPS IN CONCRETE TO BE REPAIRED AS PER SCHEDULE
- LIFTING IN SKATELITE TO BE REPAIRED AS PER SCHEDULE
- MAJOR CRACKS
- MINOR CRACKS
- CONSTRUCTION JOINT TO BE CAULKED
- SAW CUT TO BE CAULKED
- DIFFERENTIAL SETTLEMENT
- COLD JOINT
- LANDSCAPING SPILL OR WEEDS GROWING IN CONCRETE SLAB.

ROUGH AND DEGRADED CONCRETE SURFACE FINISH

REFER TO ORDER OF WORKS TABLE

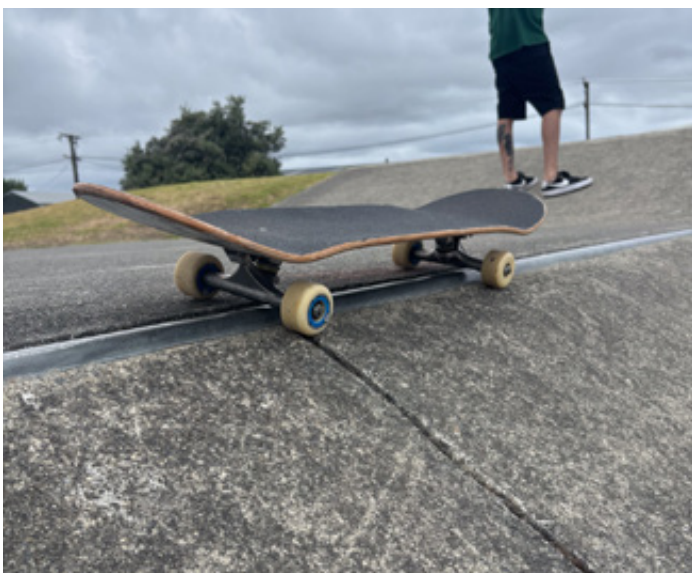
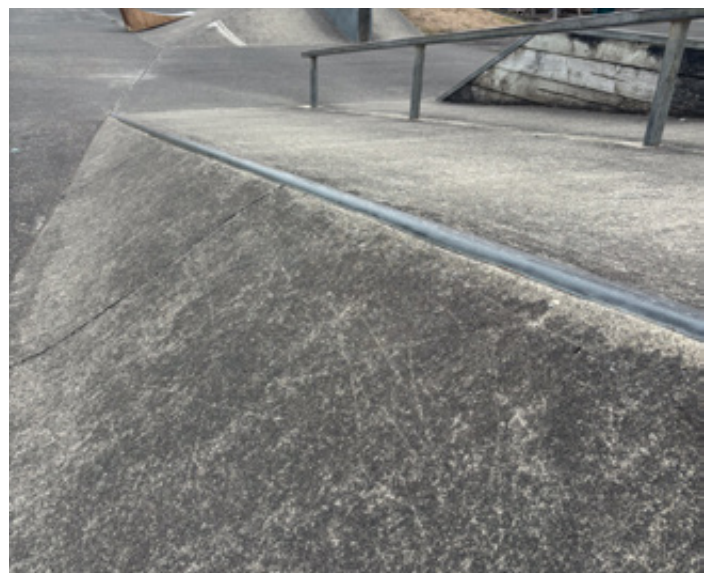
06. COPING OFFSETS:

The coping leading into the open bowl is set very low with not fit for purpose dimensions. The low set coping is unable to make contact with skateboard trucks meaning a user is unable to perform a lip trick and flow back into the open bowl.

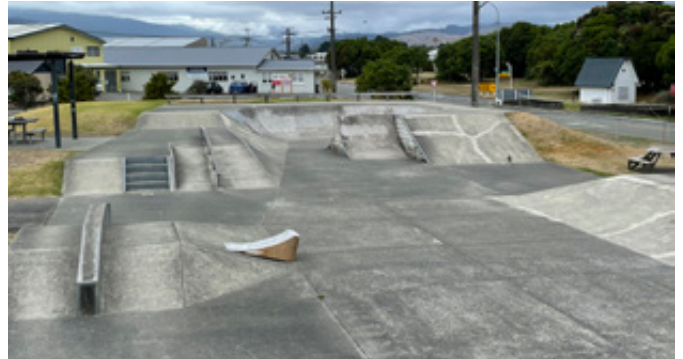
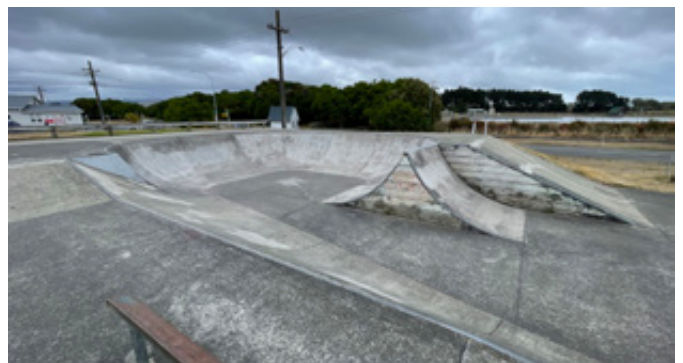
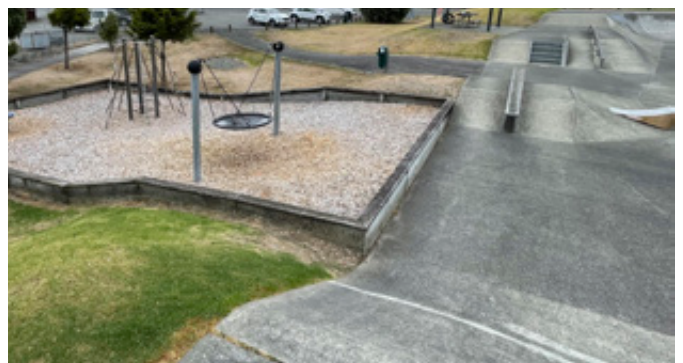
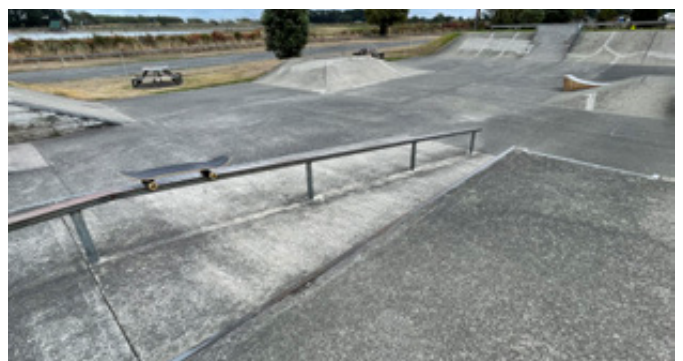
LANDSCAPE AND AMENITY

Passive + Youth Recreation Opportunities: Play space and learn to ride circuit are located adjacent the facility.

Signage: There is currently no safety or conditions of use signage accompanying the facility.
