OIR: 2324/809

**Request for Information under the Local Government Official Information and Meetings Act 1987 (the Act) (the LGOIMA)**

## Section Inspection - 8/07/2022 - KSWP003634

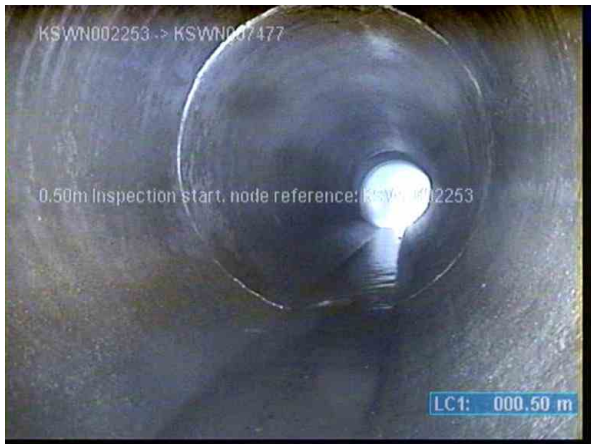
KSWP003634\_1ba1942e-786e-4d32-a0ef-3e5e99191770\_20220708\_155106\_788.jpg, 00:00:18, 0.50m  
Inspection start, node reference: KSWN002253

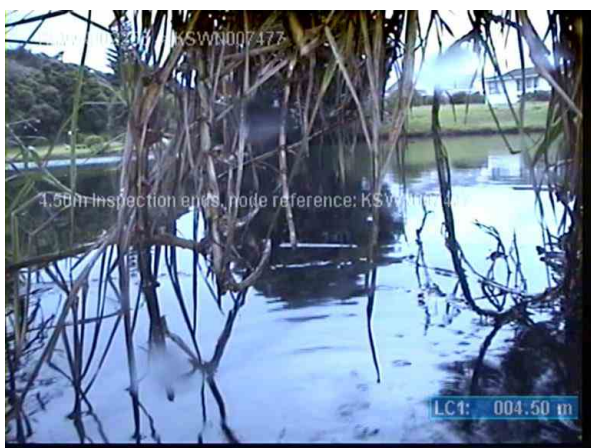
KSWP003634\_e8054480-66f1-423c-82c9-a92725071798\_20220708\_155606\_909.jpg, 00:02:28, 4.50m  
Inspection ends, node reference: KSWN007477

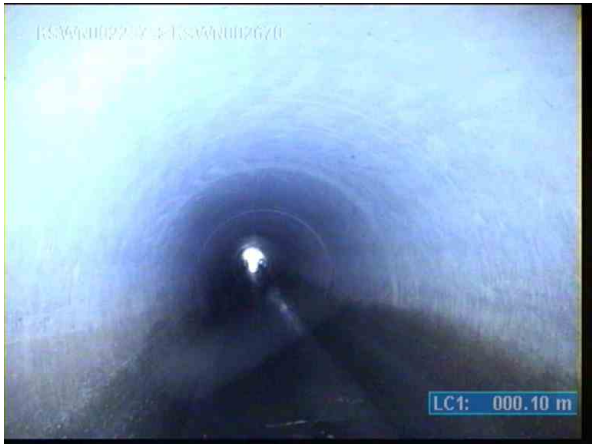
KSWP003713\_8fcaed6d-e316-4503-bd38-4c2f453a4dee\_2020811\_131533\_459.jpg, 00:00:10, 0.10m (48.10m)  
Inspection start, node reference: KSWN002237

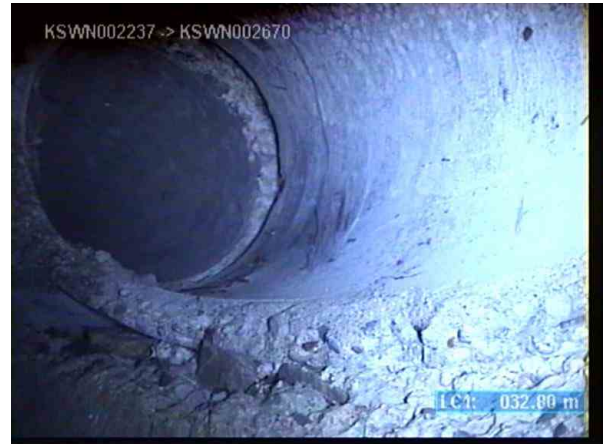
KSWP003713\_ba39b8cc-c631-4d6d-bf67-e948ee438793\_2020811\_131924\_634.jpg, 00:03:14, 32.80m (15.40m)  
The lateral is open at 9 o'clock / Ok

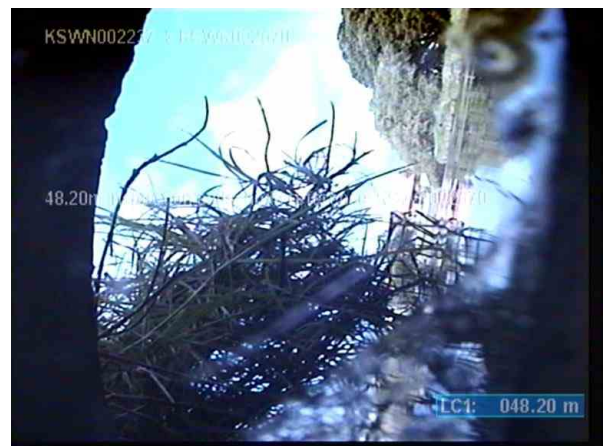
KSWP003713\_08170dd5-a2ee-498c-b1cb-0e14d6ec21e9\_20220811\_132210\_981.jpg, 00:05:25, 48.20m (0.00m)  
Inspection ends, node reference: KSWN002670

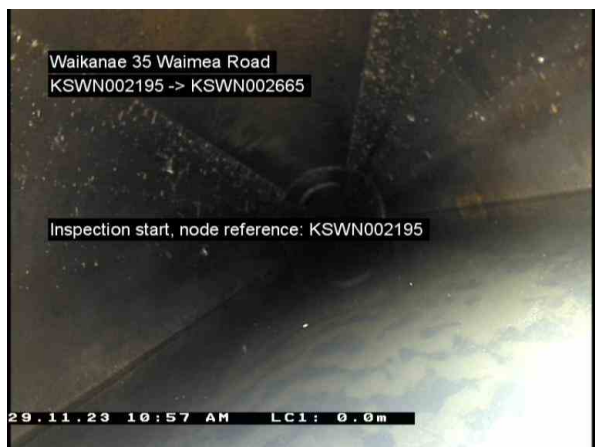
42\_KSWP003751\_195.jpg, 00:00:00, 0.00m (15.40m)  
Inspection start, node reference: KSWN002195

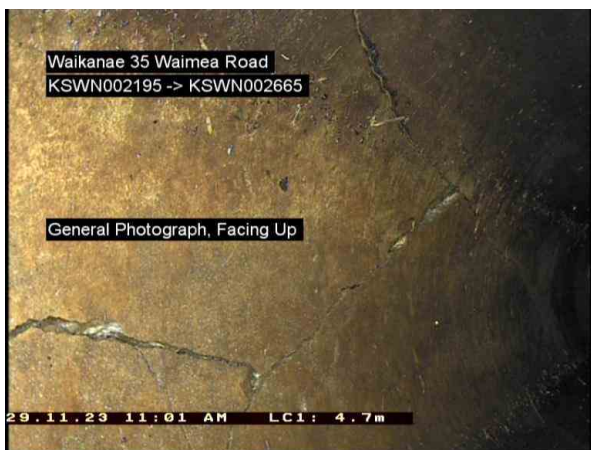
42\_KSWP003751\_201.jpg, 00:03:48, 4.70m (10.70m)  
General Photograph, Facing Up

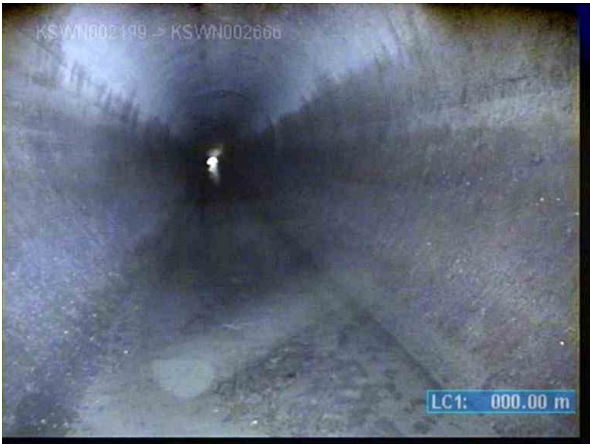
KSWP003760\_7677c142-fac2-4d80-89f4-e9575e26f6a4\_20220729\_130055\_240.jpg, 00:00:12, 0.00m (55.40m)  
Inspection start, node reference: KSWN002199

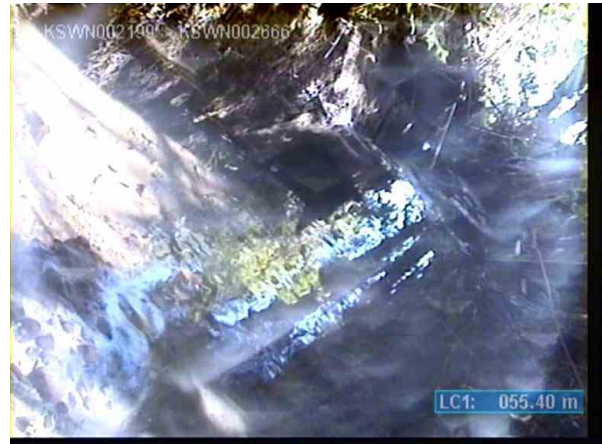
KSWP003760\_eb9b8076-ced0-4af8-a24e-2047390a5156\_20220729\_130513\_621.jpg, 00:04:25, 55.40m (0.00m)  
Inspection ends, node reference: KSWN002666

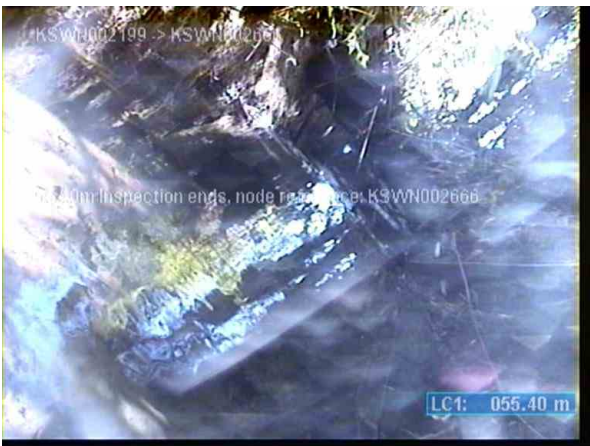
KSWP003760\_8a078897-305d-4a67-b1bc-06dc3754d98b\_20220729\_130517\_633.jpg, 00:04:25, 55.40m (0.00m)  
Inspection ends, node reference: KSWN002666

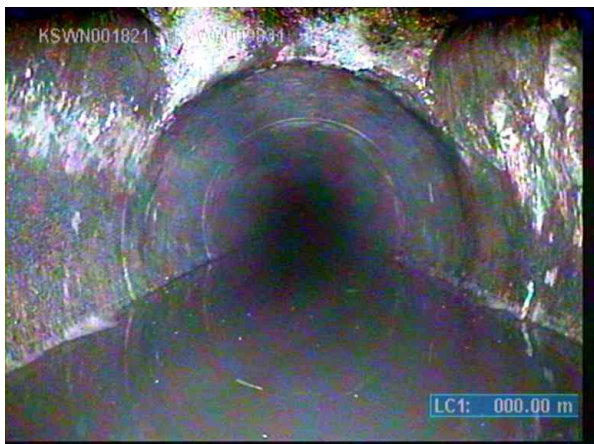
KSWP003815\_55591706-00c2-44c2-bdff-3145507a1a94\_2020701\_134803\_749.jpg, 00:00:10, 0.00m  
Inspection start, node reference: KSWN001821

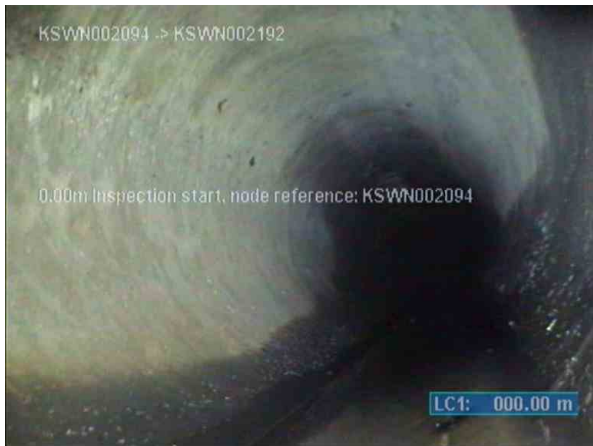
KSWP003817\_224e464b-ab95-4ae6-aa2d-987a188d07f9\_20220812\_112800\_348.jpg, 00:00:17, 0.00m (56.00m)  
Inspection start, node reference: KSWN002094

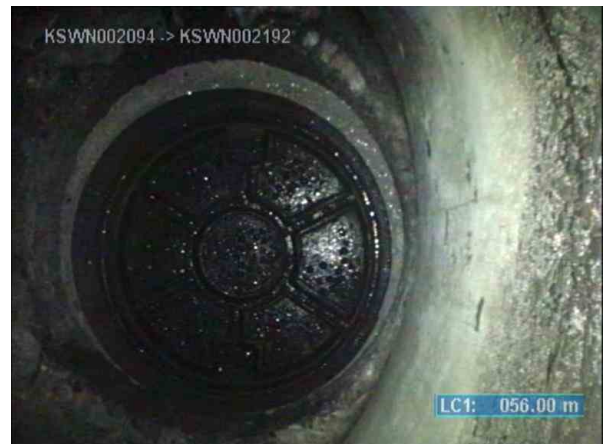
KSWP003817\_a4fb2681-563a-48bd-83bd-c1cc76266e3d\_20220812\_114139\_453.jpg, 00:12:14, 56.00m (0.00m)  
Inspection ends, node reference: KSWN002192

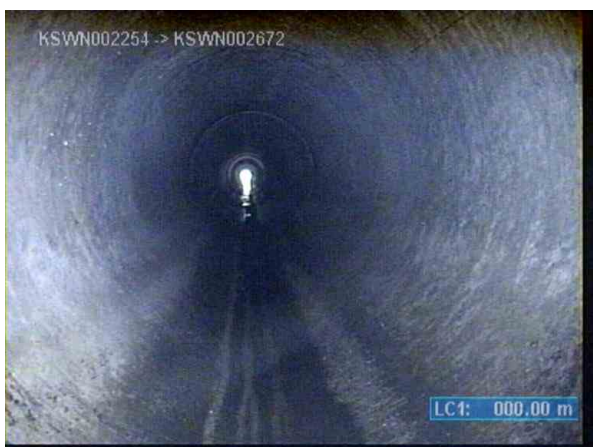
KSWP004512\_78f79a2c-7a30-477a-bdf6-03125de5751b\_20220711\_125340\_084.jpg, 00:00:12, 0.00m  
Inspection start, node reference: KSWN002254

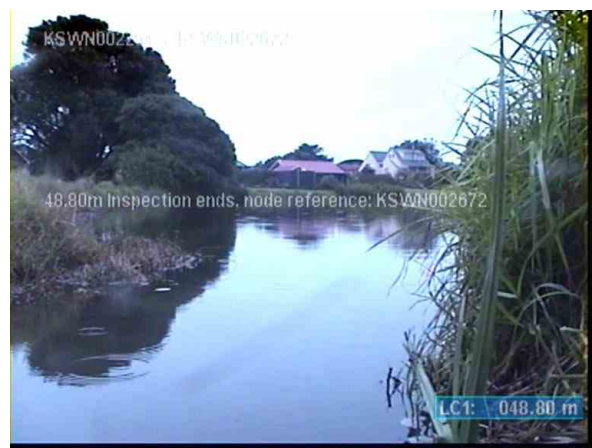
KSWP004512\_087bebea-fdb2-4655-9c99-90565d25f838\_20220711\_125923\_108.jpg, 00:05:40, 48.80m  
Inspection ends, node reference: KSWN002672

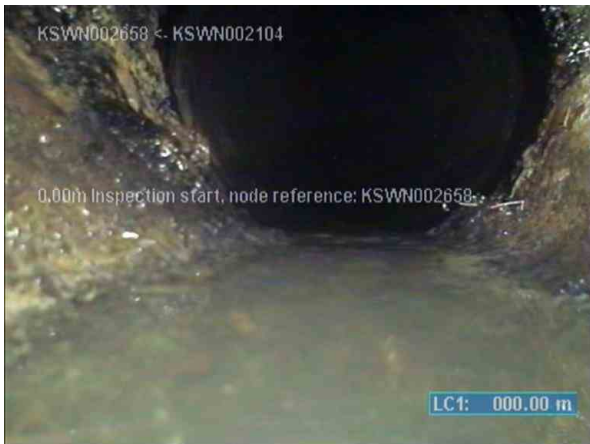
KSWP004528\_e003fdb0-c8ea-45e4-96ca-35ff473e65db\_2020809\_111906\_286.jpg, 00:00:12, 0.00m (48.70m)  
Inspection start, node reference: KSWN002658
