13. WAIKANAE SKATEPARK

WAIKANAĒ SKATEPARK

OVERVIEW

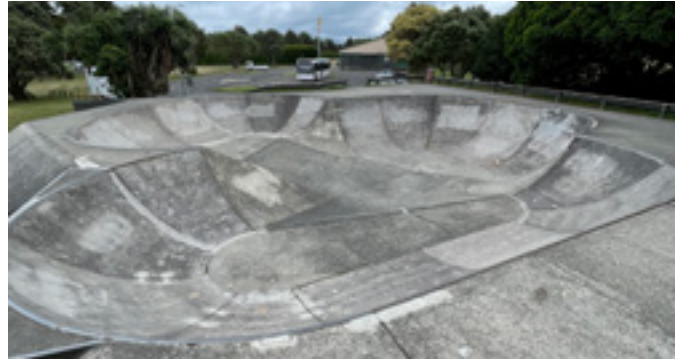
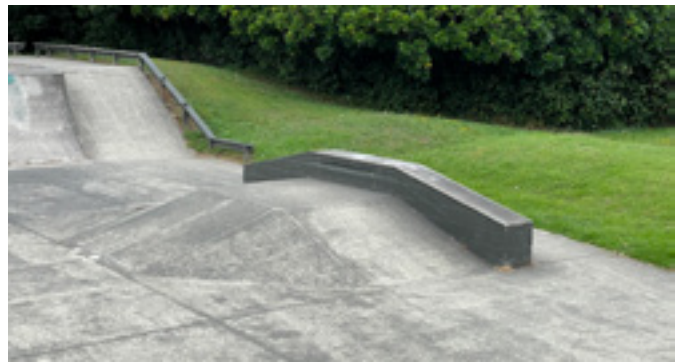
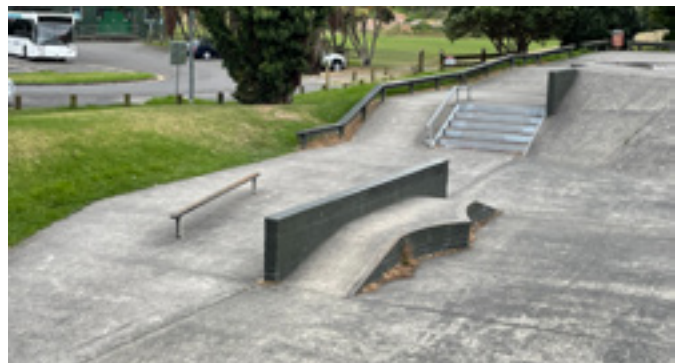
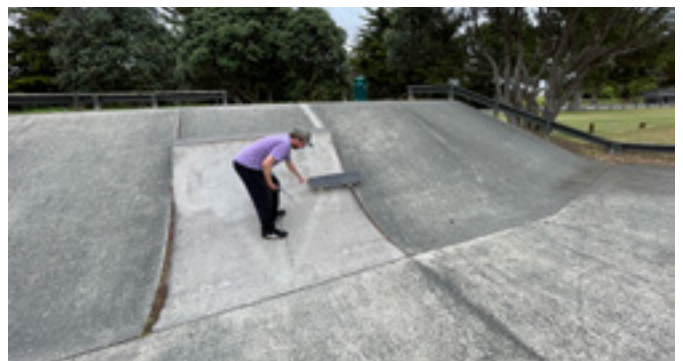
Layout, size and capacity: The existing skatepark has approximately 500m² of concrete riding surface. The skatepark is a medium 'Community Level' facility with transition and street style features. Due to the poor condition of the facility and minimal functional obstacles, for a Community Level facility it would struggle with holding its designated capacity.

Skill level: The size, style and layout of the skatepark features make the facility suitable for intermediate to advanced skill level, it lacks in beginner features. Due to the poor condition of the concrete surface it caters exclusively to more advanced riders capable of dealing with the surface and defects.

Street obstacles: There are some street obstacles with a fun box, rails, stair set and out ledge feature however all of these are difficult / hazardous to use give the surface quality and the gaps in construction joints at critical locations within the facility.

Transition obstacles and flow: The skatepark has a mix of large flatbanks, hips and quarter pipes that surround the space. These are of large proportions, aged and built to very poor quality not inline with skatepark tolerances. The transition is extremely limited in functionality. The bowl has many defects with settlement lifting coping and forcing cracks and lifting in many locations. A combination of outdated construction techniques, settlement and weathering render much of the facility unusable and unsafe.

Value contribution: Overall, although the facility is defined as a 'Community Level' skatepark, it contributes very little to the Kapiti Coast skate network due to the poor quality, hazardous unsafe nature of features and surface, outdated style and limited functionality.

FUNCTION RATING: LOW

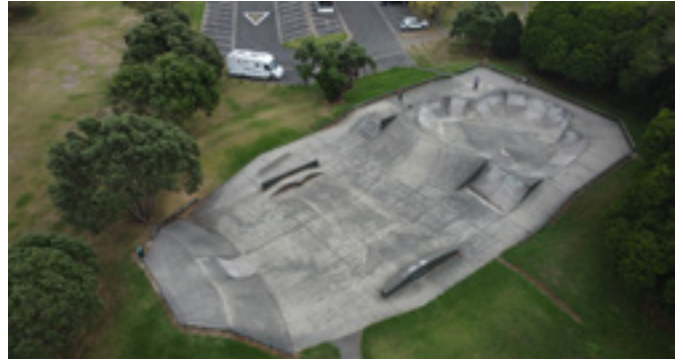
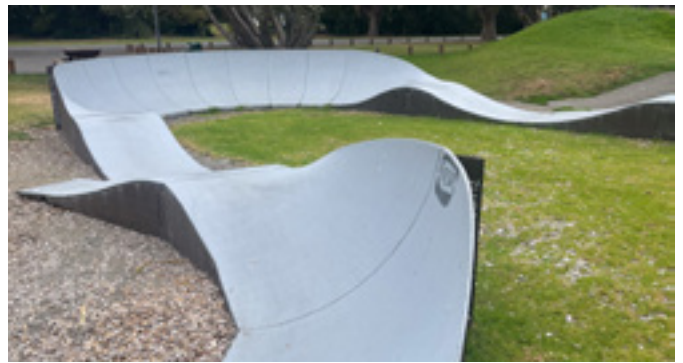
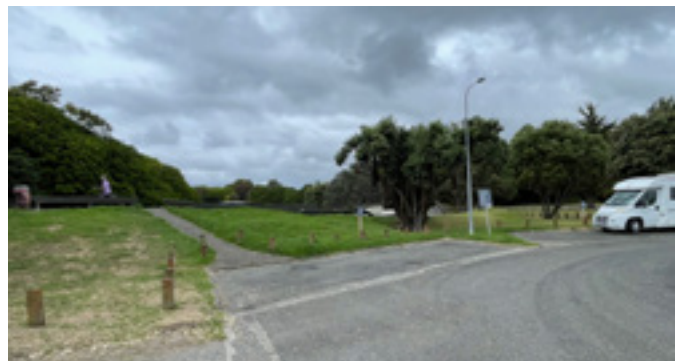
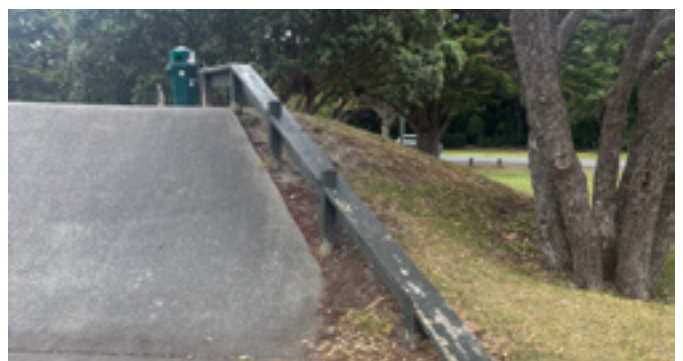
Passive + Youth Recreation Opportunities: The skatepark sits in Waikanae Park with sports fields nearby, ninja warrior course and old play ground sitting adjacent to the skatepark. Although all elements are currently detached, sitting isolated from each other.

Signage: There is currently no safety signage or conditions of use signage accompanying the facility.
