WATERFALL ROAD SLIP

Job No: 85767.002

Waterfall Road 2017 Landslip Geotechnical Hazard and Risk Assessment

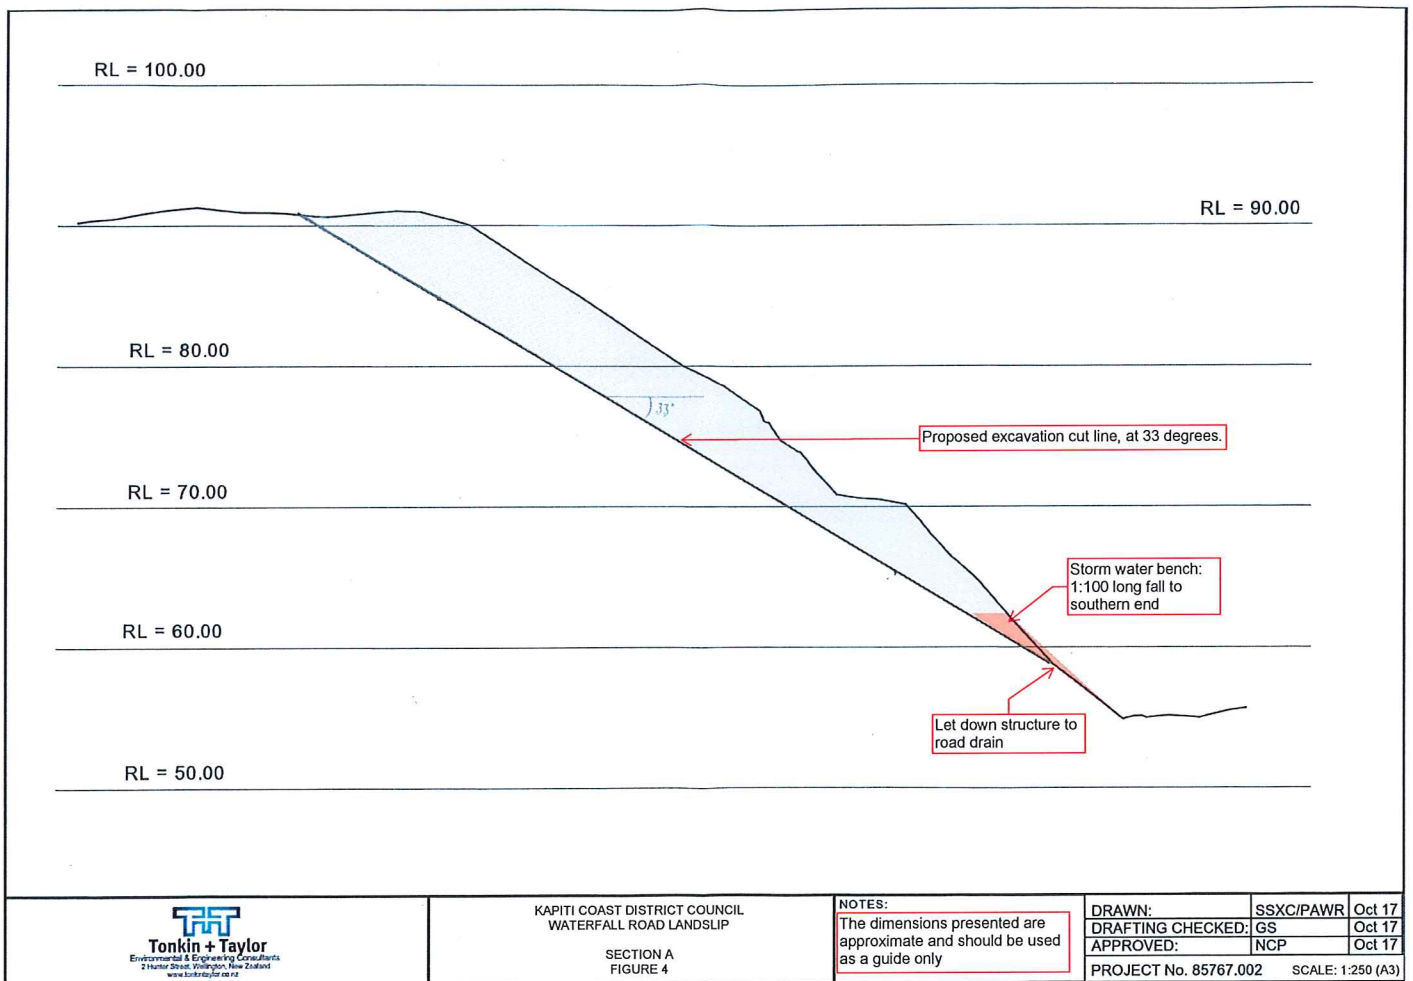
- 4 An inspection programme was put in place after these works were completed in June 2014. During the last inspection on 4 September 2017 it was observed that cracks on the top of the slip site (approximately 650m from Valley Road) had significantly widened and the slope was slumping.

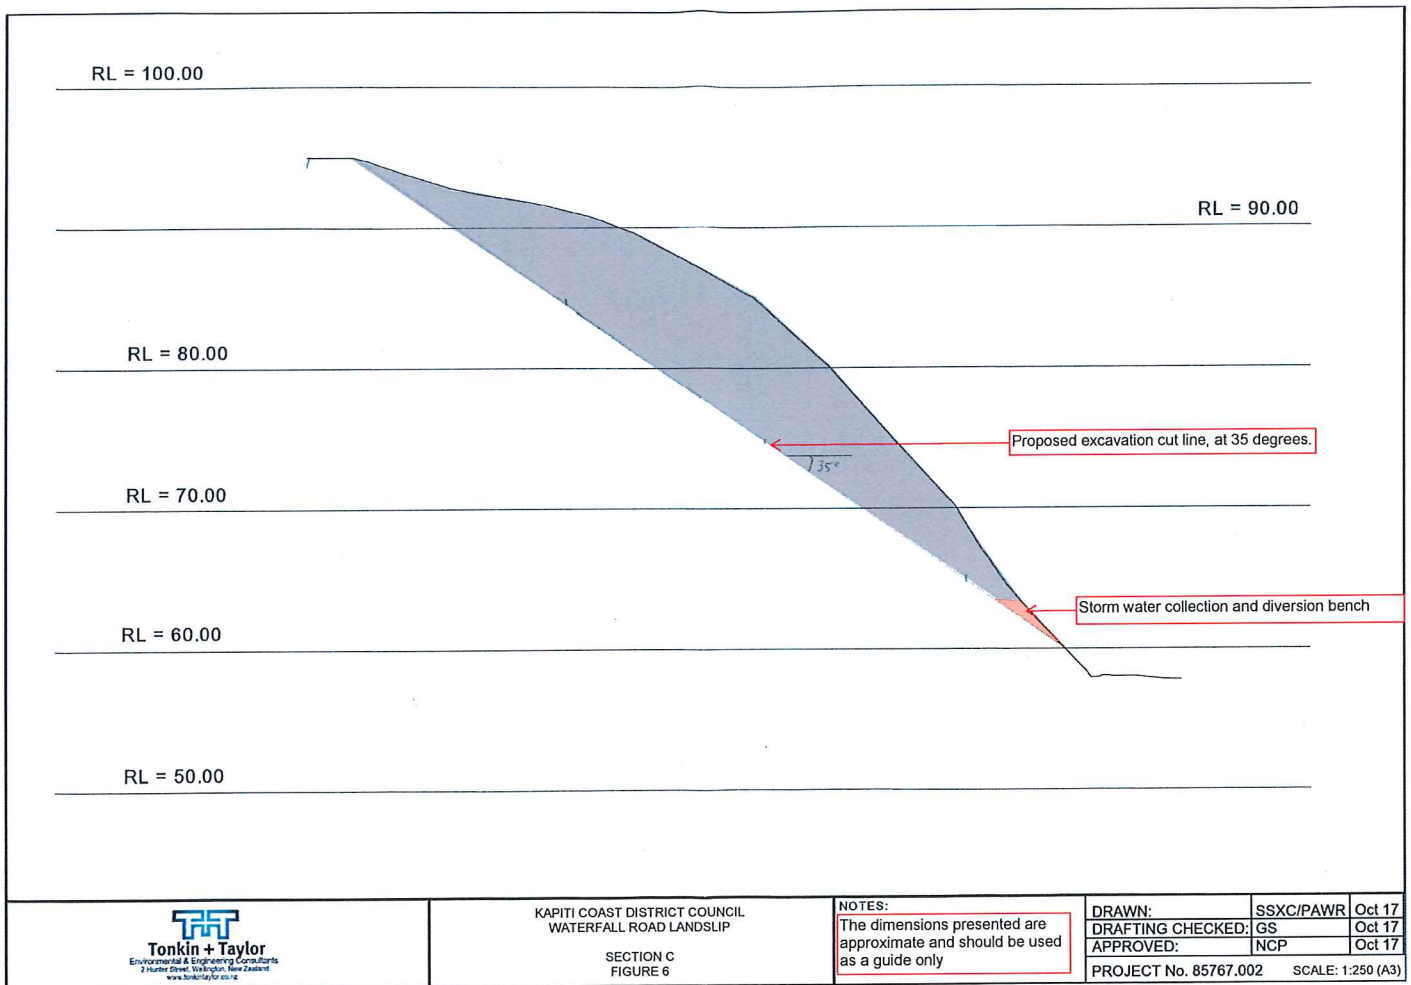
If no earthworks are completed, there will be medium to high risk of small to moderate sized landslips and a high risk of large scale failure. This option poses an unacceptable risk to the road and road users.

We recommend KCDC and Electra work through options to relocate or lower the power poles (Options 2 or 3, respectively), and we can assist if required. These options are considered lower cost, less time consuming and lower risk. Earthworks for the re-profiling of the slope can proceed and no slope specialist slope stabilisation work (i.e. anchors and shotcrete) would be required.
