# **Kapiti Coast Erosion Hazard Assessment**

# Part 2: Inlets

A report prepared for the Kapiti Coast District Council

Client Report 2008-03

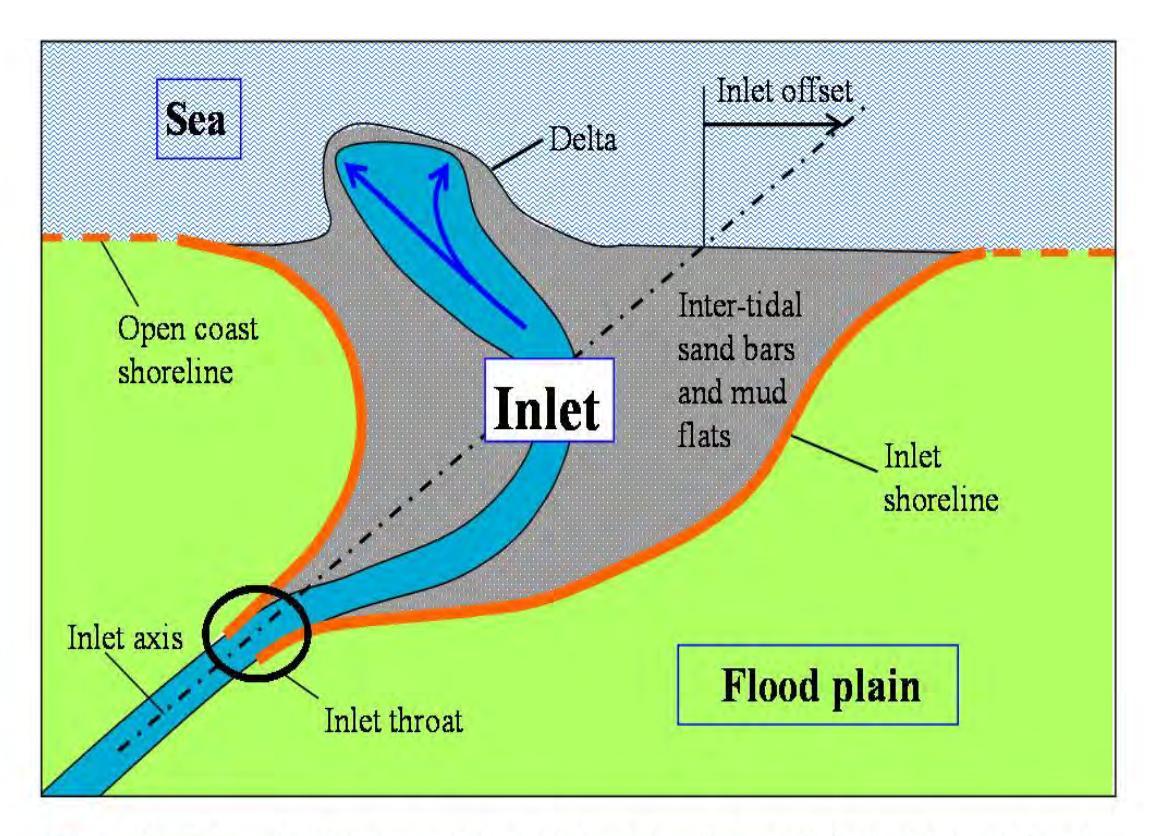
Figure 2 Schematic diagram and associated notation for morphological features found with inlets typical of those on the Kapiti Coast.

The terms used to describe aspects of the inlet environment are illustrated in Fig 2. An inlet is an indentation in the coastal shoreline which reflects the interaction between marine and fluvial processes. The terms *outlet* and *entrance* may also be used to describe such a feature. The inlet includes *inter-tidal sand bars and mud flats*. As with the open coast shoreline, the *inlet shoreline* is defined by the permanent terrestrial (c.f. aquatic) vegetation boundary. The

*channel* also forms part of the inlet and as noted earlier, this feature is prone to significant and rapid change in terms of both location and form. The area where the channel meets the sea is termed the *river or stream mouth*, although sometimes this term is more broadly used to refer to the whole inlet. A seaward protrusion of sediment (a *delta*), may occur where the channel meets the sea. The inlet narrows to landward and the location where the width thereafter remains relatively constant, and equal to that of the channel itself, is called the *throat*. The inlet may be symmetrical or, as in the illustration, skewed in the longshore direction. The amount of skew (or *offset*) is related to several interacting factors including the dominant marine energy (wave and current) approach direction, the coastal and fluvial sediment budget, and the upstream channel geometry. For the present exercise, the inlet merges with the open coast where the historical set of shorelines become parallel.

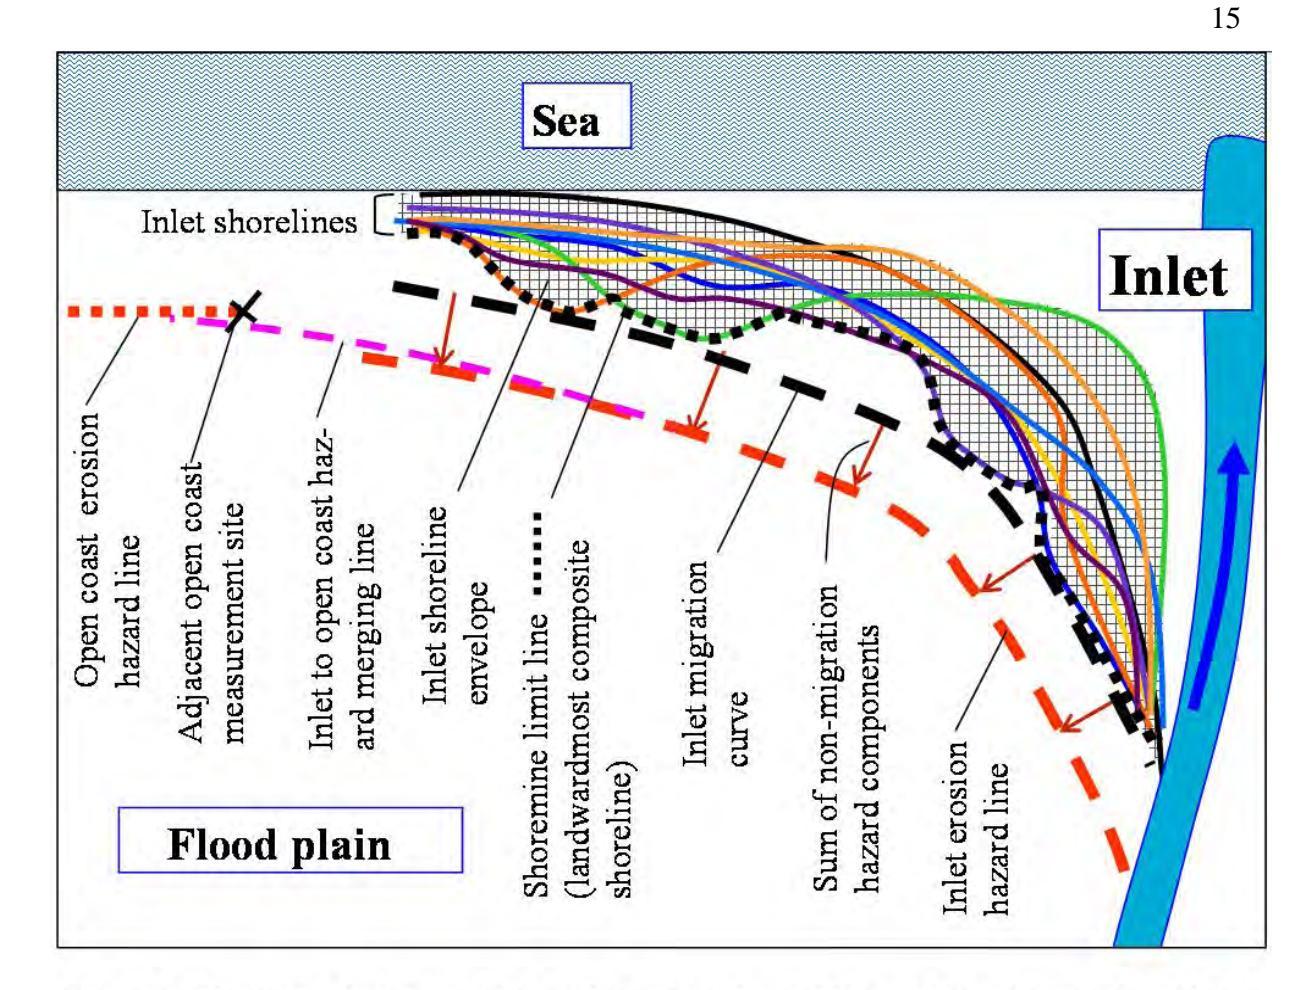
Figure 3 Illustrated derivation of the inlet erosion hazard line and its relationship with the open coast erosion hazard line

For each inlet, the following procedures (illustrated in Fig 3) were used to locate the erosion hazard line:

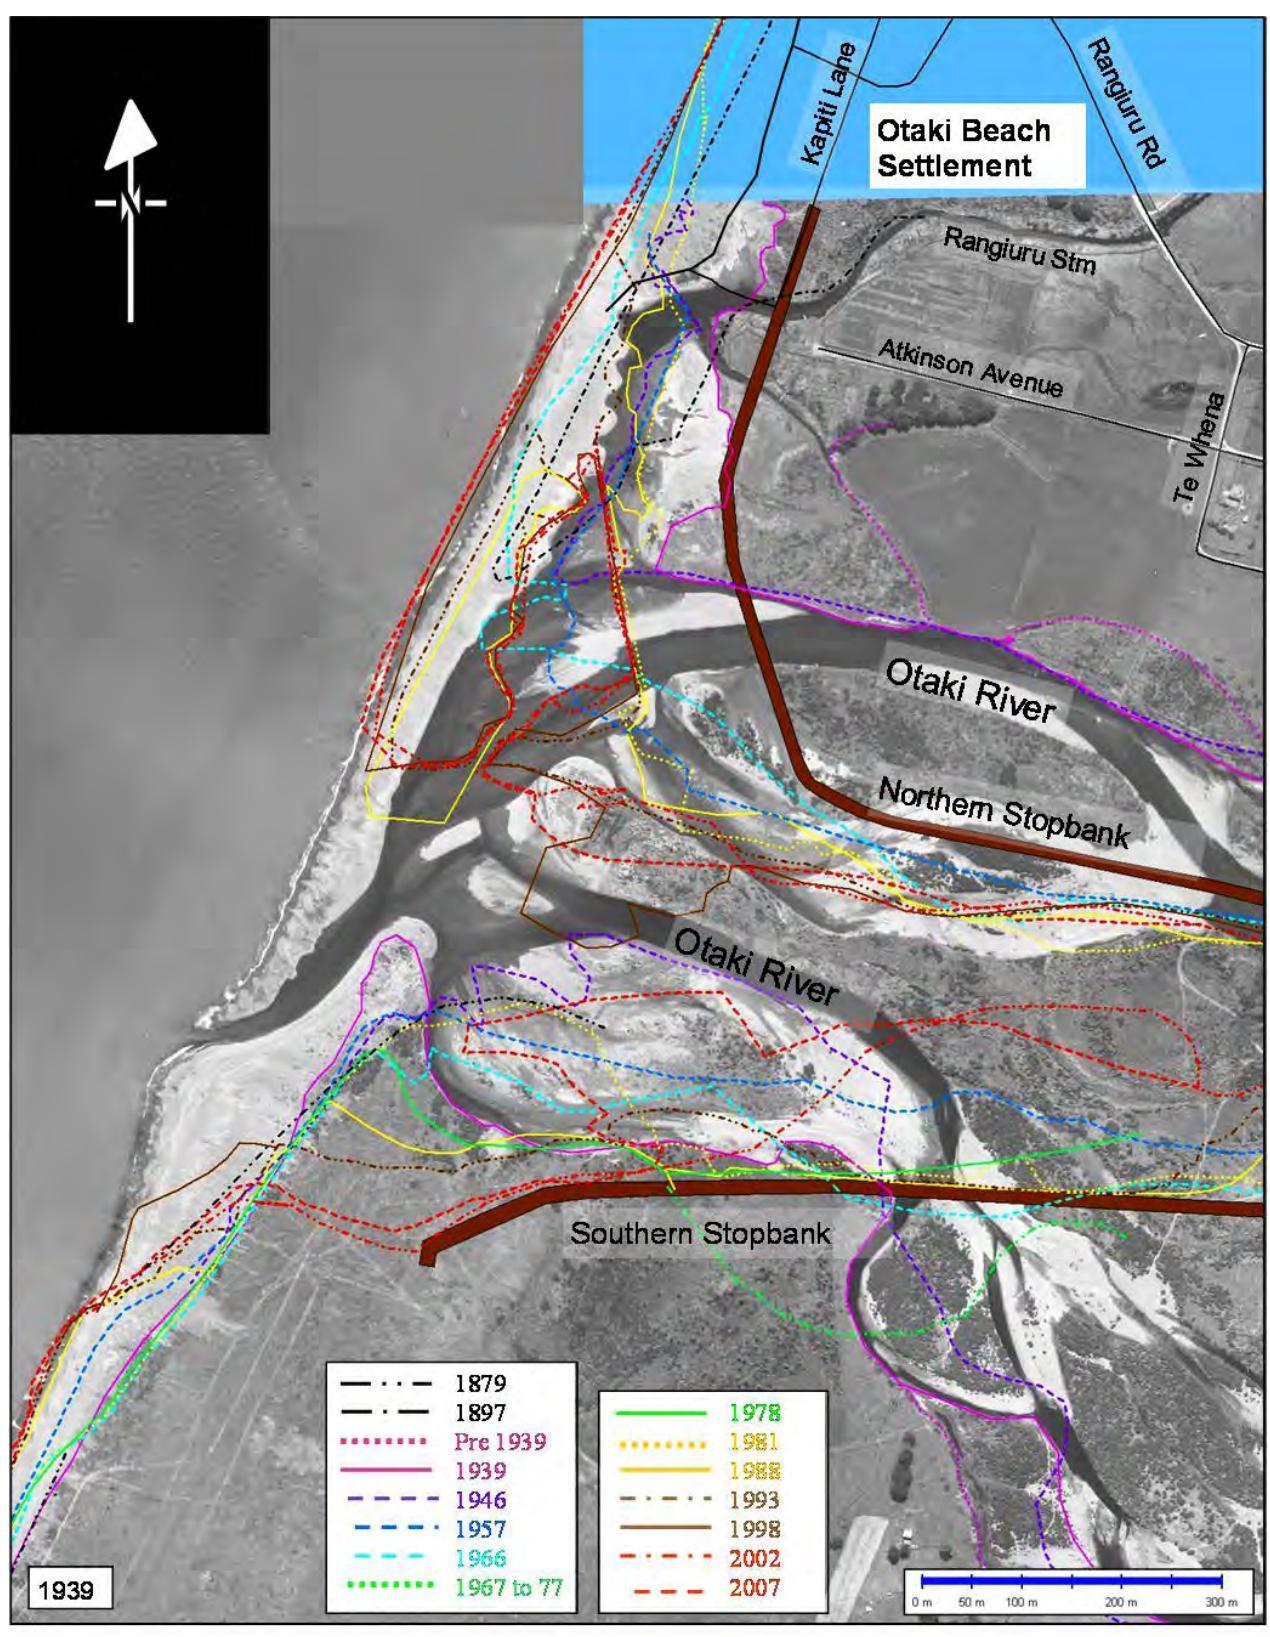
Figure 6 Historical shorelines lines for the Otaki inlet superimposed upon the first vertical aerial photo (1939). The 19th century shorelines are derived from survey cadastral plans and relate to the high water mark and the spring high water mark for 1879 and 1897 surveys respectively, while the remaining shorelines are derived from aerial photos and relate to the permanent vegetation front. The contemporary roading and stopbanks have been overlayed to assist interpretation.

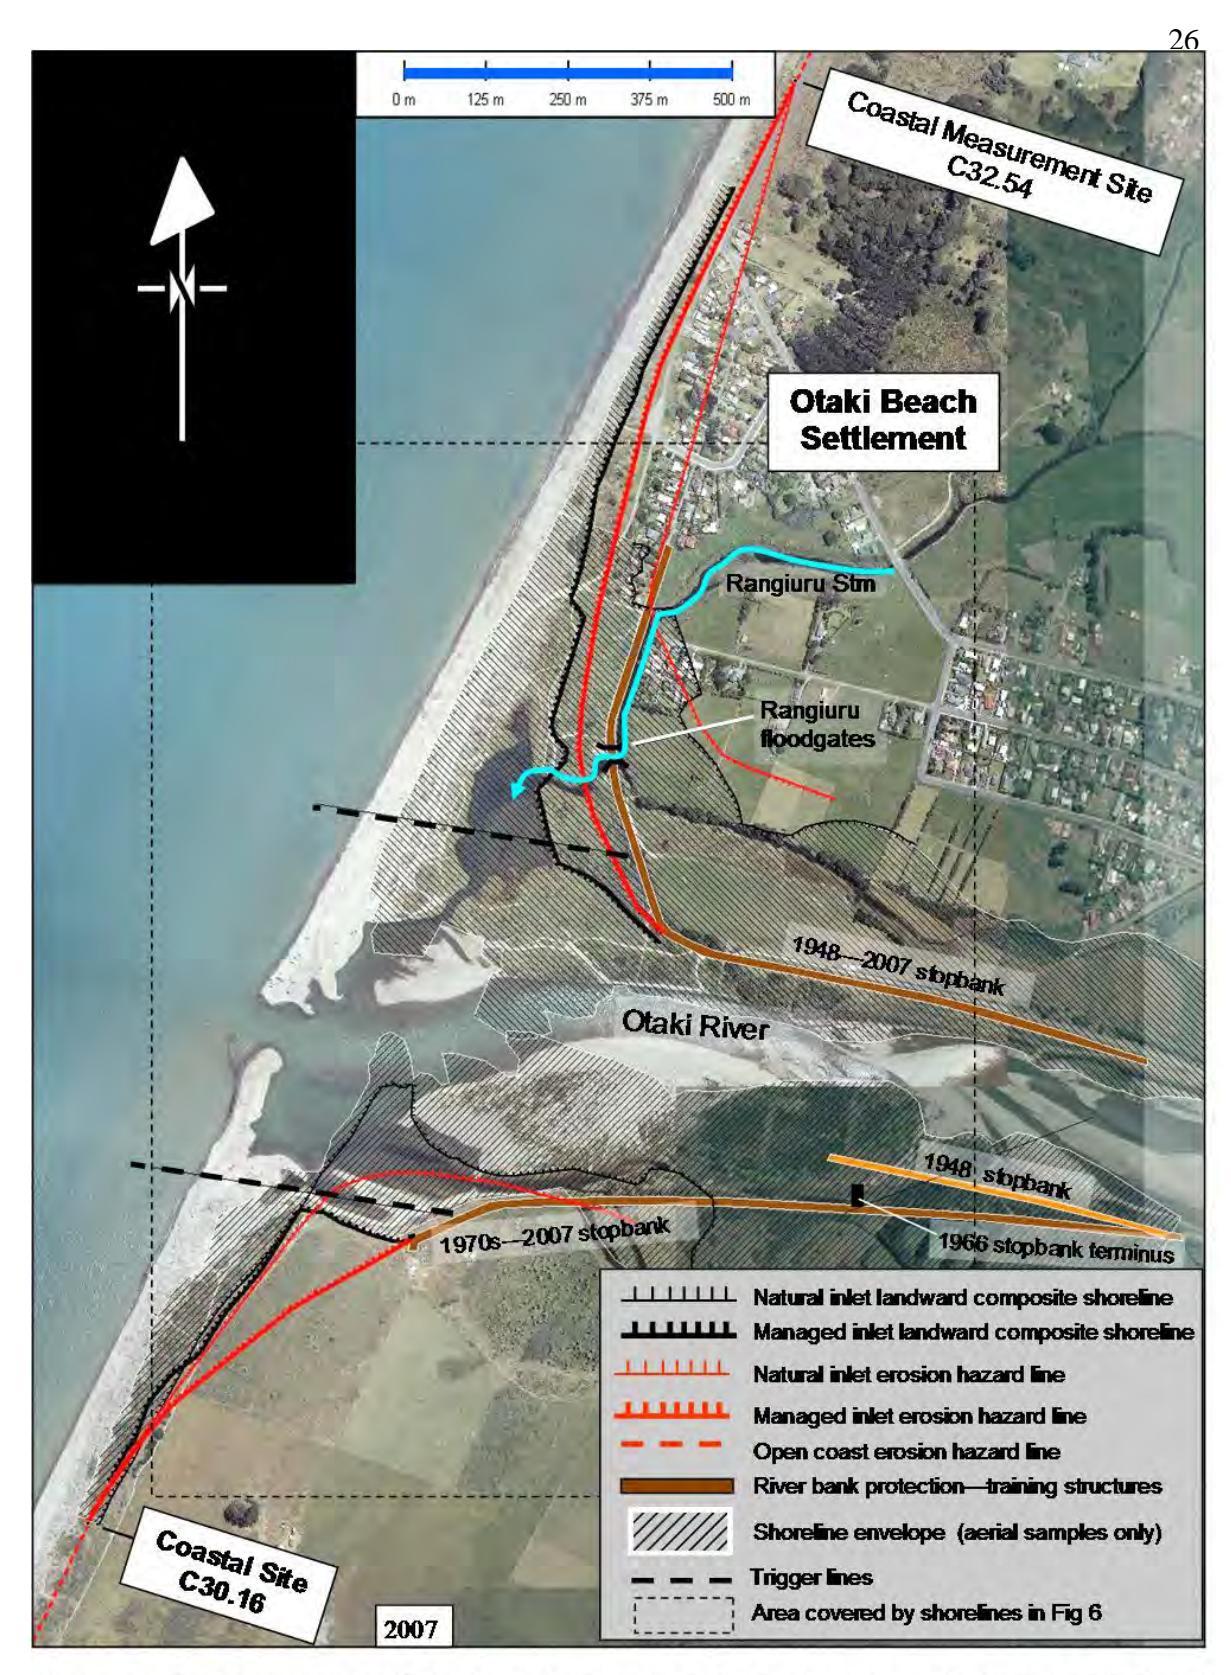
Figure 7 Erosion hazard lines for the natural and managed Otaki inlet superimposed upon the 2007 aerial photo. The shoreline envelopes are also shown for the full set of shorelines depicted in Fig 6, together with the landwardmost composite shorelines used to define inlet migration. Inlet migration was then combined with the other hazard components for coastal measurement sites C30.16 in the south and C32.54 in the north to derive the erosion hazard lines. Also depicted are river stopbanks and their development stages, together with trigger lines for mouth cutting.

the river, this being over 400 m inland from the present shoreline. The hazard line then curves to the north and follows the general shape of the shorelines to merge with the open coast erosion hazard line at Coastal Measurement Site C32.54. No private property lies within the hazard area of the managed inlet.

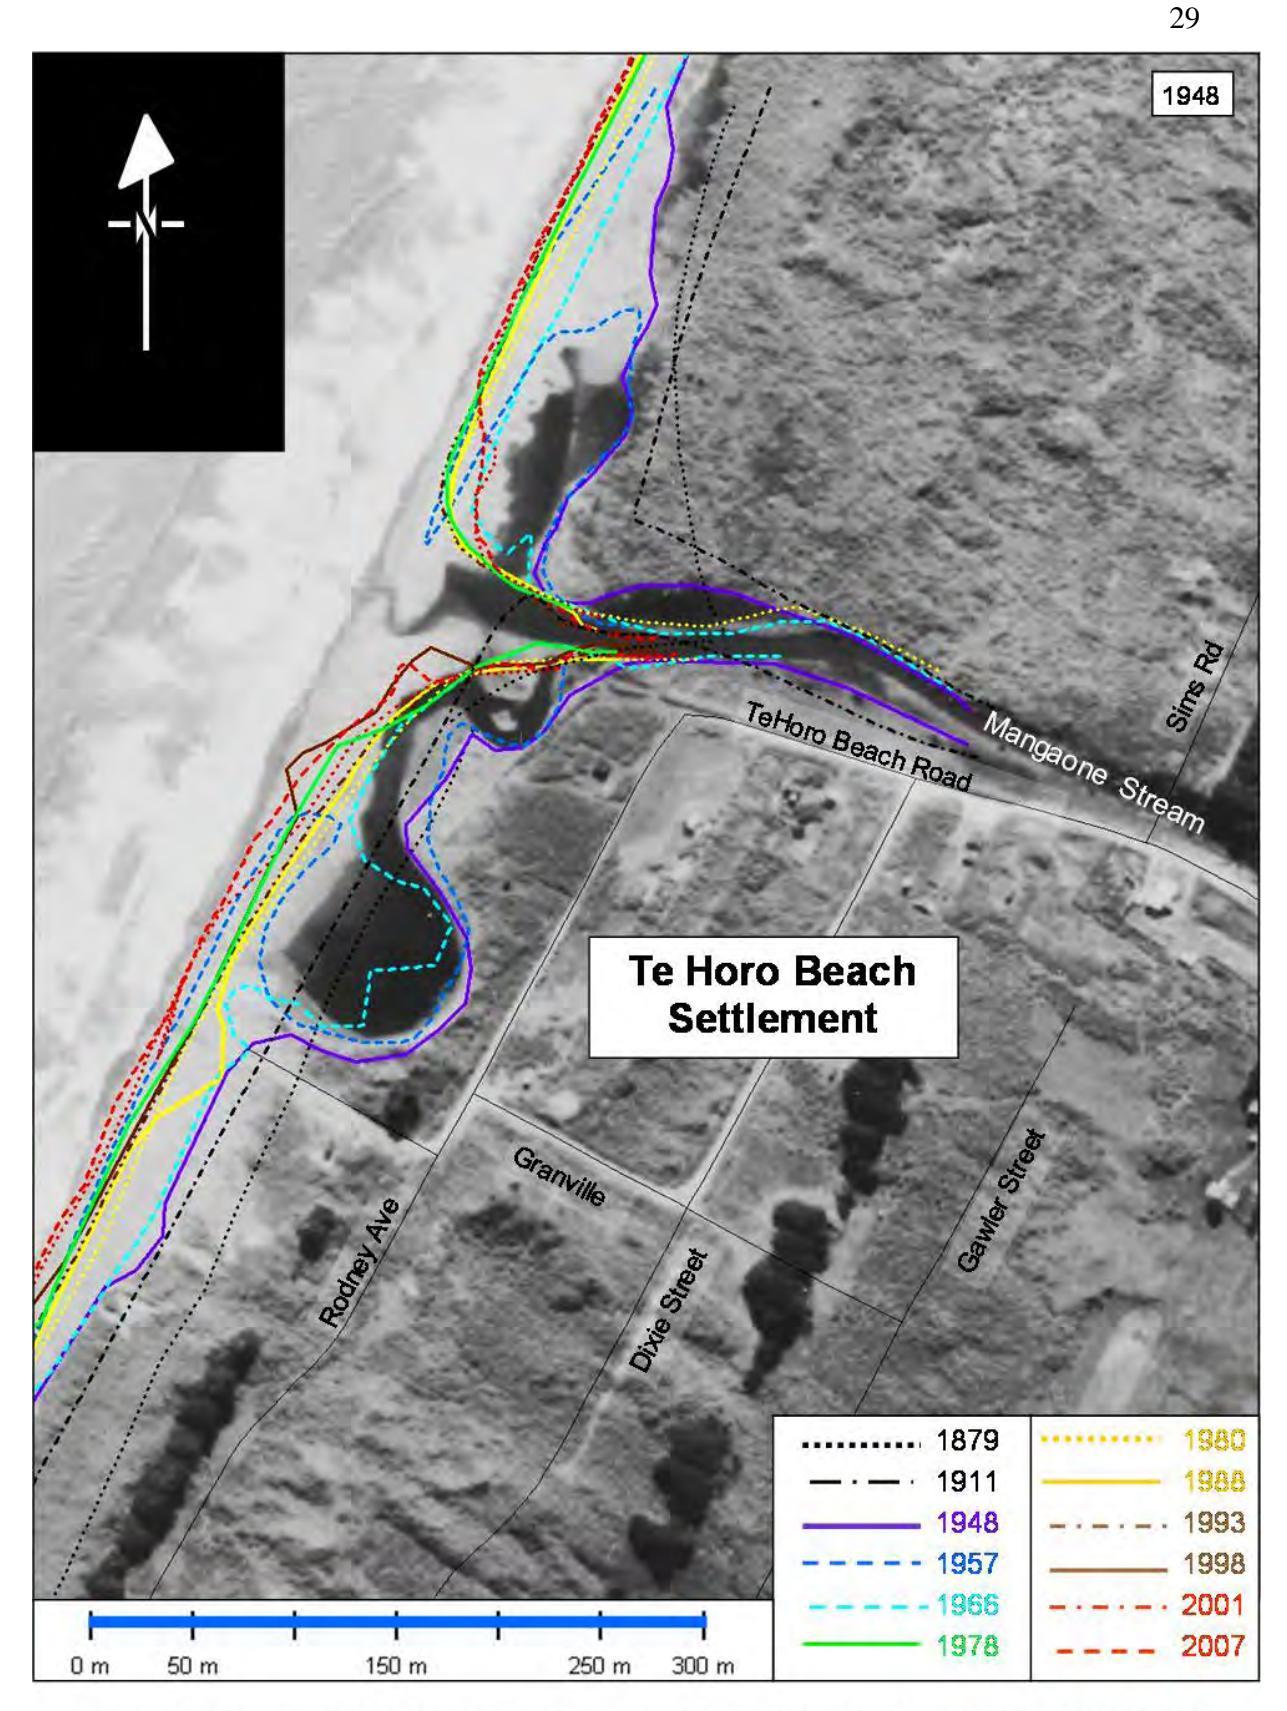
Figure 8 Historical shorelines lines for the Mangaone inlet superimposed upon the first vertical aerial photo (1948). The 19th century shorelines are derived from survey cadastral plans and relate to the high water mark, while the remaining shorelines are derived from aerial photos and relate to the permanent vegetation front. The contemporary roading has been overlayed to assist interpretation.

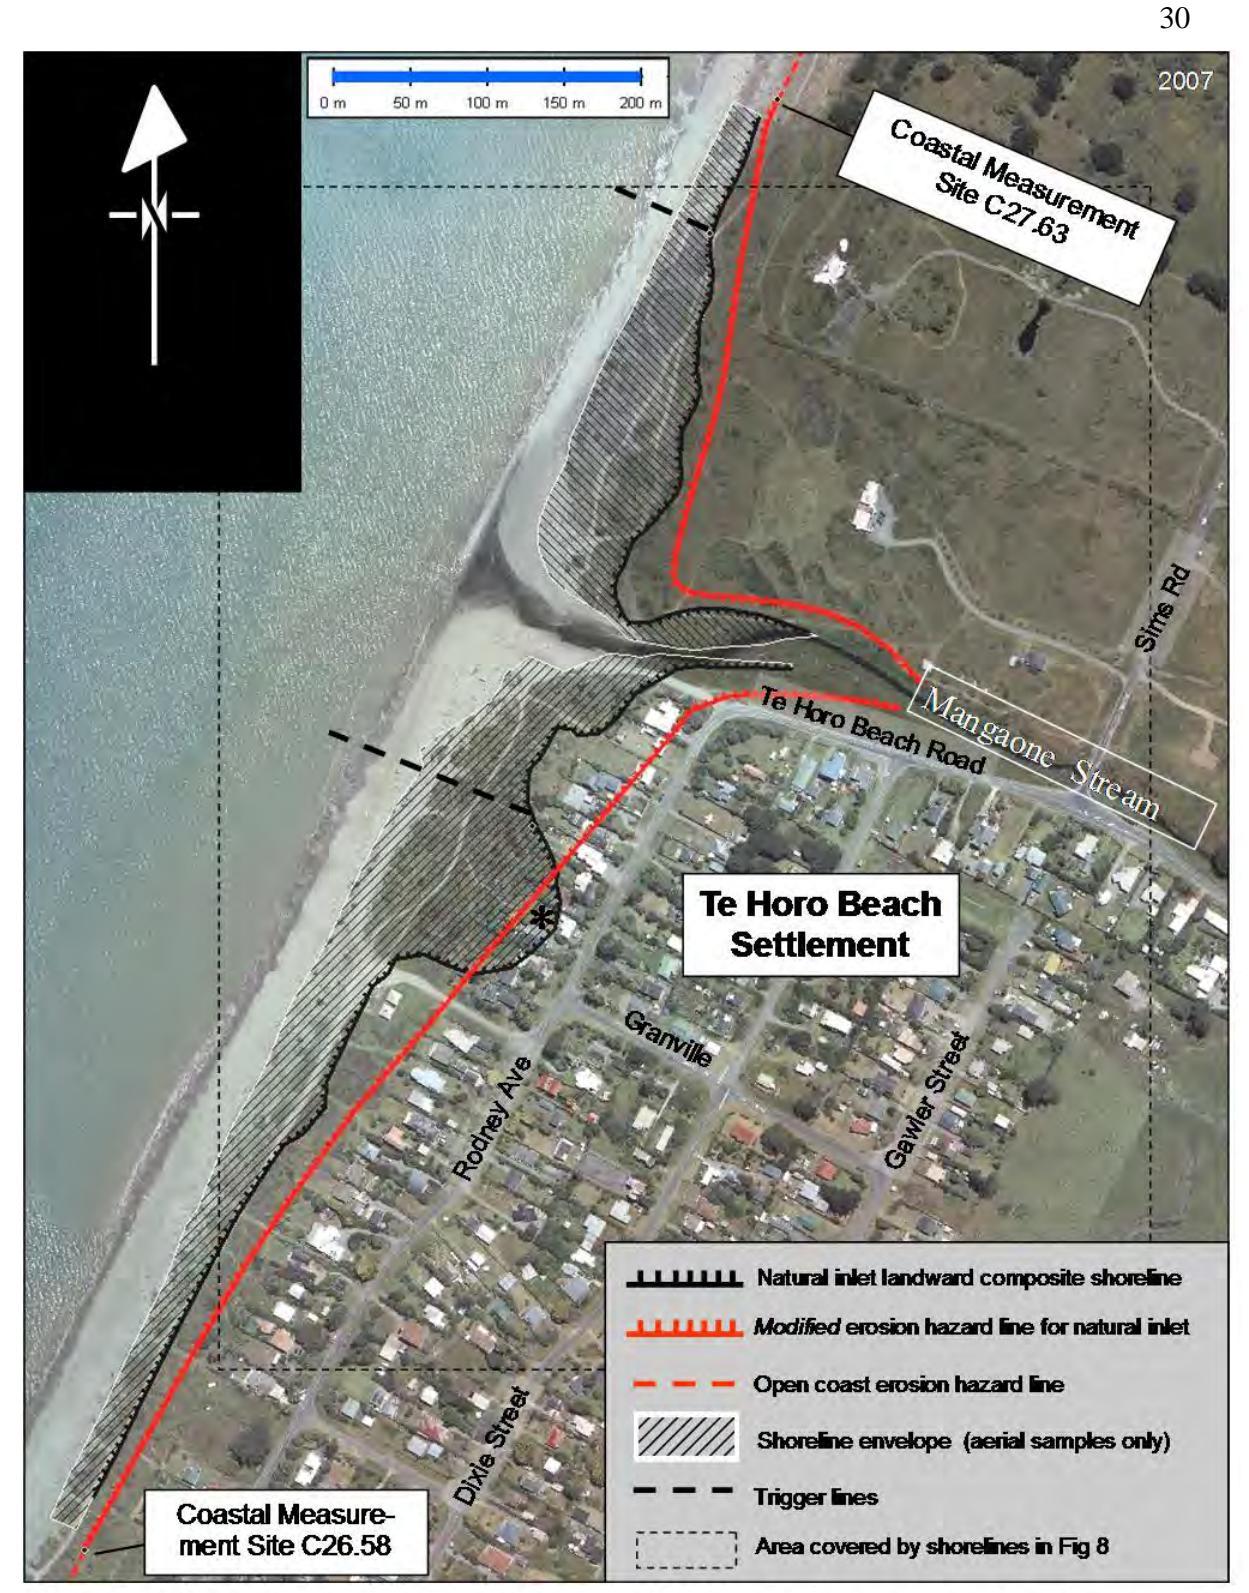
Figure 9 *Modified* erosion hazard lines for the natural Mangaone inlet superimposed upon the 2007 aerial photo. The shoreline envelopes are also shown for the shorelines depicted in Fig 8, together with the land-wardmost composite shoreline used to define inlet migration. Because this inlet has only been subject to minimal management, there is no managed hazard scenario. However, the migration line (and hence the subsequently derived hazard line) has been modified to account for this particular inlet's characteristics (see text). Inlet migration was then combined with other hazard components for coastal measurement sites C26.58 in the south and C27.63 in the north to derive the erosion hazard line. Also depicted are trigger lines for mouth cutting and the asterisk locates the large embayment discussed in text.

On the southern side of the inlet, the erosion hazard line is, on average, 72.5 m landward of the present shoreline and affects several dwellings closer to the stream. On the northern side the hazard line is, on average, 62 m behind the present shoreline and no properties are affected.

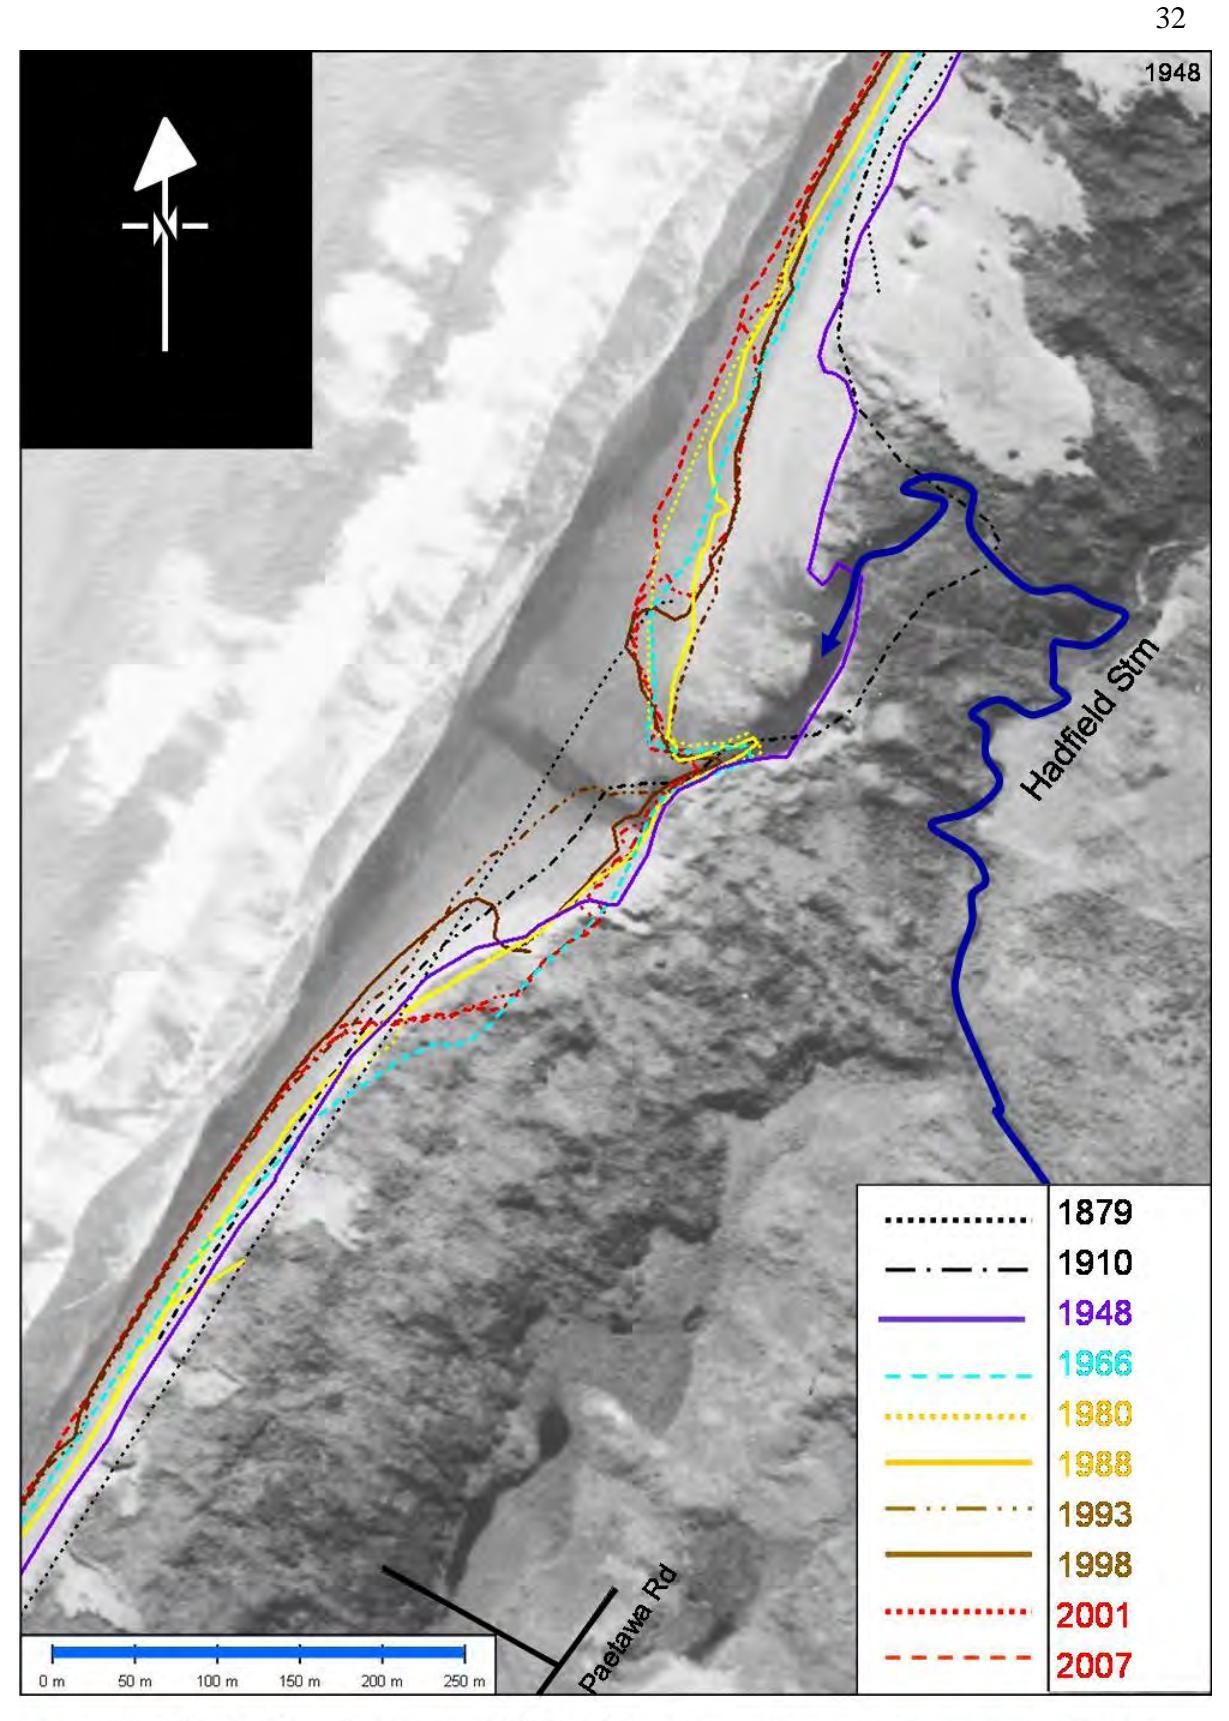
Figure 10 Historical shorelines for the Hadfield Inlet superimposed upon the first vertical aerial photo (1948). The first two shorelines are derived from survey cadastral plans and relate to the high water mark, while the remaining shorelines are from aerial photos and relate to the vegetation front. The northern end of Paetawa Road is marked to assist with interpretation.

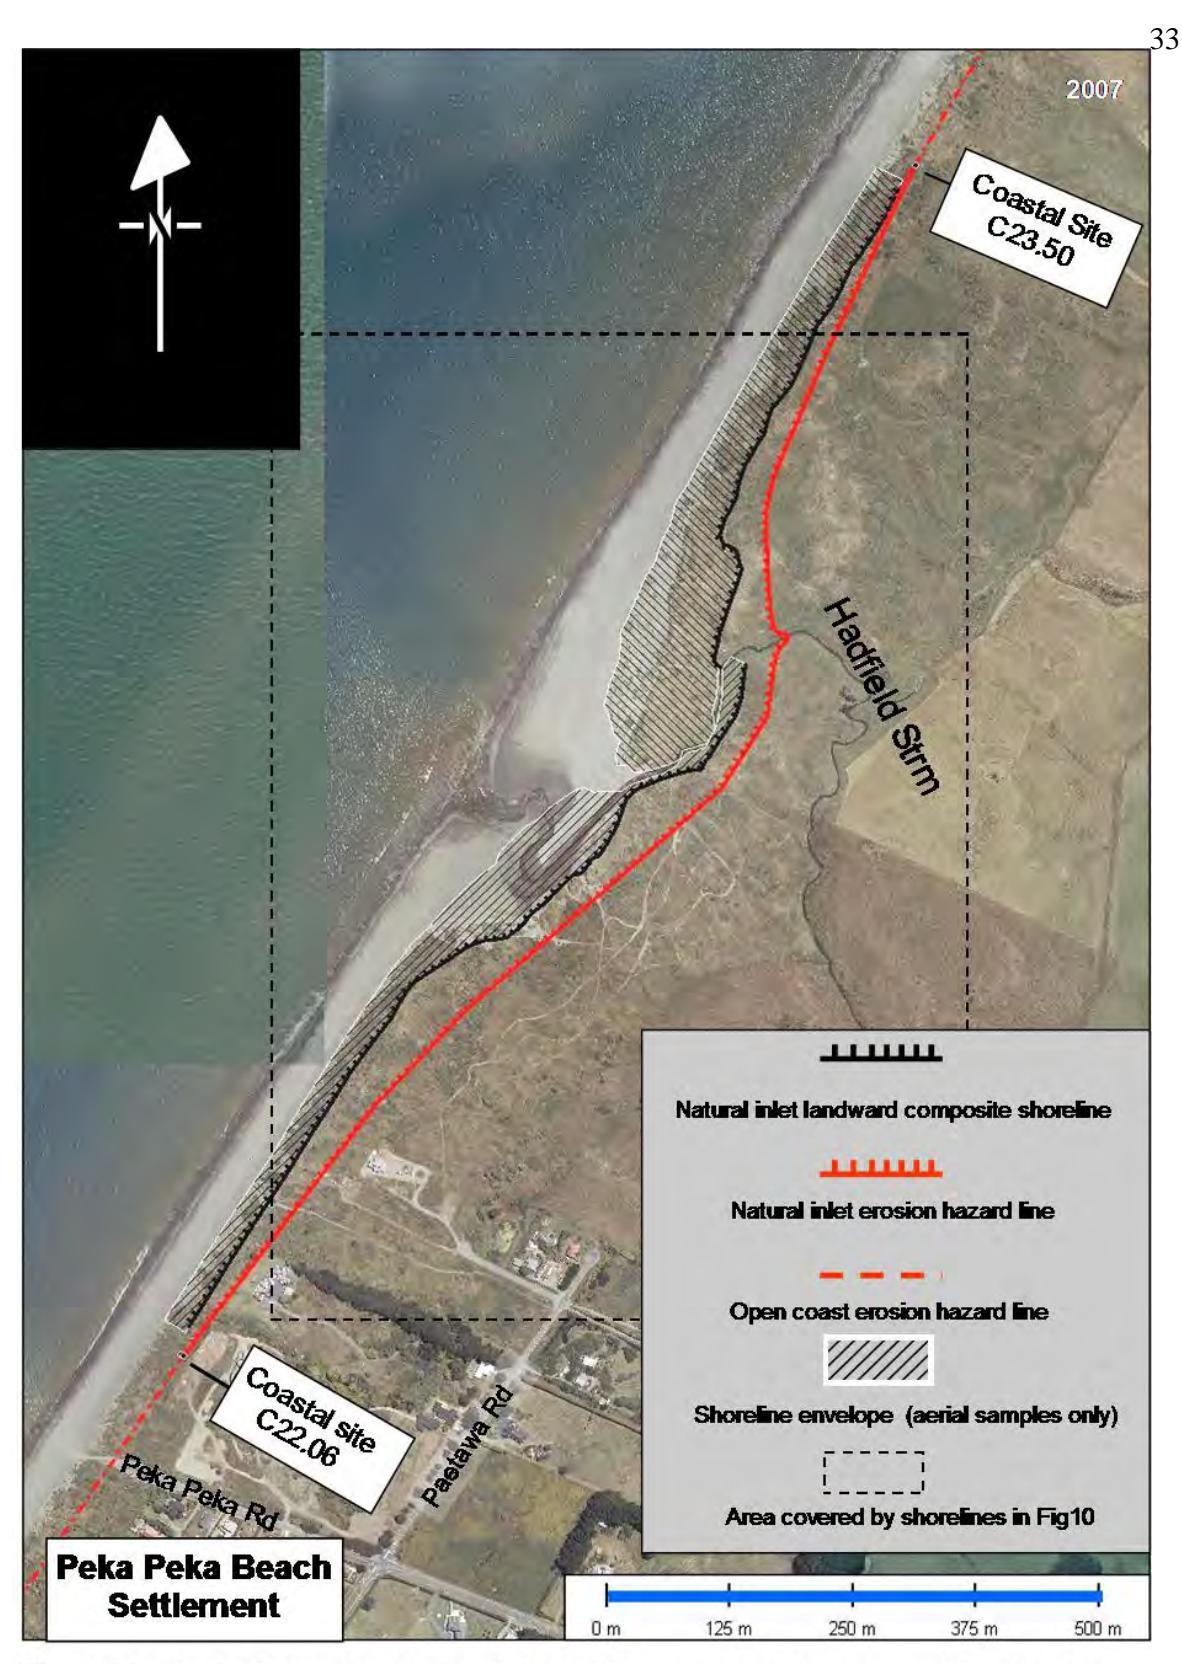
Figure 11 Erosion hazard lines for the Hadfield Inlet superimposed upon the 2007 aerial photo. The shoreline envelopes are also shown for the set of shorelines depicted in Fig 10, together with the landwardmost composite shoreline used to define inlet migration. Inlet migration was then combined with the other hazard components for adjacent coastal measurement sites C22.06 to the south and C23.50 to the north to derive the erosion hazard lines. Because this inlet has only been subject to minimal management, no managed inlet erosion hazard scenario was included.

On the southern side of the inlet the erosion hazard line is, on average 58 m landward of the present shoreline and cuts across the front of several properties, partially affecting one dwelling. On the northern side the hazard line is, on average, 95 m landward of the present shoreline and no properties are affected.

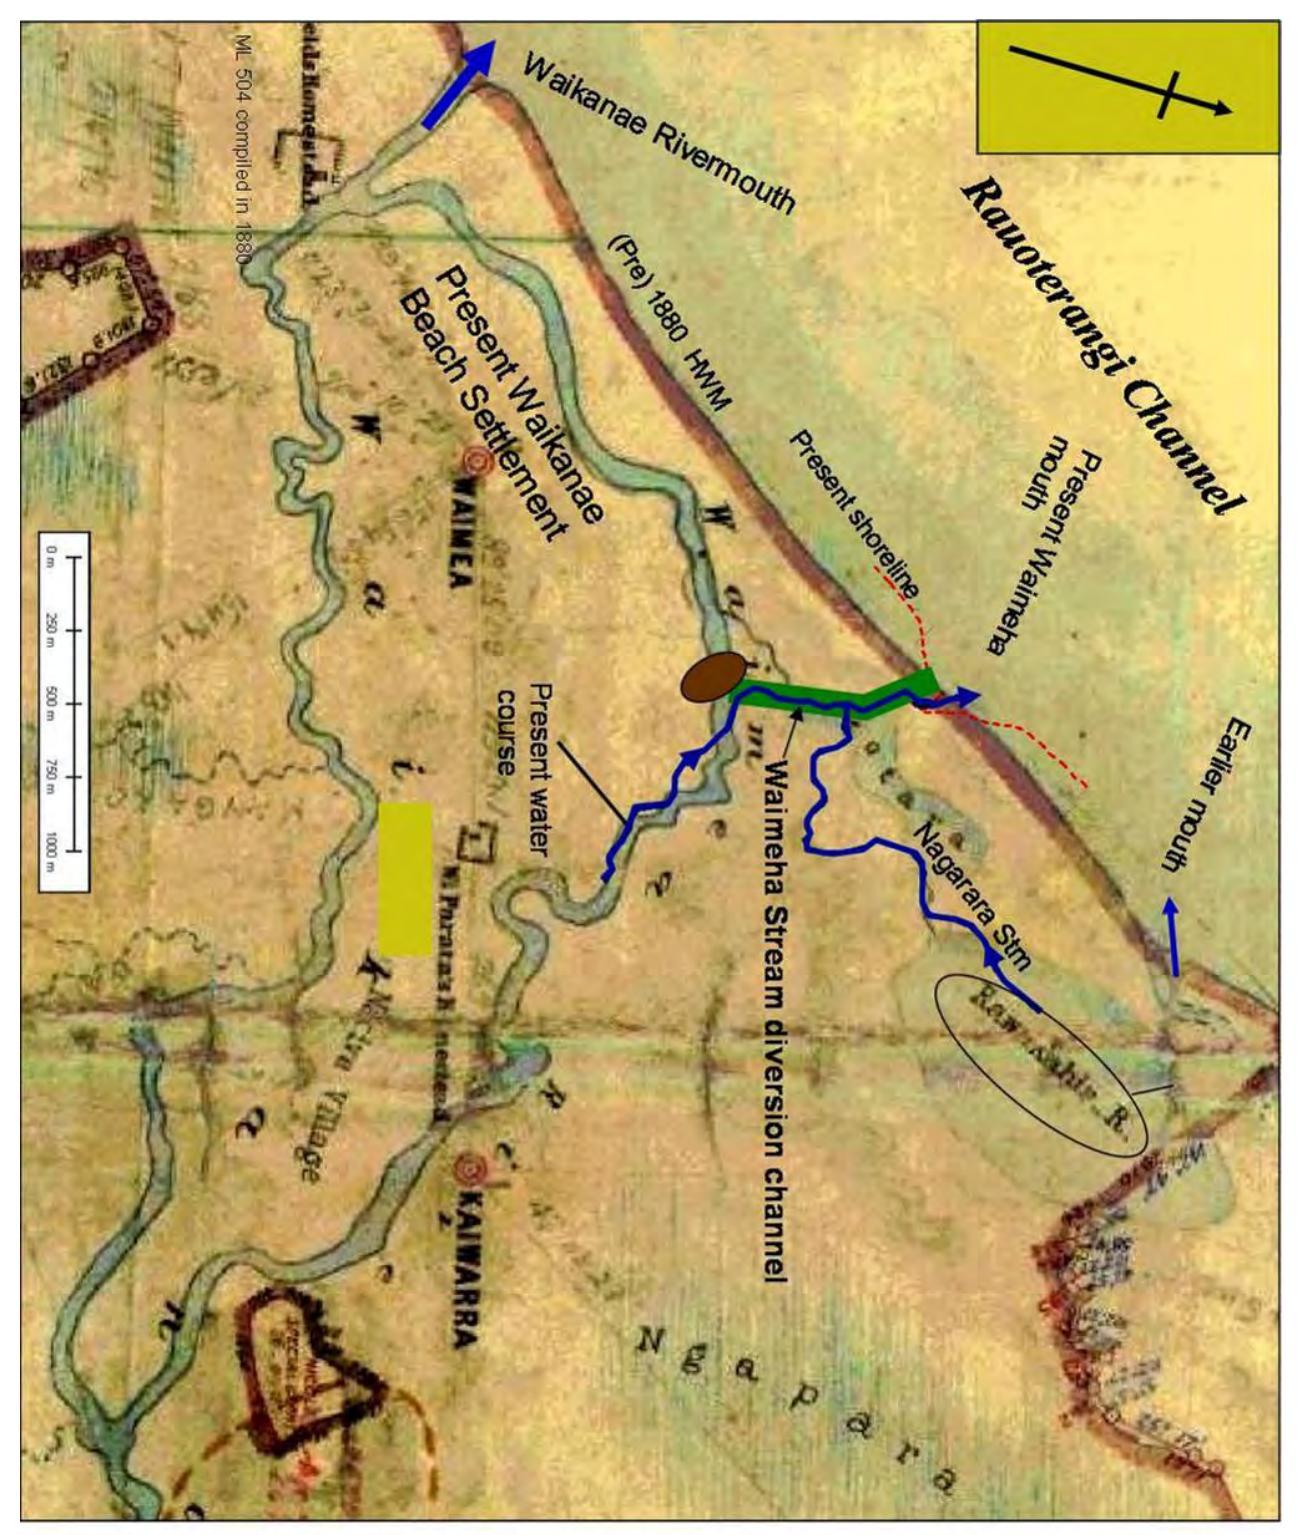
Figure 12 Cadastral survey plan ML 504A compiled in 1880 showing early water courses in the Waikanae flood plain area. The 1921 diversion channel (green) of the Waime(h)a River to create the Waimeha Inlet are shown, together with the present Waimeha Mouth. Note the old inlet at top of figure; it appears that this stream (the Rawanahia?) may have been diverted into the Waimeha via the Nagarara Stm which drains the intervening swamps. Note how the Waimeha originates where the Waikanae River diverges (lower right of figure) which the approximate location of the railway bridge. This branch appears to have been cut off during the early 1890s by natural processes.

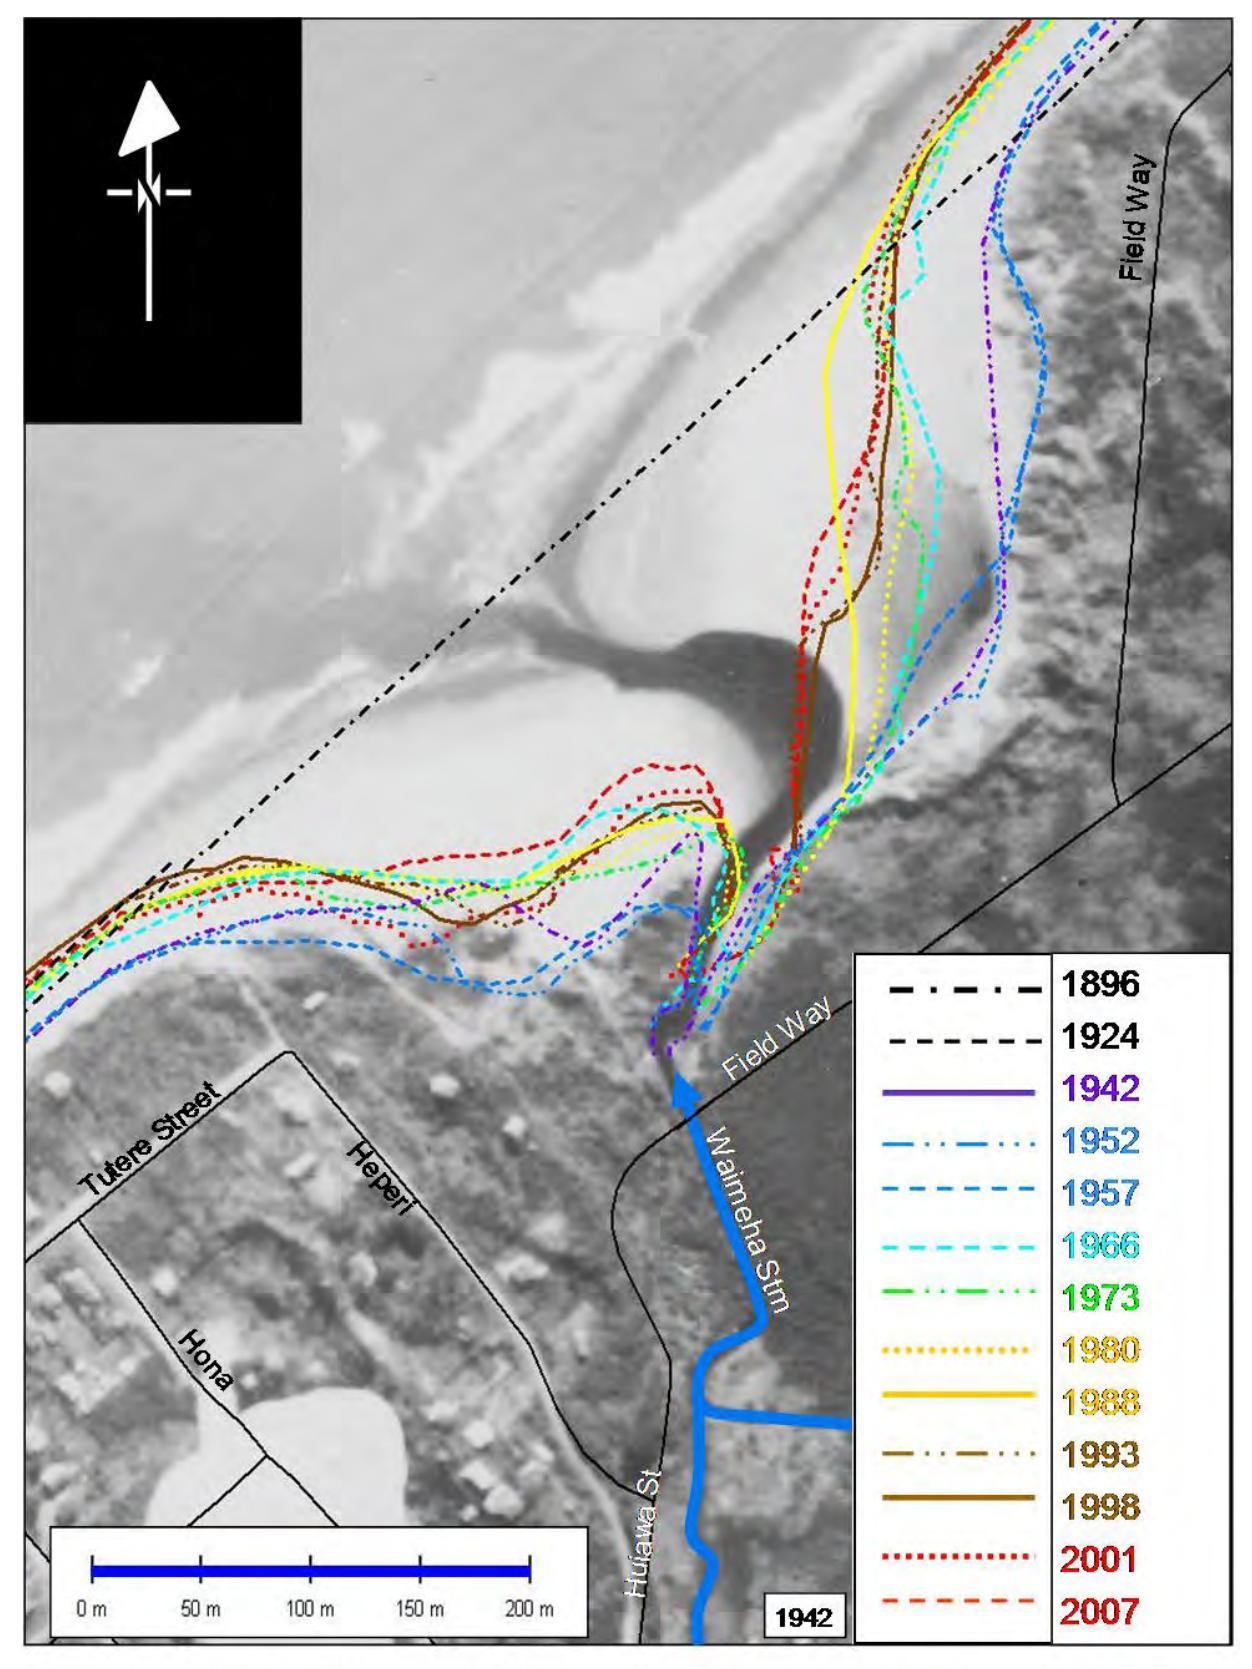
Figure 13 Historical shorelines for the Waimeha Inlet superimposed upon the first vertical aerial photo (1942). The first two shorelines are derived from survey cadastral plans and relate to the high water mark, while the remaining shorelines are from aerial photos and relate to the vegetation boundary. The modern roading is included to assist with interpretation.

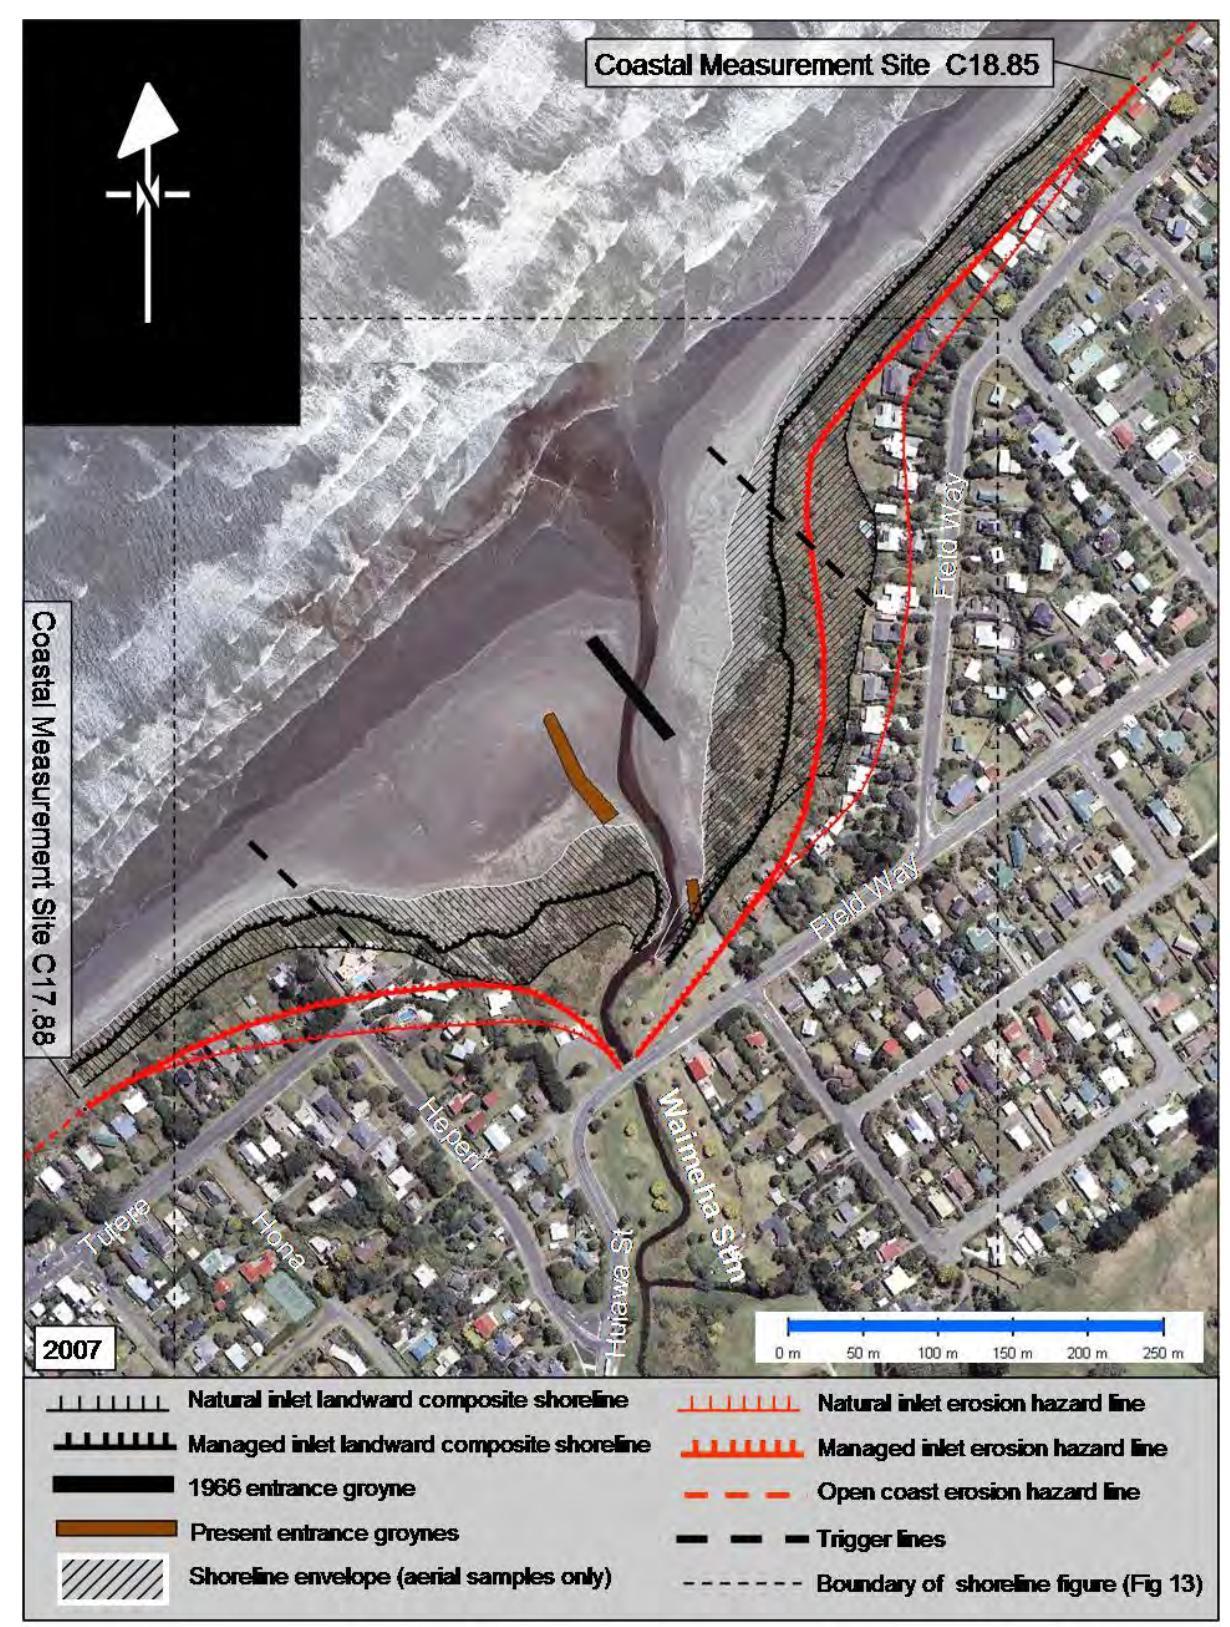
Figure 14 Erosion hazard lines for the Waimeha Inlet superimposed upon the 2007 aerial photo. The shoreline envelopes are also shown for the set of shorelines depicted in Fig 13, together with the landwardmost composite shoreline used to define inlet migration. Inlet migration was then combined with the other hazard components for coastal measurement sites C17.88 in the south and C18.85 in the north to derive the erosion hazard lines for both managed and natural inlet scenarios.
