# **Kapiti Coast Erosion Hazard Assessment**

# Part 2: Inlets

A report prepared for the Kapiti Coast District Council

Client Report 2008-03

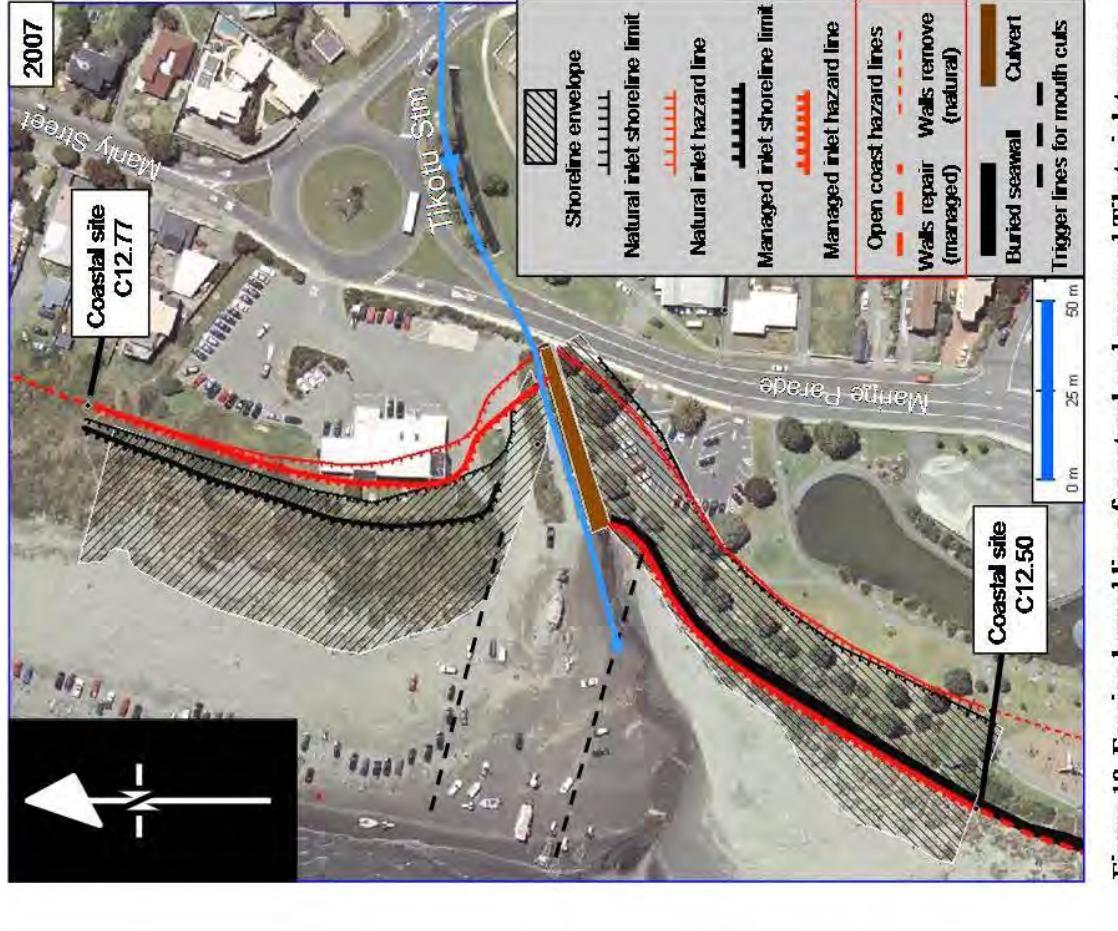
Figure 18 Erosion hazard lines for natural and managed Tikotu inlet superimposed upon the 2007 aerial photo. The shoreline envelopes, landward limit (composite) lines, and control structures (buried seawall and culvert), are also depicted. Note that for the managed southern inlet the landwardmost shoreline limit line is the seawall and is not depicted.

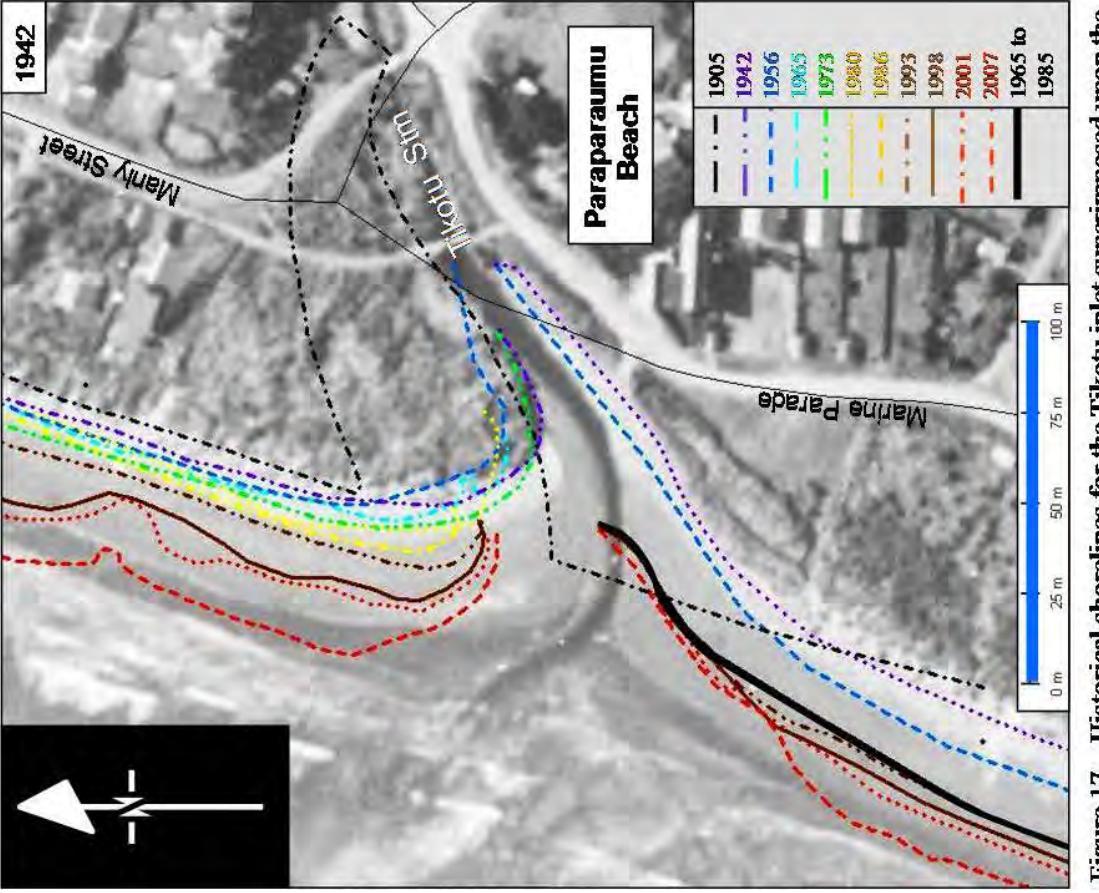
Figure 17 Historical shorelines for the Tikotu inlet superimposed upon the first vertical aerial photo (1942). The bold black line on the southern side of the inlet locates the 1965 to 85 shorelines which were controlled by the seawall. The contemporary roading is also shown.

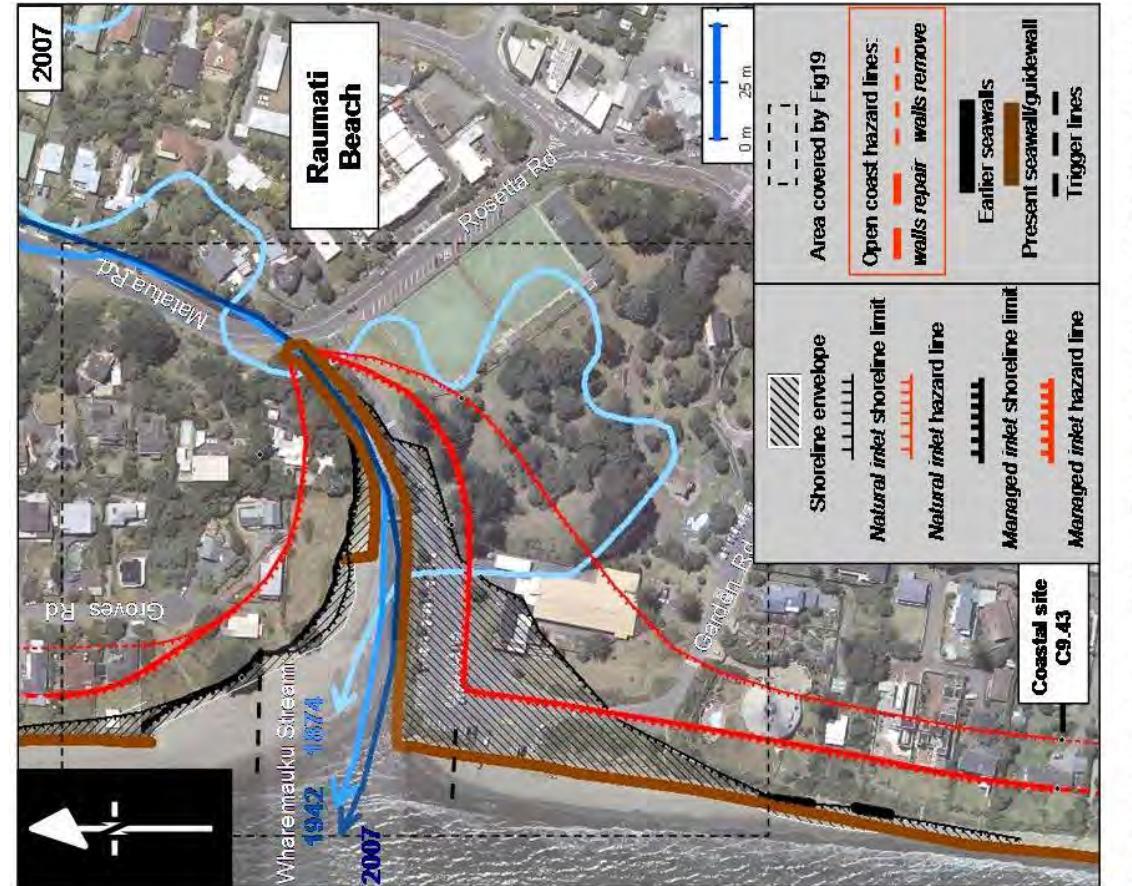
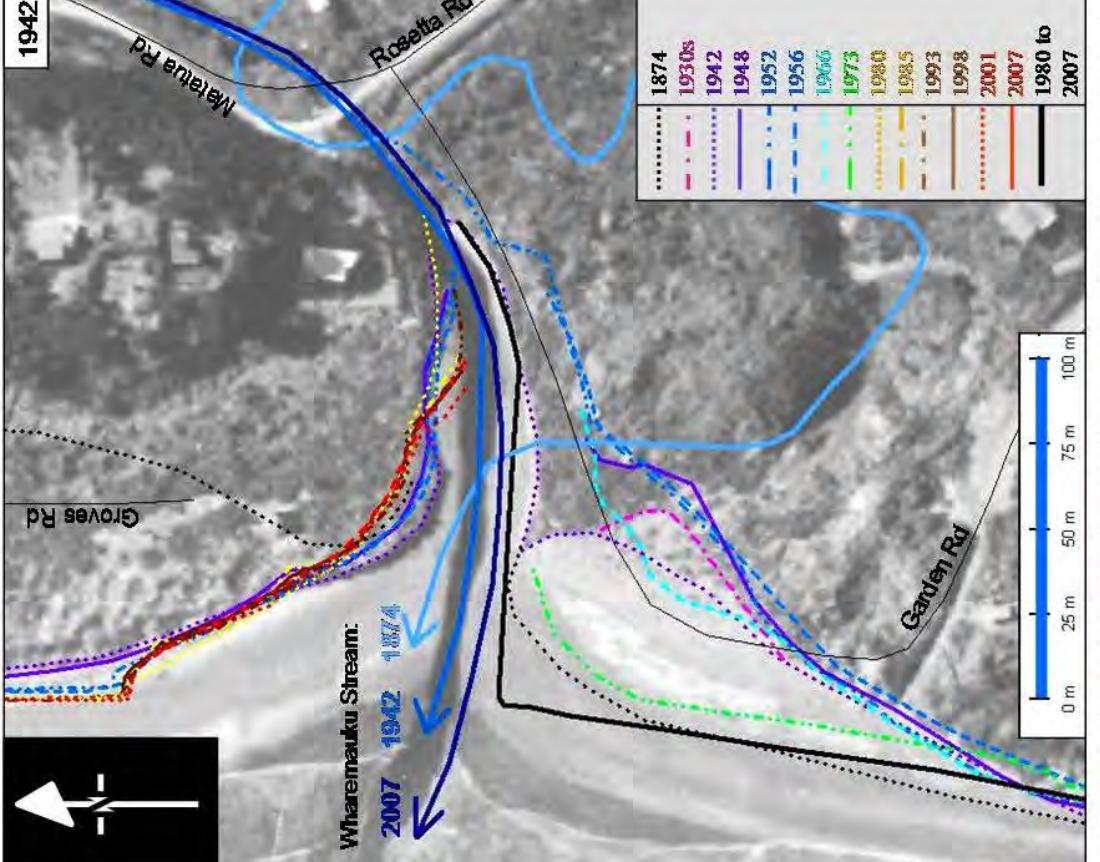
Figure 20 Erosion hazard lines for natural and managed Wharemauku inlet superimposed upon the 2007 aerial photo. The shoreline envelopes, landward shoreline limit lines, and control structures (seawalls and guidewalls) are also depicted. Note that for the northern inlet, the hazard line is the same for both inlet scenarios and for the southern inlet the managed inlet shoreline limit line is the seawall and is not depicted.

For the northern side of the inlet, the hazard line is, on average, 30 m behind the present shoreline. Four private dwellings are affected. By contrast, along the southern side of the inlet the hazard lines are, on average, 28 m and 69 m behind the present shoreline for the managed inlet and the natural inlet respectively. Five private properties plus the reserve are affected under each scenario; with the pool complex and dwellings lying partially within the hazard area under the natural inlet scenario.

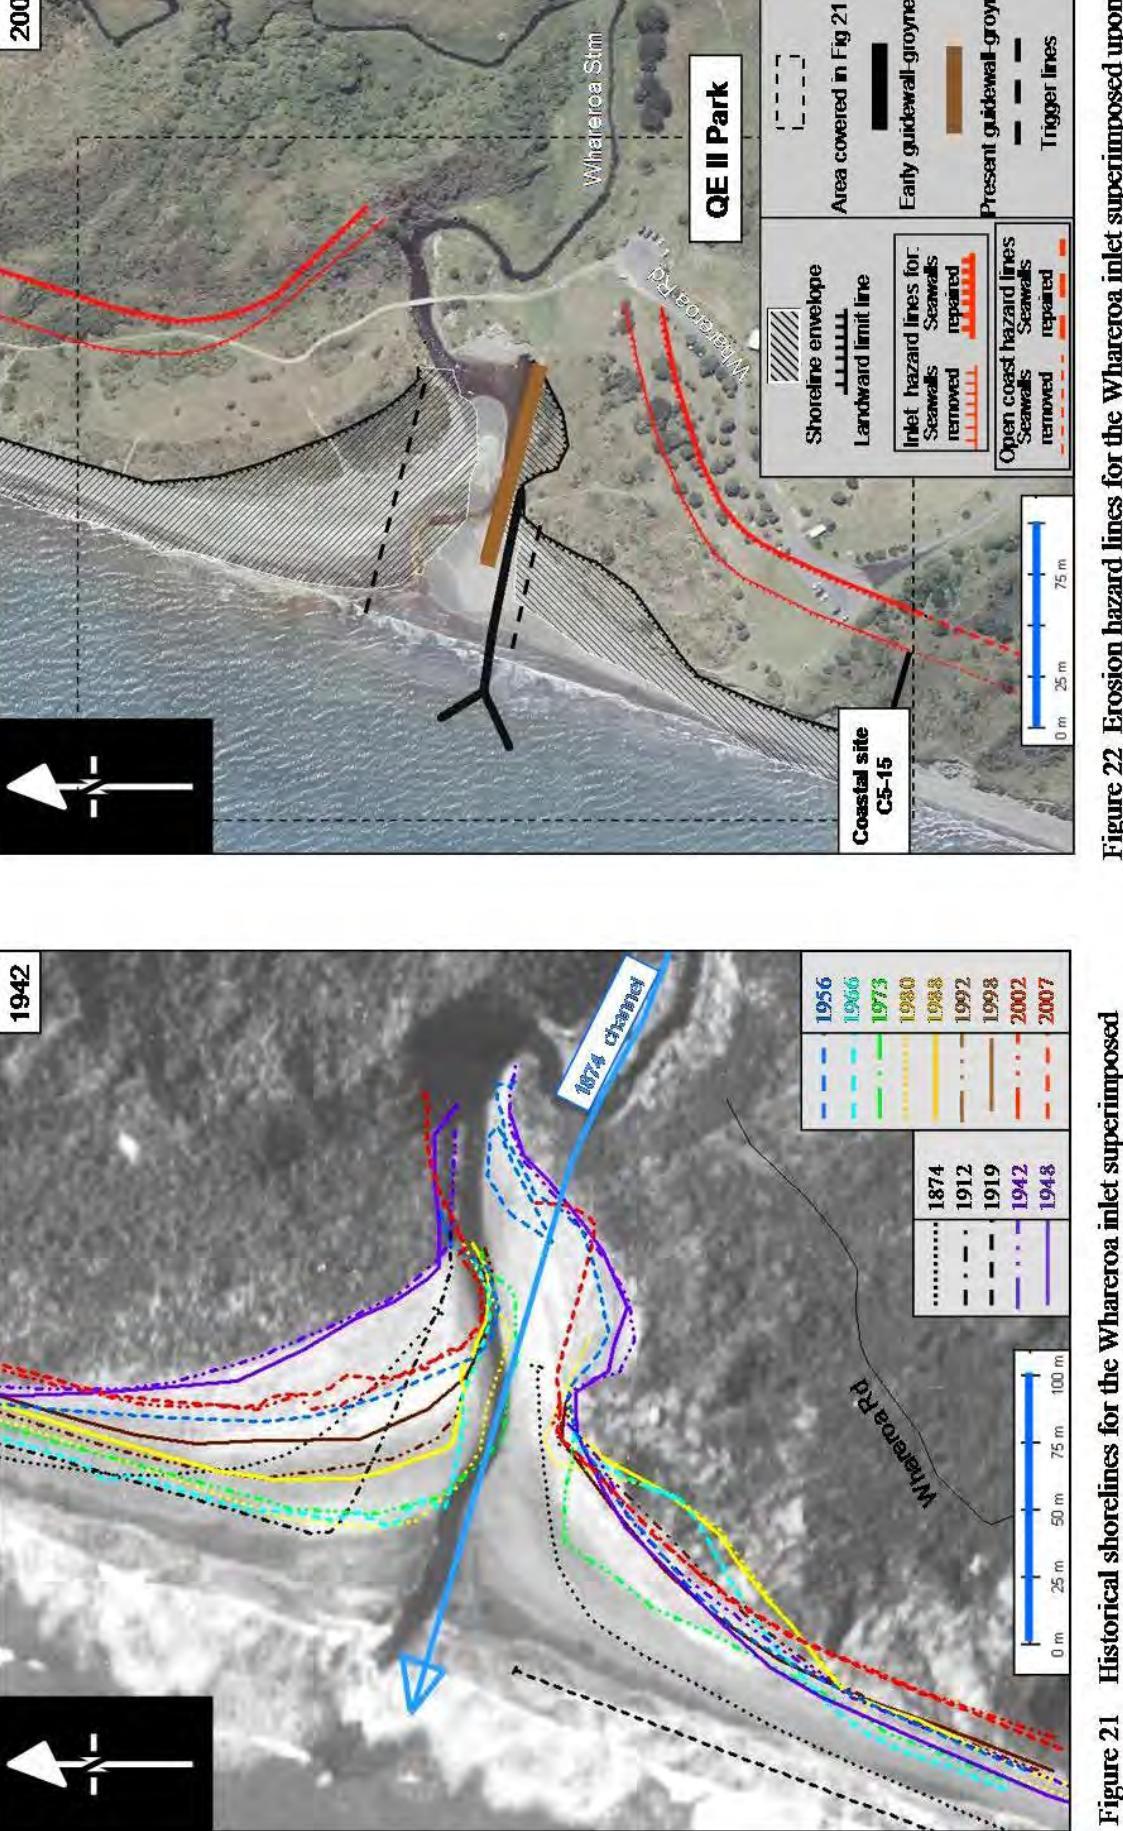
depicted. Note that the northern coastal measurement site (C5.70) is 96 m Figure 22 Erosion hazard lines for the Whareroa inlet superimposed upon the 2007 aerial photo. The shoreline envelopes, landwardmost composite shorelines (limit line), and control structures (groyne-guidewalls) are also seyond the upper boundary of image.

On the southern side of the inlet, the hazard line for the *seawall repair* scenario is, on average, 77 m landward of the present shoreline, while for the *seawall remove* scenario it is 60 m landward. On the northern side of the inlet, the hazard line for the *seawall repair* scenario is, on average, 88 m landward, and the line for the *seawall remove* scenario is 71 m landward. Minimal park utilities lie within these hazard areas.

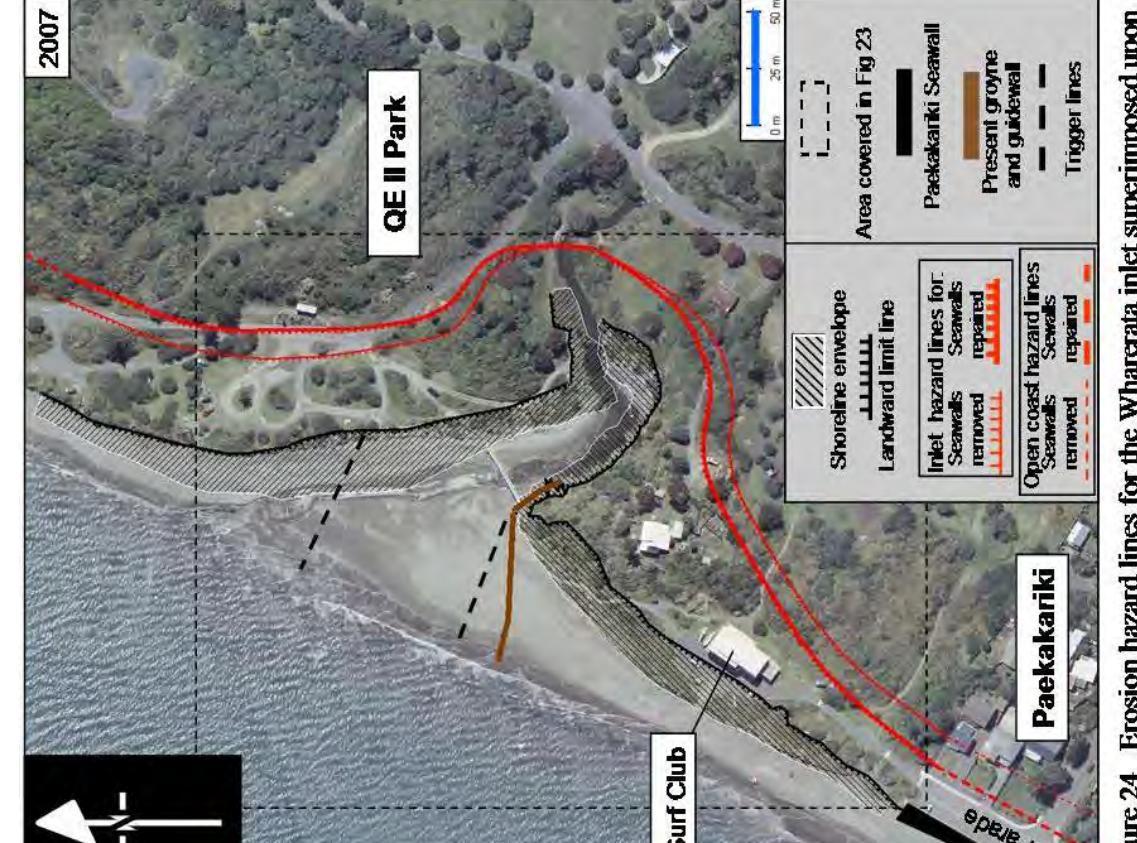
Figure 24 Erosion hazard lines for the Wharcrata inlet superimposed upon the 2007 aerial photo. The shoreline envelopes, landward limit lines (composite shorelines), and control structures (the inlet groyne and guidewall, plus the Packakariki seawall on the open coast) are also depicted.

On the southern side of the inlet the hazard line for the *seawall repair* scenario is, on average, 49 m landward of the present shoreline, while for the *seawall remove* scenario it is 59 m landward. Reserve land, the Surf Club and one private property lie within the hazard areas. On the northern side of the inlet, the hazard line for the *seawall repair* scenario is, on average, 65 m landward, and the line for the *seawall remove* scenario is 52 m landward. In these cases only reserve land and park utilities are affected.

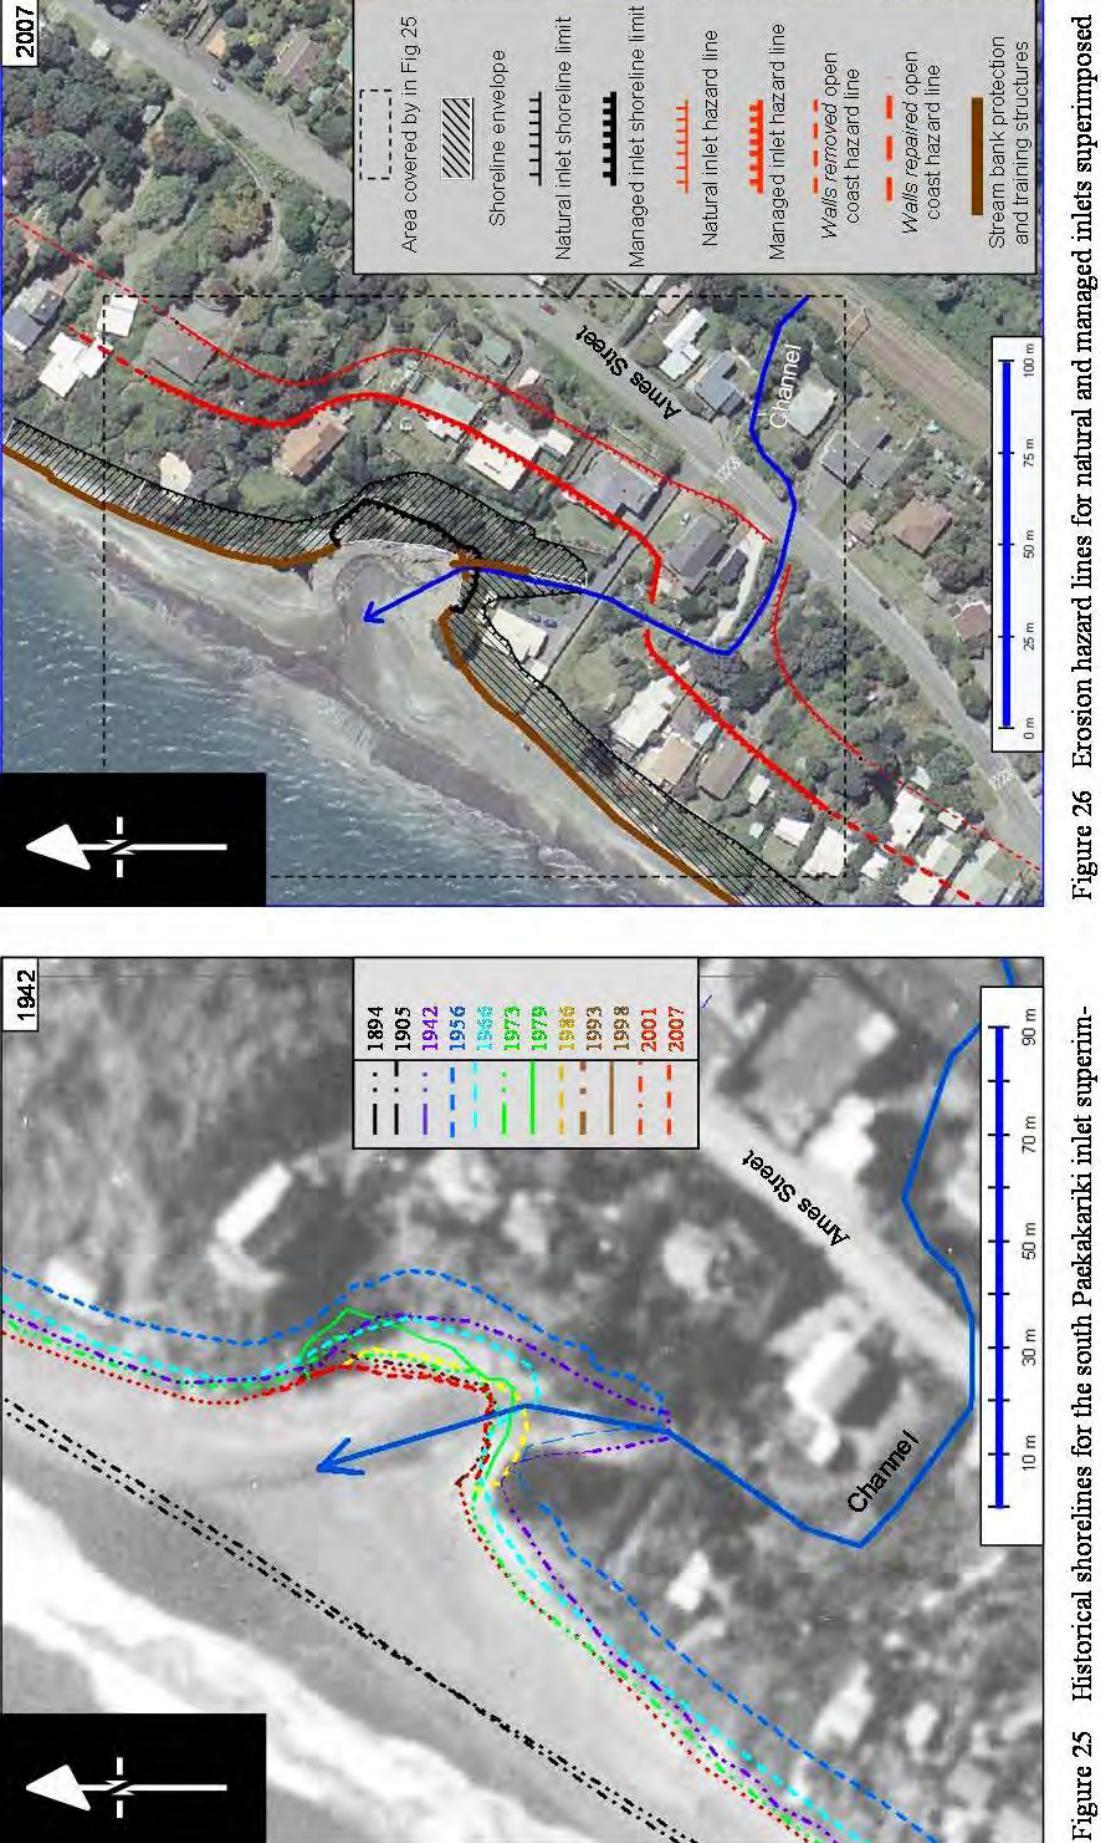
upon the 2007 aerial photo. The shoreline envelopes, landward limit (composite) lines, seawalls, stream guide and debris grate are also depicted.

The inlet hazard lines on the southern side of the inlet are, on average, 41 m behind the present shoreline for the managed scenario and 62 m for the natural scenario. On the northern side the hazard lines are 35 m (managed) and 47 m (natural) behind the present shoreline. Twelve properties lie at least partially within the hazard area under each scenario.

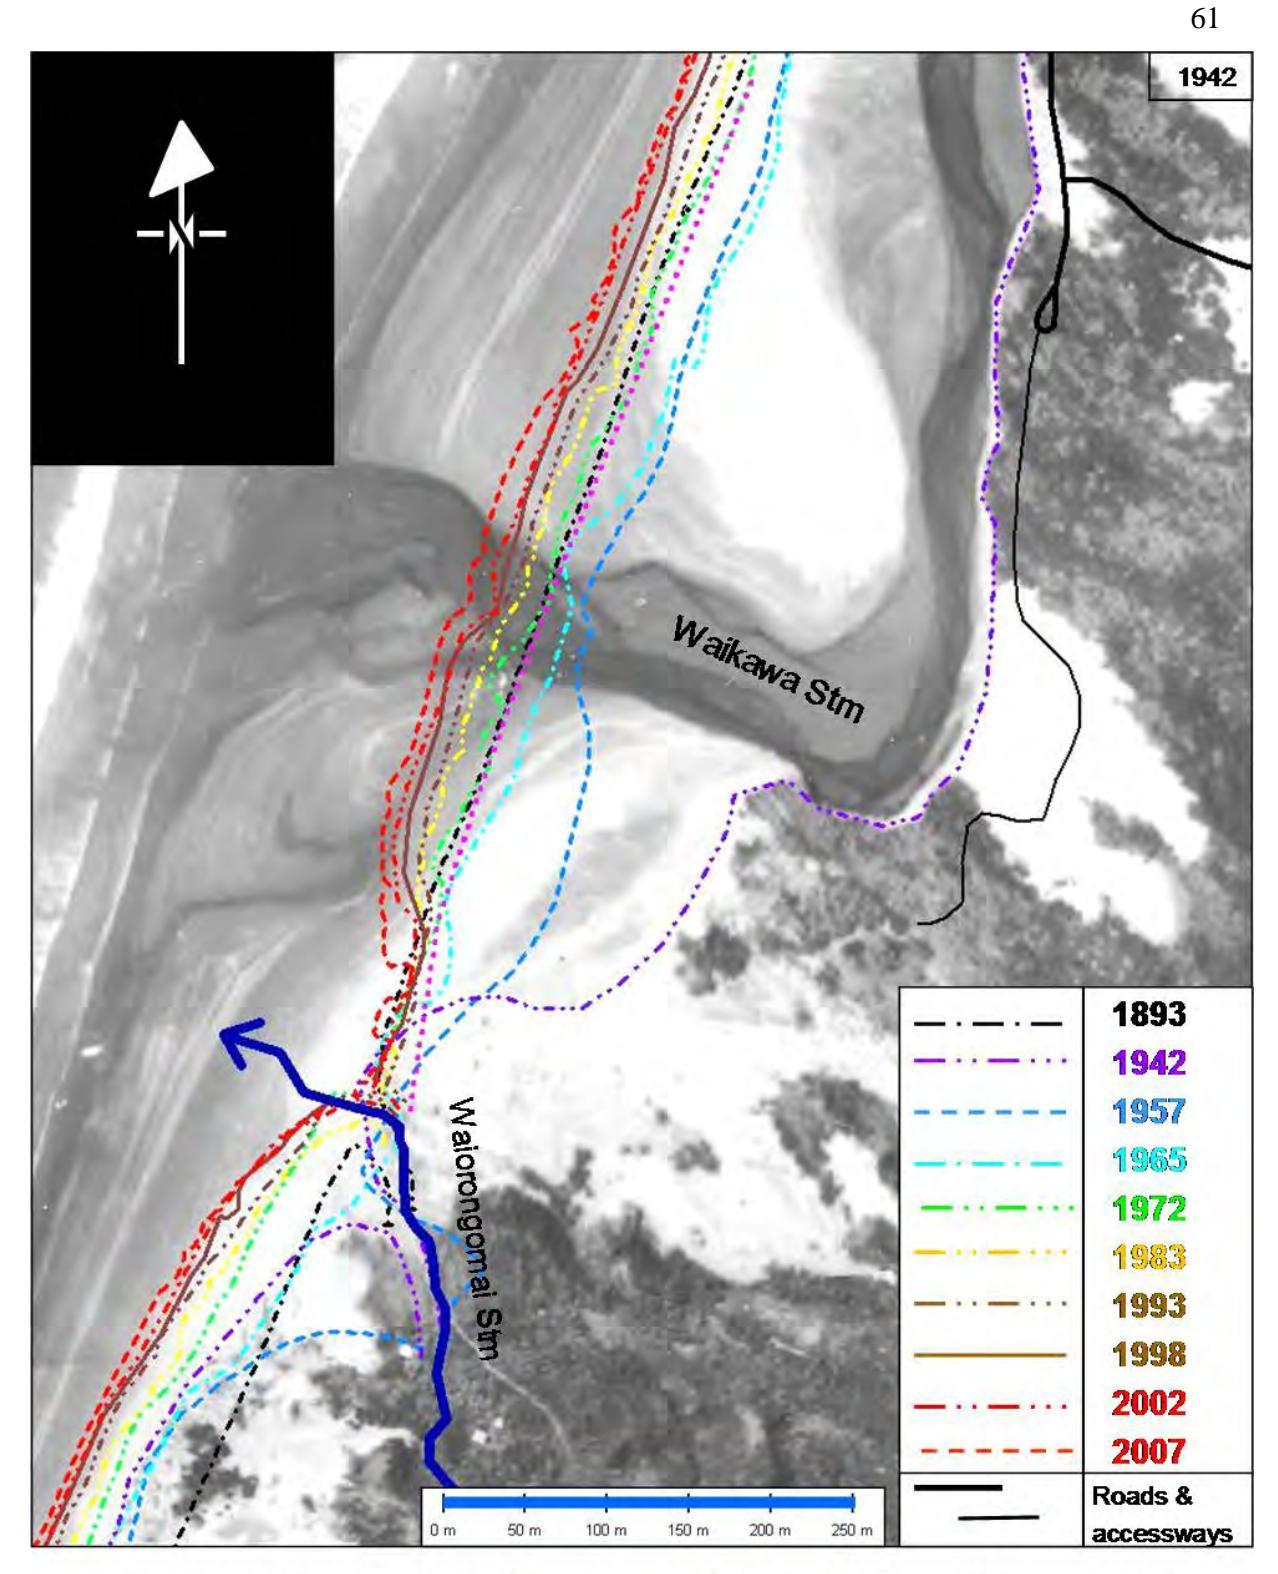
Figure 27 Historical shorelines for the Waiorongomai and southern Waikawa Inlets superimposed upon the first vertical aerial photo (1942). The first shoreline is derived from a survey cadastral plan and relates to the spring high water line, while the remaining shorelines are from aerial photos and relate to the vegetation front. Roading and major accessways are marked to assist with interpretation.

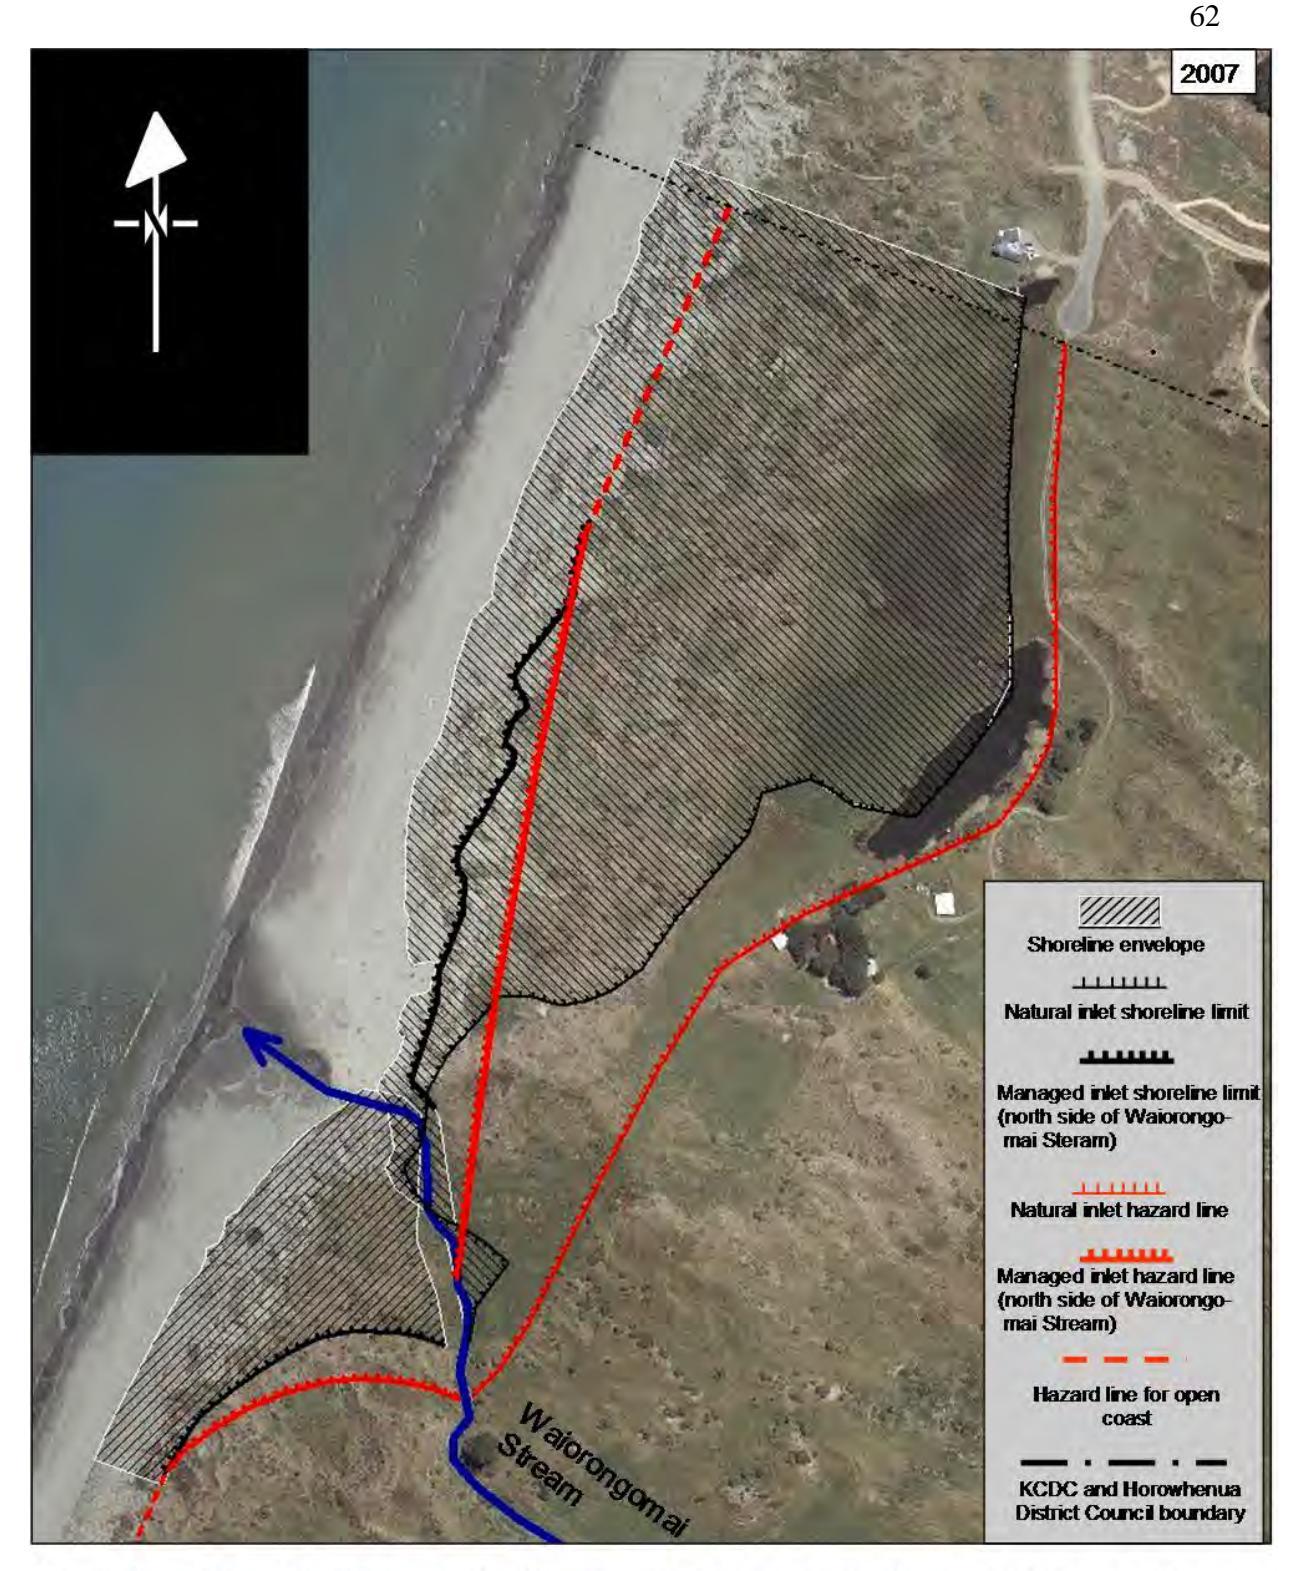
Figure 28 Erosion hazard lines for the Waiorongomai Inlet superimposed upon the 2007 aerial photo. The shoreline envelopes are also shown for the set of shorelines depicted in Fig 27, together with the land-wardmost composite shoreline (landward shoreline limit) used to define inlet migration. Inlet migration was then combined with the other hazard components for the closest coastal measurement site (C36-89) to derive the erosion hazard lines. Note that on the nortern side of the inlet there are hazard lines for both managed and natural shorelines; this relates to management of the Waikawa inlet some 1600 m to the north by the Horowhenua District Council (see text).

On the southern side of the inlet the (natural inlet) erosion hazard line is, on average, 92 m landward of the present shoreline. On the northern side the managed hazard line is, on average, 57 m landward of the present shoreline, while the natural inlet hazard line is, on average, 262 m landward. The erosion hazard area on the southern side of the Waiorangomai Inlet, and also the hazard area for the managed scenario on the northern side, comprises duneland. However, the erosion hazard area for the natural inlet incorporates farmland and, as noted earlier, lies adjacent to present residential development, so such zoning could have relevance in the future.
