Annual Waikanae Borefield Report 2016-17 (Consent WGN130103 [34384])

Prepared for Greater Wellington Regional Council On behalf of Kāpiti Coast District Council Prepared by CH2M Beca Ltd

22 September 2017

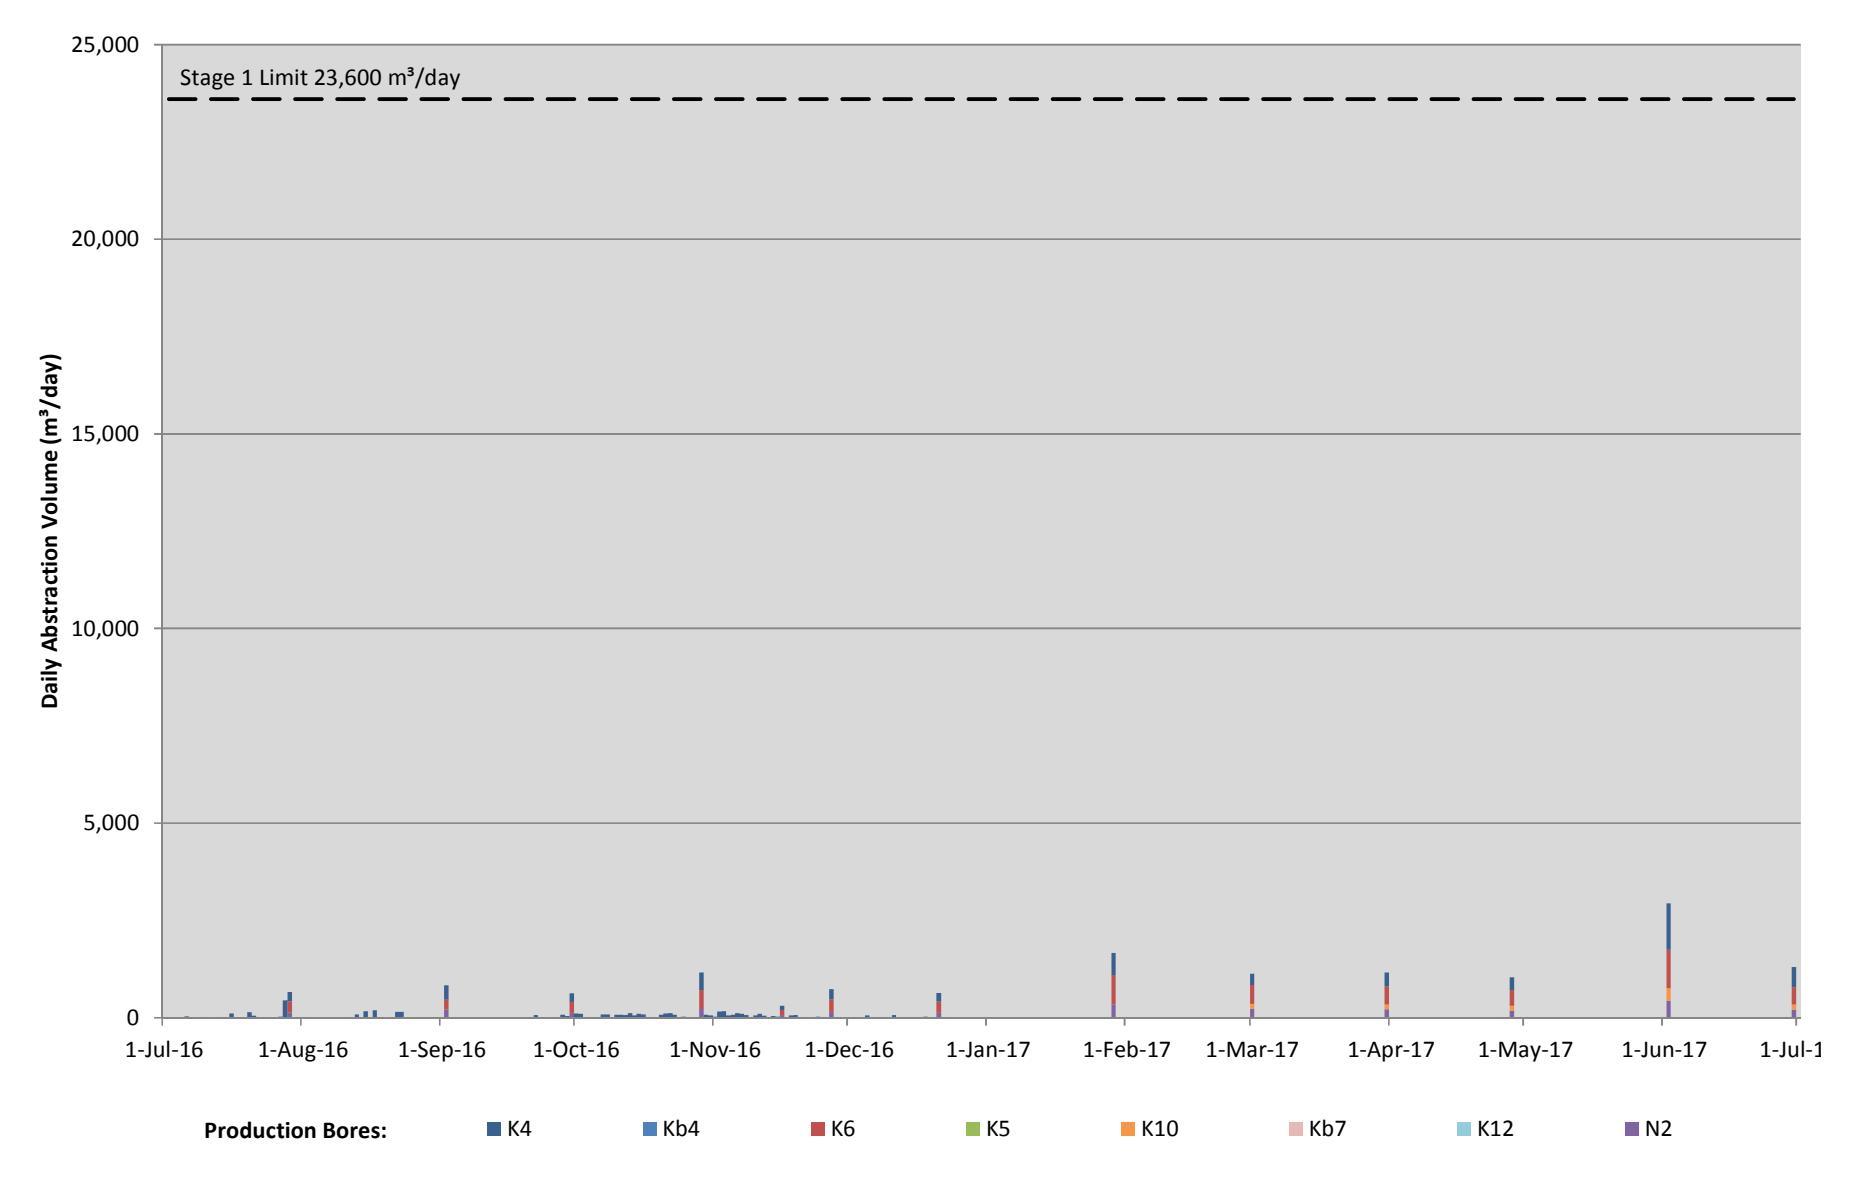
Figure 3: Daily Abstraction Volumes from Production Wells

The total daily abstraction from the Waikanae Borefield is plotted in Figure 3. The maximum total daily take was 4,489 m³/day on 31 May 2017, which is also less the maximum daily take permitted by Condition 8.

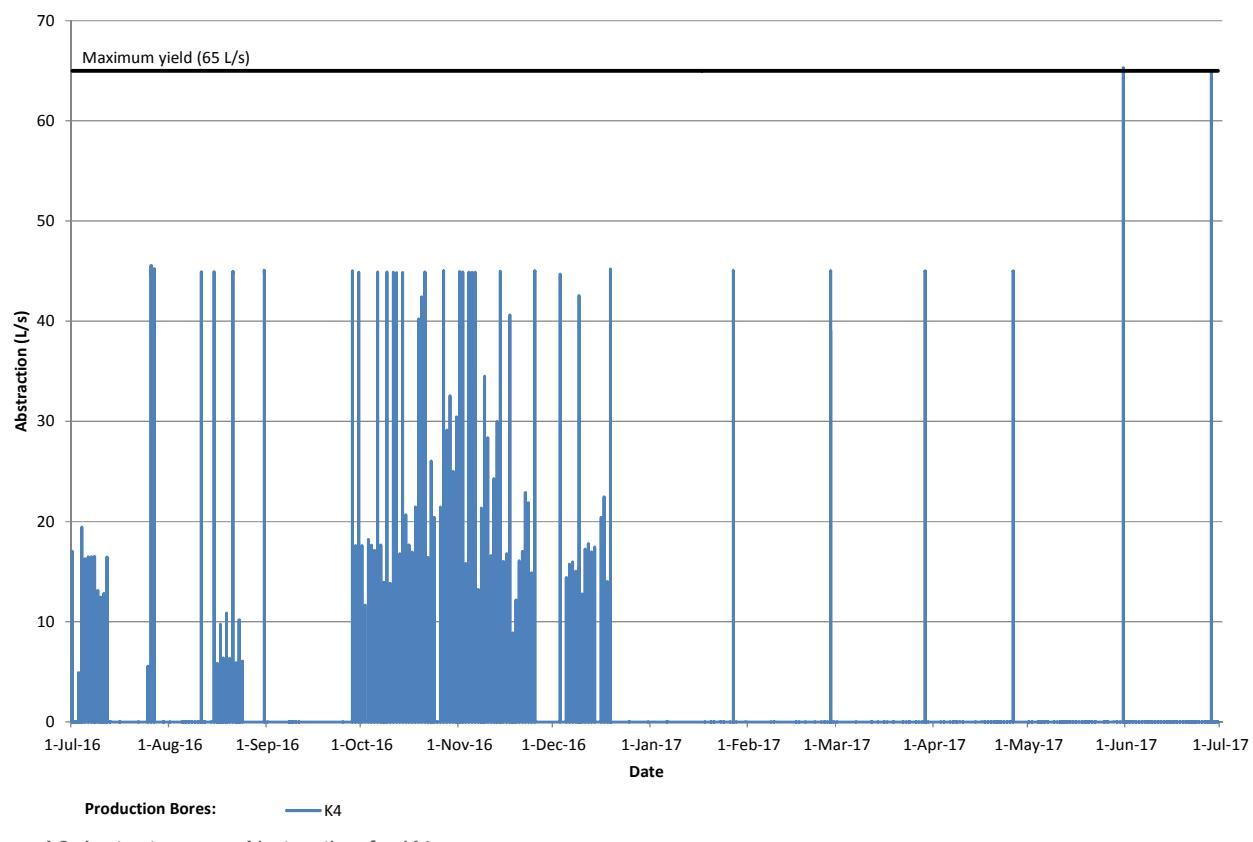
Figure A2: Instantaneous Abstraction for K4

Summary graphs of the instantaneous rates for the individual wells are included in Appendix A. On two occasions the pumping rates for the production wells K4 and Kb4 were greater than the instantaneous abstraction rates given by Table 2 of Condition 8. In both cases the flow exceedances that was over was in the order of 0.5% of the total flow, which is within the allowable flows as defined by Condition 8 of up to 15% for a maximum duration of 15 minutes.

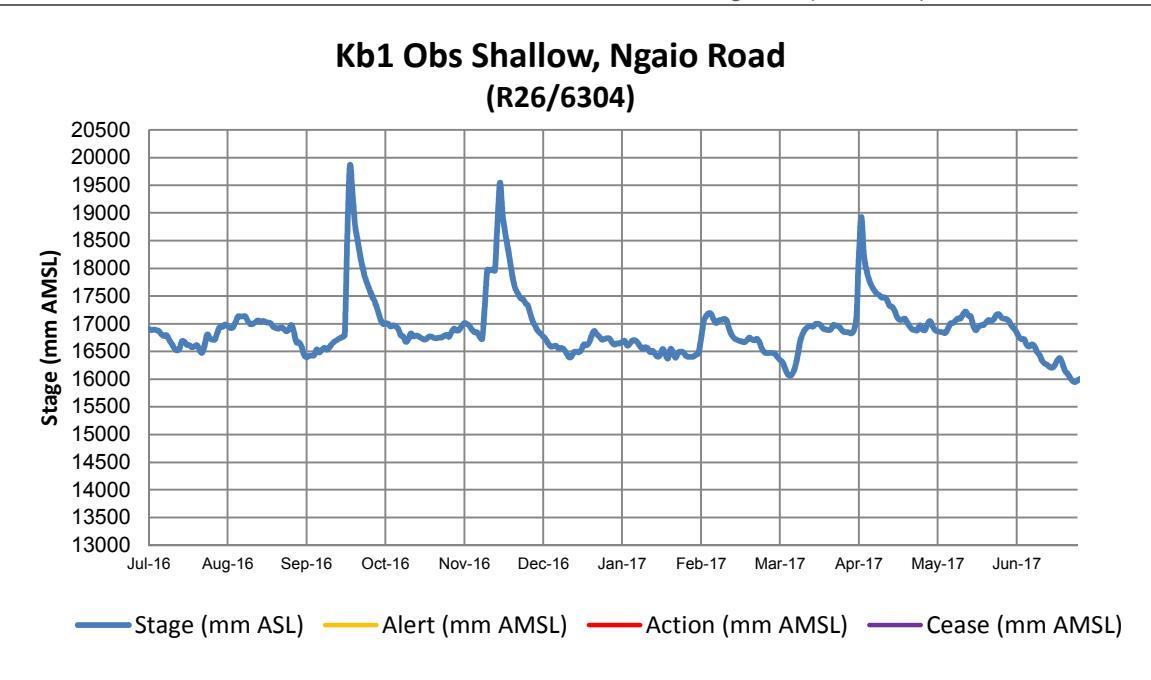
Figure C1. 8 Water Levels at Kb1 Observation Shallow, Ngaio Road Monitoring Bore (R26/76304). Note: Triggers not applicable to this site because the water level naturally falls below the bottom of the well.

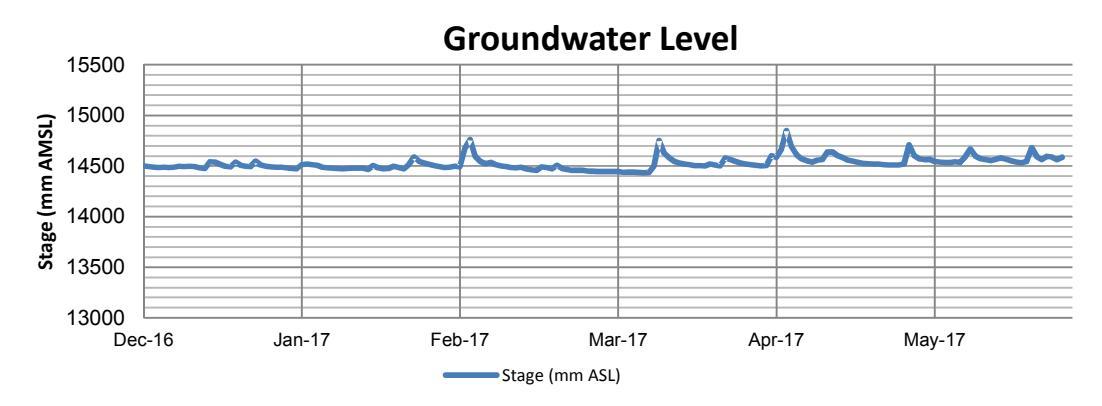
Figure 18: Ground water levels, upper Muaupoko Stream through the monitoring period December 2016 to June 2017

Oxygen levels on two occasions declined markedly (~ 15th January and ~ 20th February), but was otherwise generally normal. These lower periods do not coincide with stream depth changes of any magnitude. Temperature followed the trend already noted with is daily variation normal and no middle summer peak but an autumn decline.
