Chairperson and Community Board Members PARAPARAUMU/RAUMATI COMMUNITY BOARD

NO STOPPING LINES PARAPARAPUMU - VARIOUS LOCATIONS

1 This report seeks the Paraparaumu/Raumati Community Board's approval to install broken yellow No Stopping lines on Kāpiti Road, Callender Terrace, Belford Court and on the corner of Ocean Road and Eatwell Avenue. A plan of each location is included in **Appendices 1 to 4 of this report IS-17-389.**

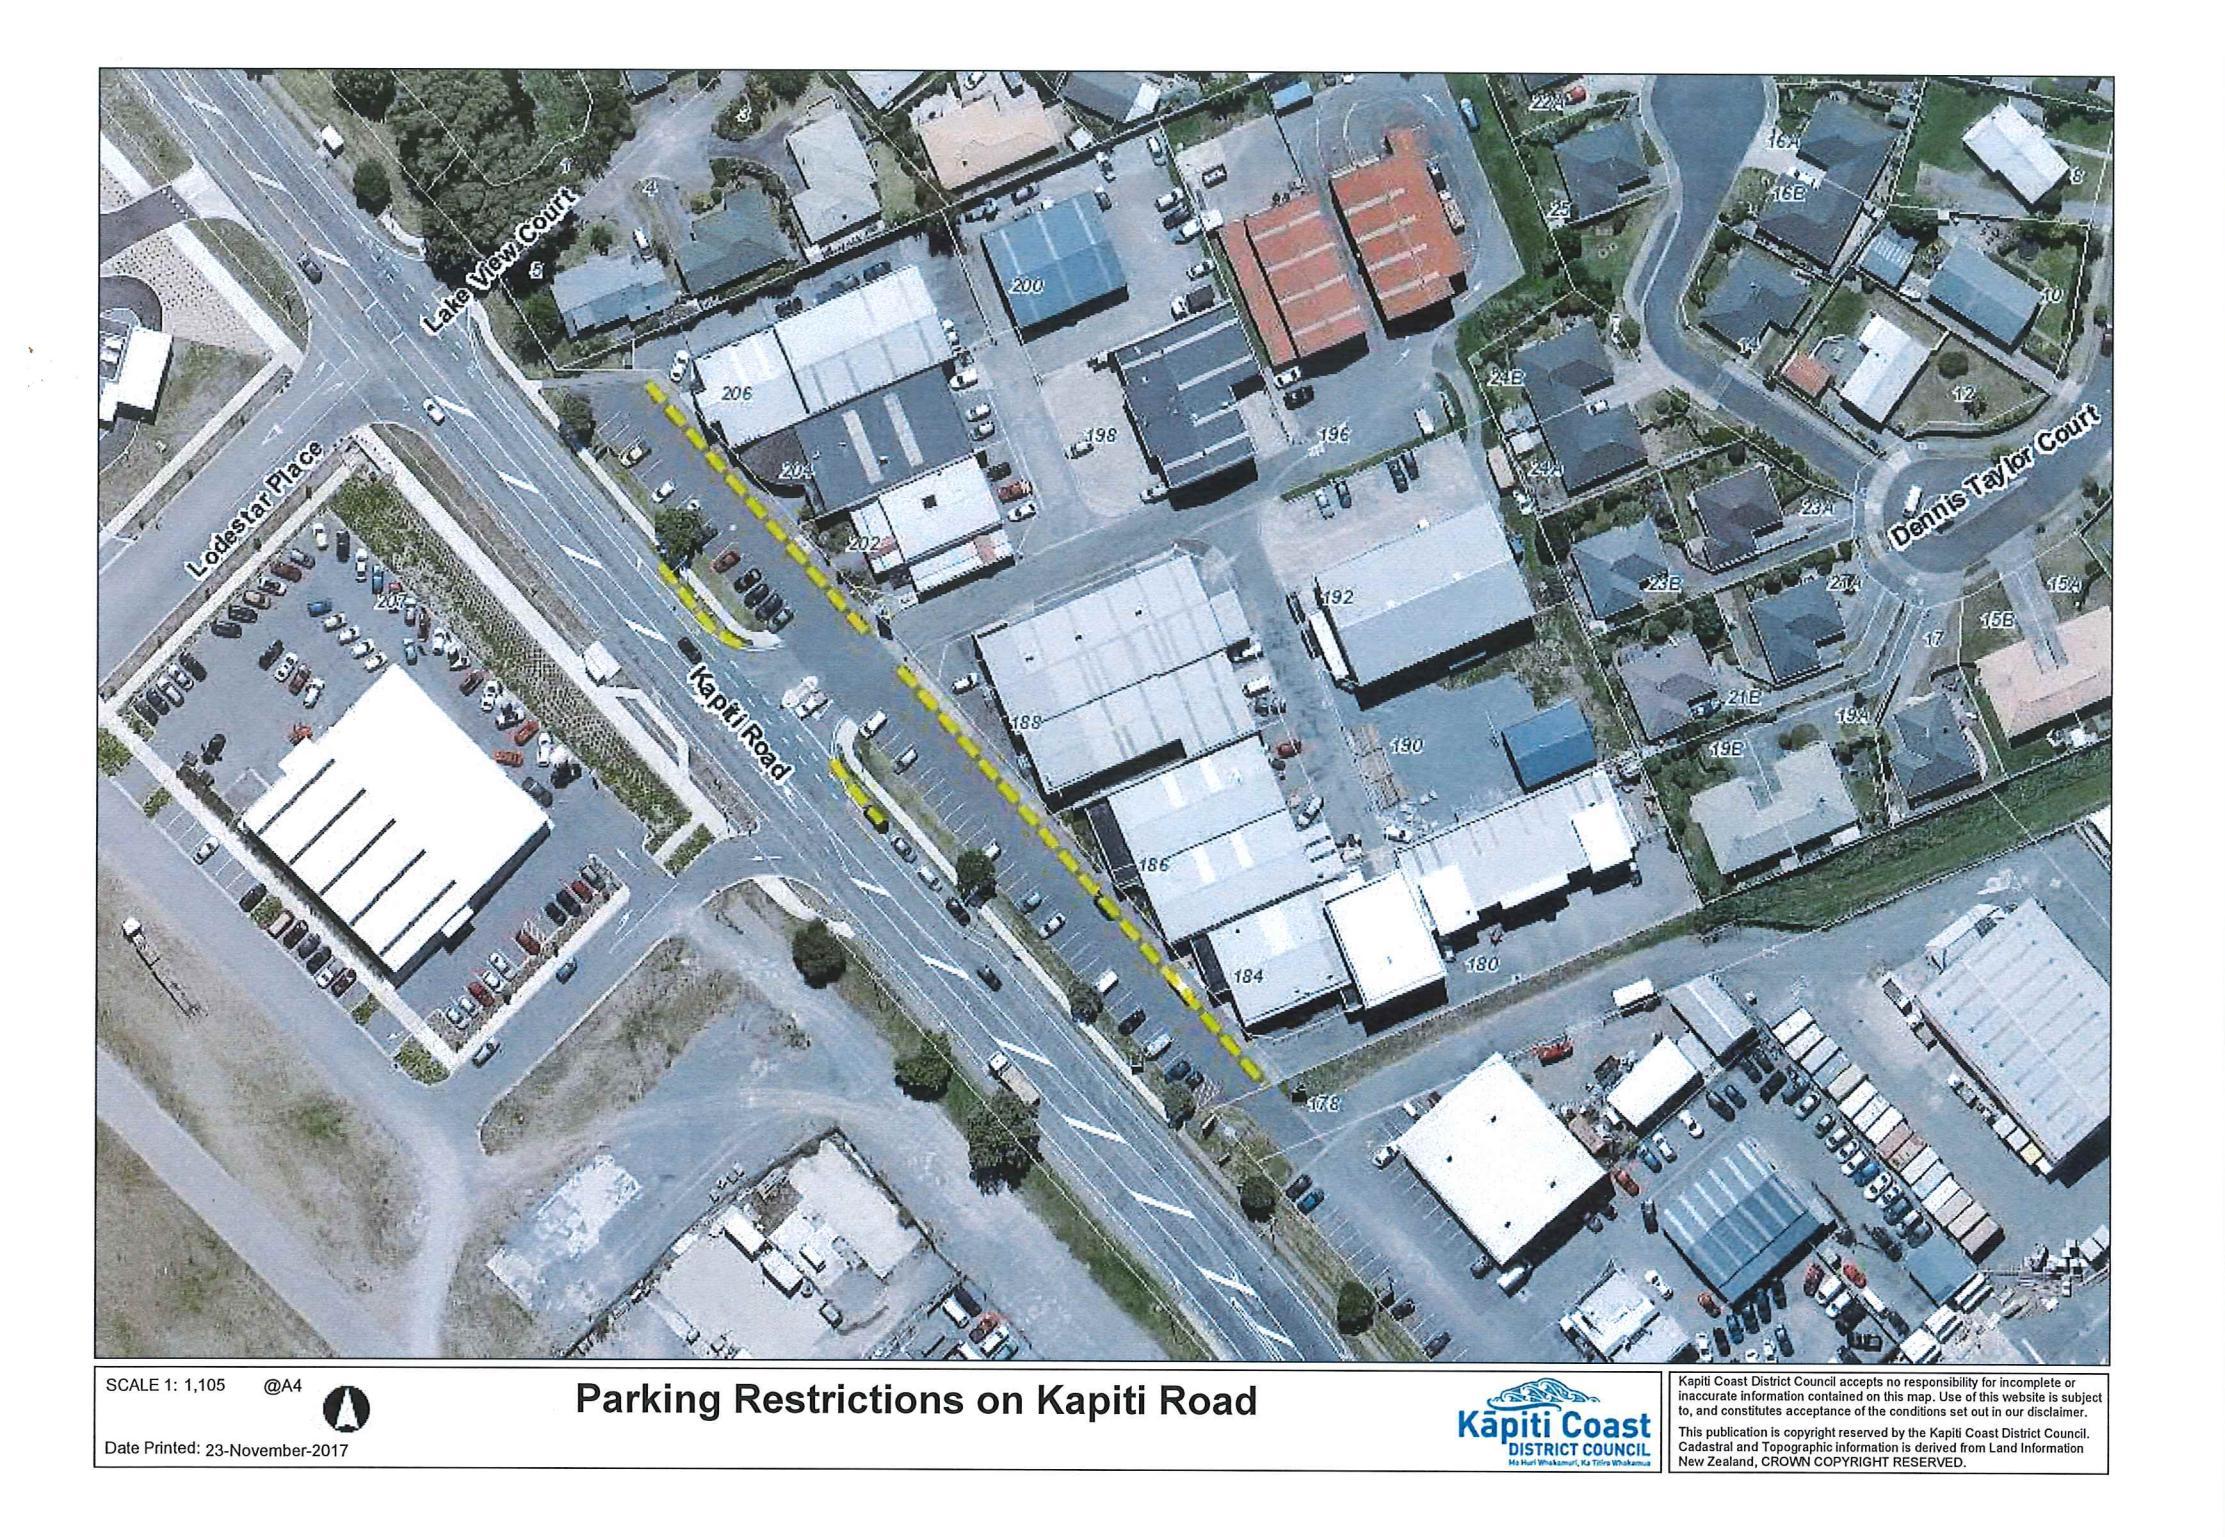
- 23 That the Paraparaumu/Raumati Community Board approves:
- 24 Installation of 140m of broken yellow lines outside numbers 180, 184, 186, 188, 202, 204, and 206 Kāpiti Road on the northern side of the service lane as shown in Appendix 1 of report IS-17-389.

- 25 Installation of broken yellow lines 10m east and 15m west of the service lane intersection with Kāpiti Road as shown in Appendix 1 of report IS-17-389.

5 In front of the commercial properties from 180 to 206 Kāpiti Road is a Council owned service lane and parking area. The car parking spaces are at 90 degrees and approximately 4.5m long with a 6.5m roadway behind them. A problem arises when vehicles parallel park outside the businesses in the roadway. This reduces the roadway width down to 4.5m which is sufficient for vehicles to pass

but not wide enough for vehicles to reverse out of the angle parking without hitting the parallel parked vehicle. The business owners have reported numerous collisions and near misses in this area. NZ Standard 2890.1 Parking Facilities specifies dimensions for the design of parking modules. In this case the 90 degree bays should be 4.8m long with a 5.8m aisle width to allow manoeuvring. To achieve this all of the parallel parking needs to be prevented by installing parking restrictions.

- 6 The secondary issue at this location is the parallel parking on Kāpiti Road proper. There is unrestricted parking for approximately four vehicles east of the service lane entrance and eight vehicles to the west. Business owners have complained of restricted visibility when trying to exit the service lane on to Kāpiti Road due to vehicles being parked too close to the junction.

10 A survey letter was hand delivered to the affected businesses on Kāpiti Road and they were asked to give their opinion on installing no parking lines on the north side of the car park/service lane and on Kāpiti Road itself. Each business was very engaged when spoken to but only half returned a survey response. All responders supported the restriction in the service lane but only one fully supported restrictions on Kāpiti Road. The properties at the rear of 180 to 206 Kāpiti Road (No's 190 to 200) have limited onsite parking and their staff are parking out on Kāpiti Road. The businesses on the service lane are therefore reluctant to restrict parking which would displace these "all day parkers" into their customer parking areas. This has highlighted that the consultation needs to be more inclusive of these other businesses and any restriction on Kāpiti Road could have unintended consequences. Therefore for road safety purposes the restriction will be reduced to 10m east and 15m west of the service lane intersection with Kāpiti Road to provide clear sightlines for vehicles, pedestrians, and cyclists.

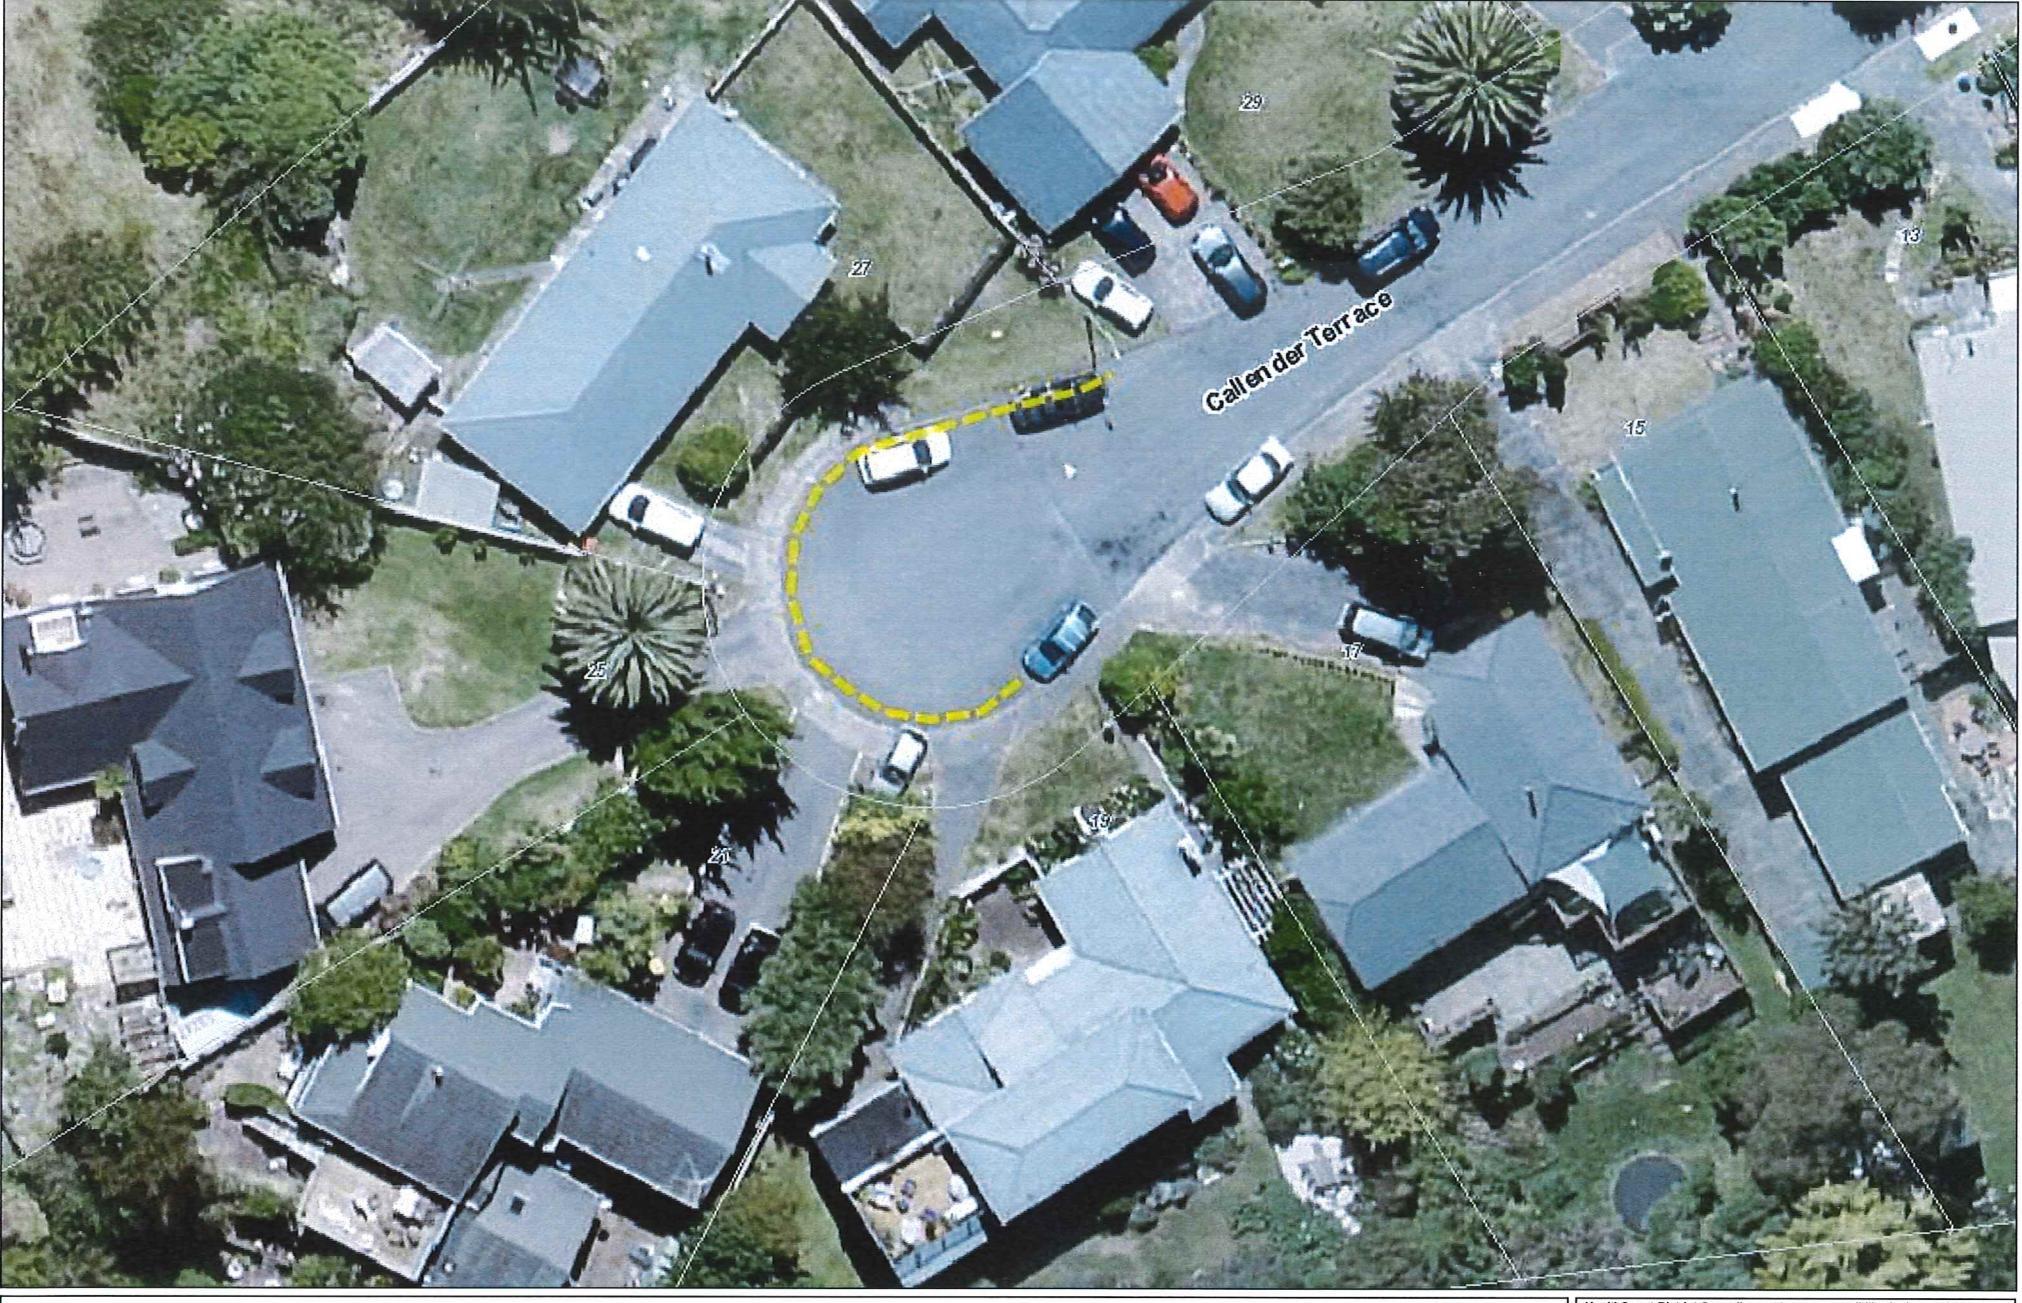
Parking Restriction on Callender Terrace

- 26 Installation of 35m of broken yellow lines outside numbers 19 to 27 Callender Terrace as shown in Appendix 2 of report IS-17-389
- 27 Installation of 30m of broken yellow lines around the perimeter of the central traffic island in Belford Court and 30m along the frontage of numbers 4, 6, and 8 Belford Court as shown in Appendix 3 of report IS-17-389.

- 7 The cul-de-sac/turning area at the southern end of Callender Terrace is a residential area and every home has off street parking areas with most having at least a single garage or car port. Therefore residents should be able to constrain their parking to their own properties and not block the cul-de-sac. We have received multiple complaints that cars are continually parking on the street and restricting property access. Turning issues have also been confirmed by the Council's Solid Waste Services Manager who receives feedback from the Waste Collectors, who are unable to turn their rubbish trucks easily due to the parked vehicles.

- 11 On Callender Terrace residents were surveyed for their preferences on the extent of the no stopping restriction in the cul-de-sac. The options were to restrict parking on the whole turning area between numbers 19 and 27 and to extend the restriction further out to numbers 17 and 29. Plus they were given the option to suggest their own combination of treatments. The results were split for and against, mainly influenced by the amount of street frontage a resident had. Those who had any amount of street frontage were frustrated at being parked in by other people's vehicles and supported maximum restrictions. Therefore to maintain a small amount of visitor parking but to improve the overall safety and access at number 19 around to the end of the frontage on number 27.

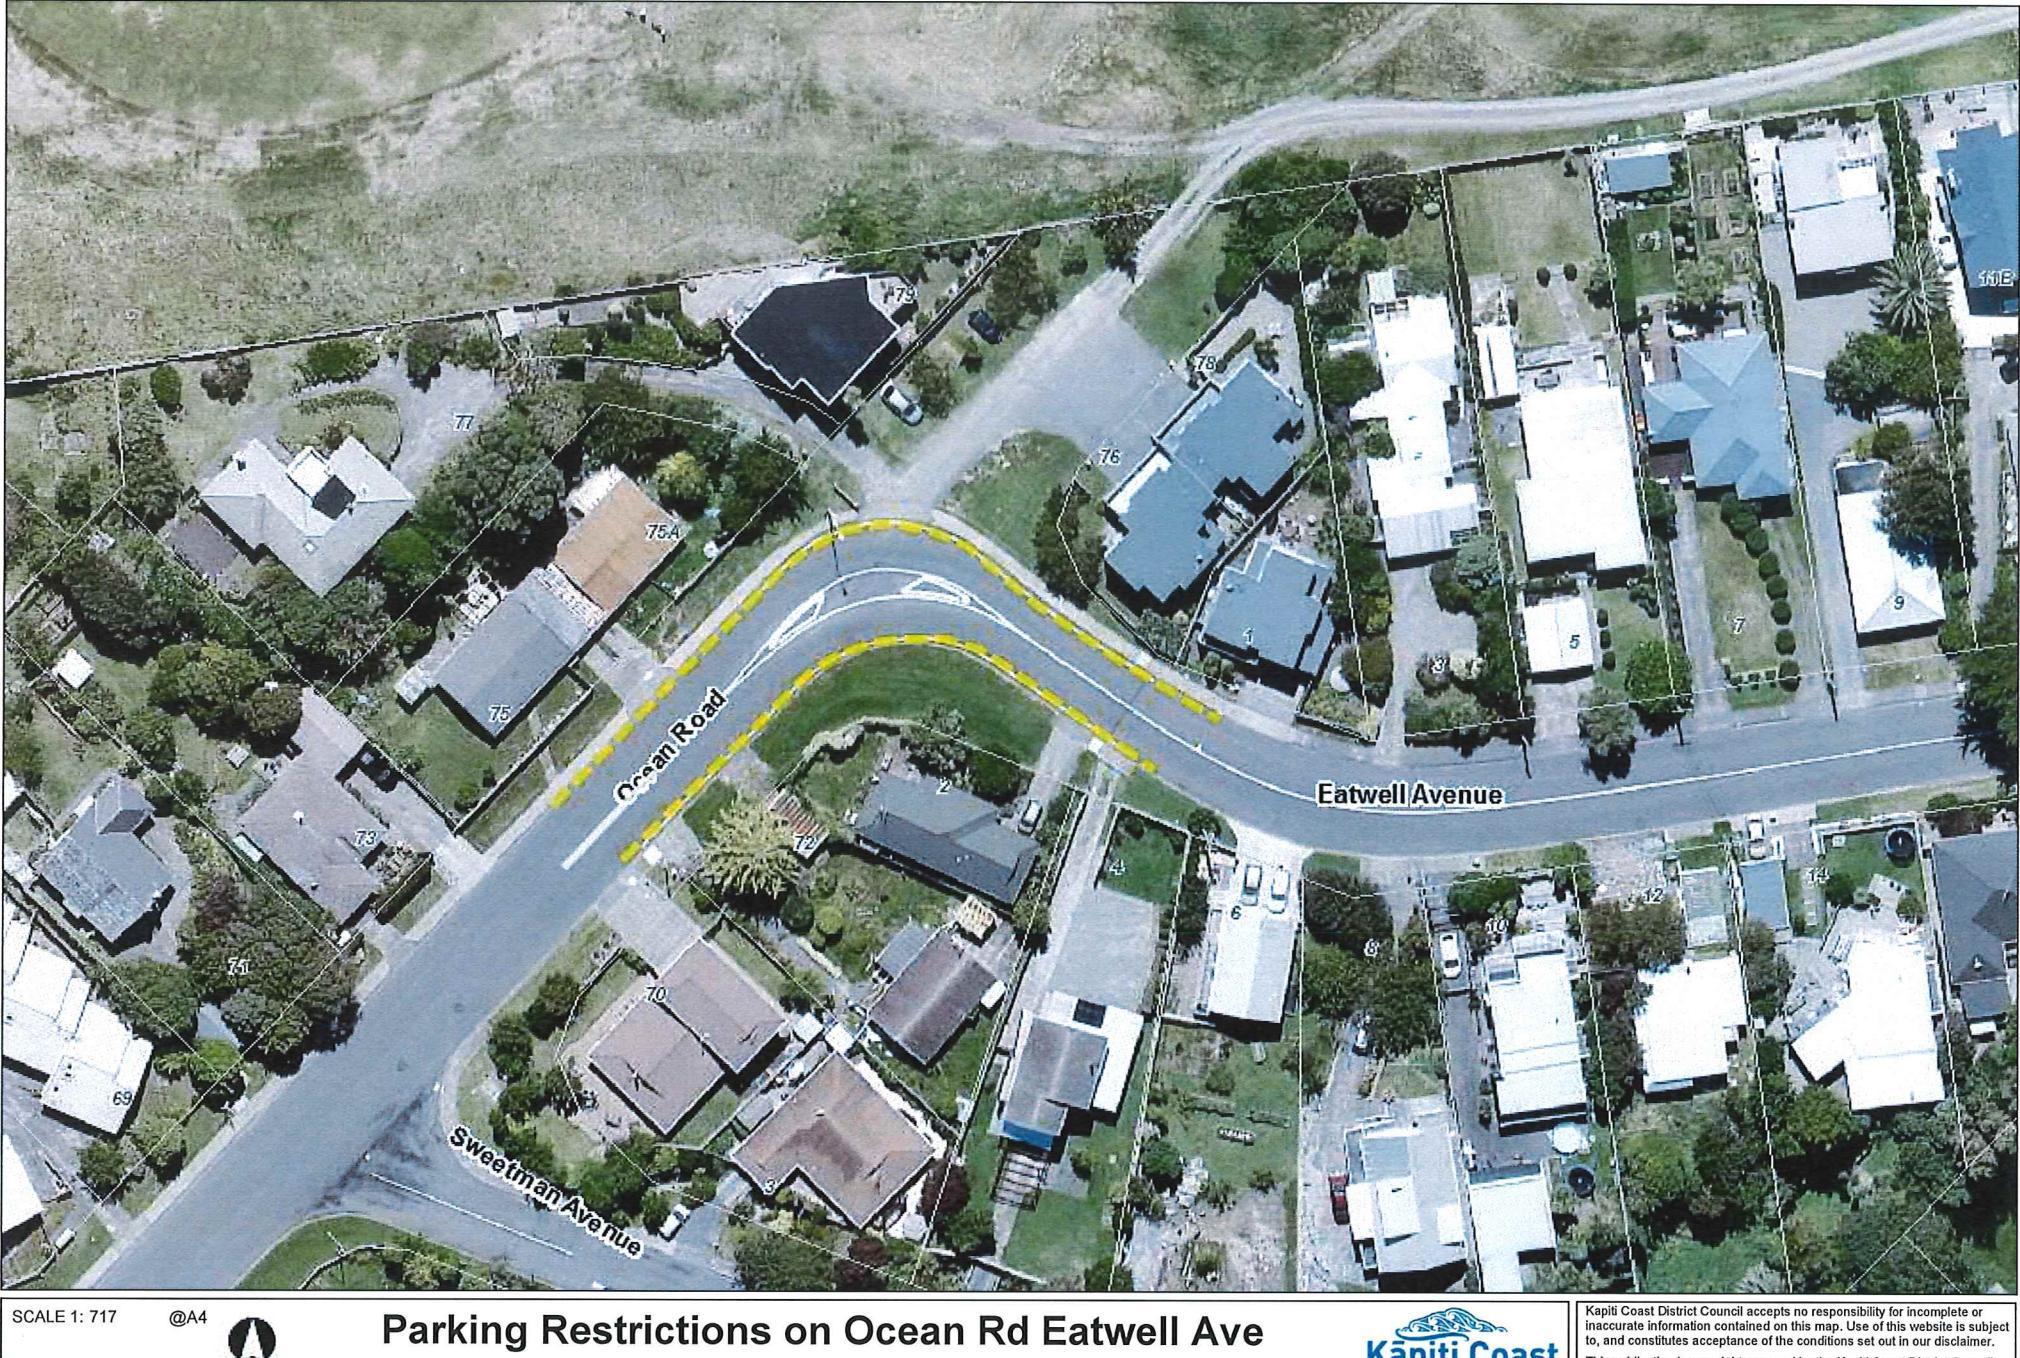
- 28 Extend the centreline on Ocean Road by 14m and install approximately 80m of broken yellow lines on either side of Ocean Road and install approximately 70m of broken yellow lines on either side of Eatwell Avenue as shown in Appendix 4 of report IS-17-389.

- 9 The corner of Ocean Road and Eatwell Avenue is a 90 degree bend with a pair of triangular traffic islands either side of the apex of the corner. There are no parking restrictions on this corner so vehicles are legally able to park on the corner and right next to the traffic islands. Mostly common sense does prevail and people park safely, but a large furniture truck is now parking on this corner, blocking visibility for residents exiting their property and causing approaching traffic to veer into the middle of the road just before one of the traffic islands. A parking restriction is needed to improve safety at this corner.

- 13 The lane widths through the corner of Ocean Road and Eatwell Avenue are between 3.5m and 4.4m wide which do not allow enough width for vehicles to pass a parked vehicle without crossing the centreline. New Zealand Transport Association (NZTA) Guidelines specify that there should be a continuous white centreline preceding any traffic island for a distance of 30m. On Eatwell Avenue the solid centreline extends for 167m but on Ocean Road it is only 16m long and will need to be extended. Therefore a centreline extension and broken yellow lines are required on both sides of the road extending 30m past the traffic islands.
