Poplar Avenue/Te Ara o Whareroa Crossing

Safe System Assessment

Prepared for
Kapiti Coast District Council

Prepared by
Tonkin & Taylor Ltd

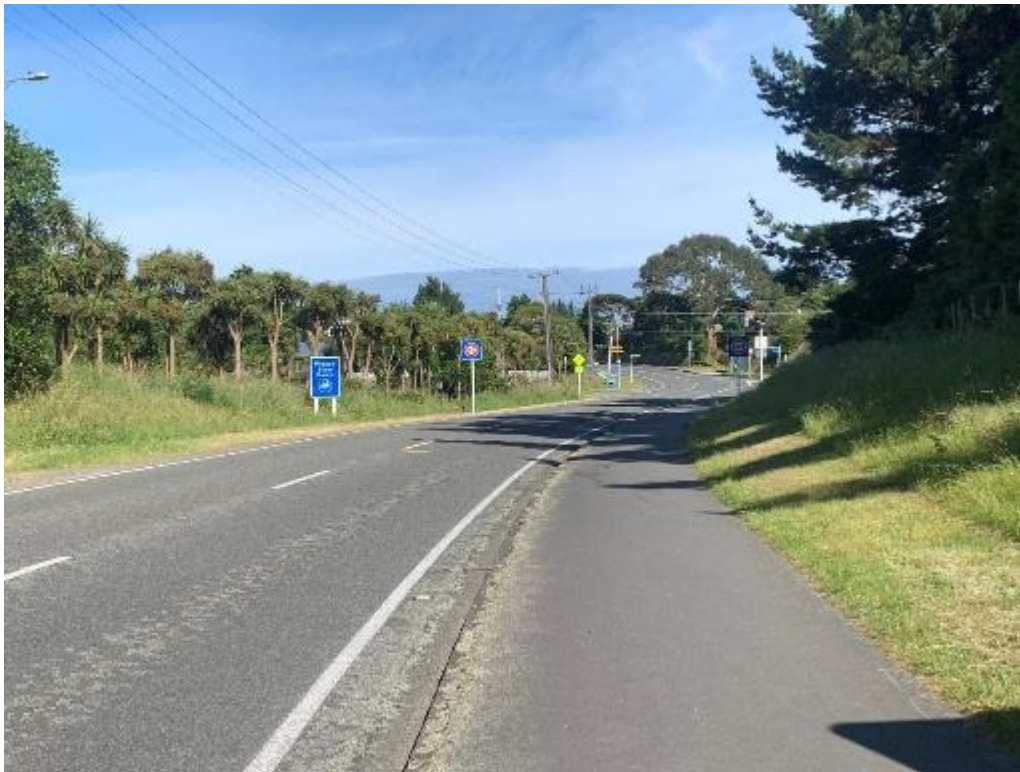
For **westbound** vehicles the **85th%tile** vehicle speeds at **45 km/h** exceed the speed limit and the Austroads 30km/h threshold, with a **median** speed of **39 km/h**. Westbound vehicles approach the crossing from a long straight section of 50 km/h road (whose environment does not look and feel like a 50 km/h zone) and the crossing point is not that visible/obvious to drivers.

Image 1 – Westbound approach to crossing point

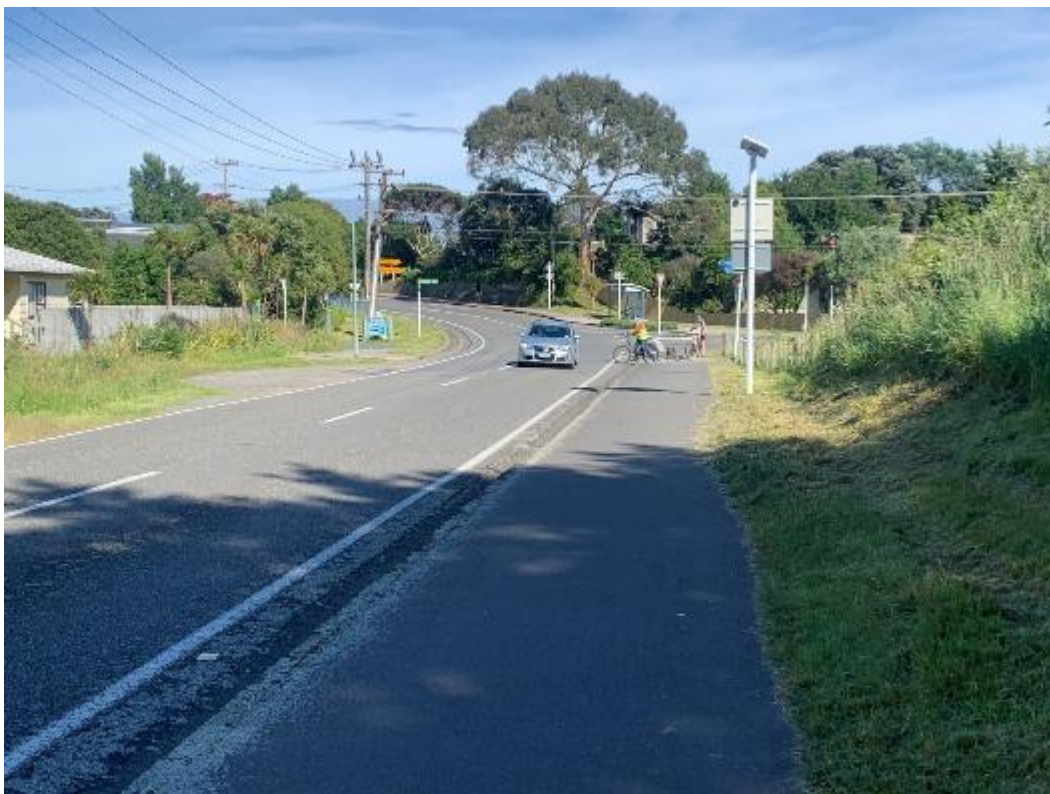
Image 2 – Westbound approach to crossing point

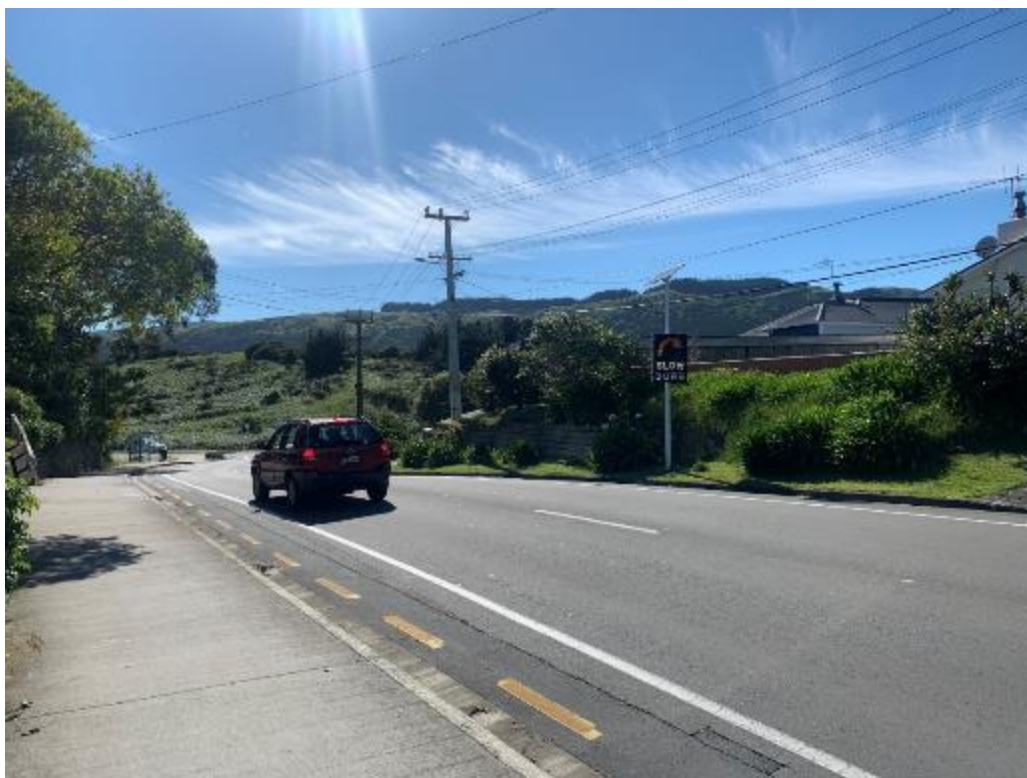
85th%tile vehicle speeds on the **eastbound** approach are **48 km/h**, which exceeds the speed limit (and these have altered little since the speed limit was reduced from 50km/h to 40 km/h). These speeds also exceed the Austroads indicated speed threshold of 30km/h, which is the maximum that any vulnerable or unprotected road user (particularly pedestrians) can withstand without sustaining death or serious injuries. **Eastbound median** speeds of **42 km/h** also exceed the speed limit and Austroads threshold. Eastbound vehicles approach the crossing downhill, on a right-hand bend (which restricts forward visibility of the crossing), pass the bus stop and the Matai Road intersection and then, with very little advance warning, pass through the crossing point.

Image 3 – Eastbound approach to crossing point and bend/slow down electronic sign

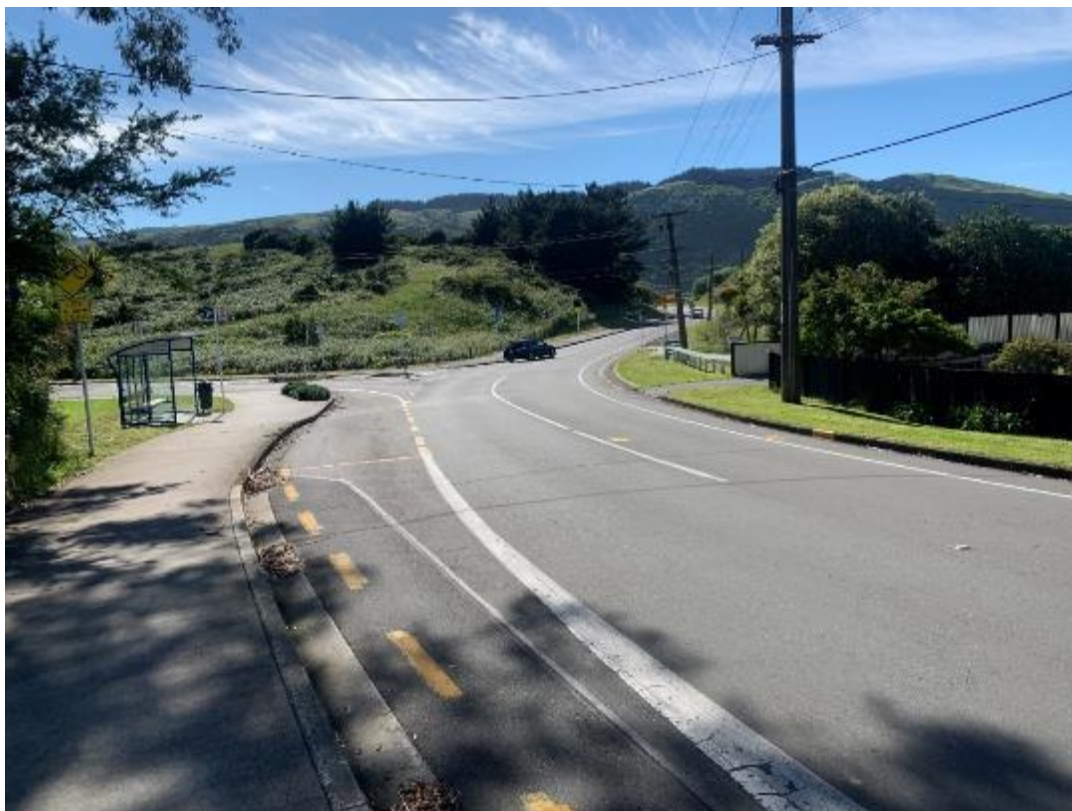
Image 4 – Eastbound approach to crossing point

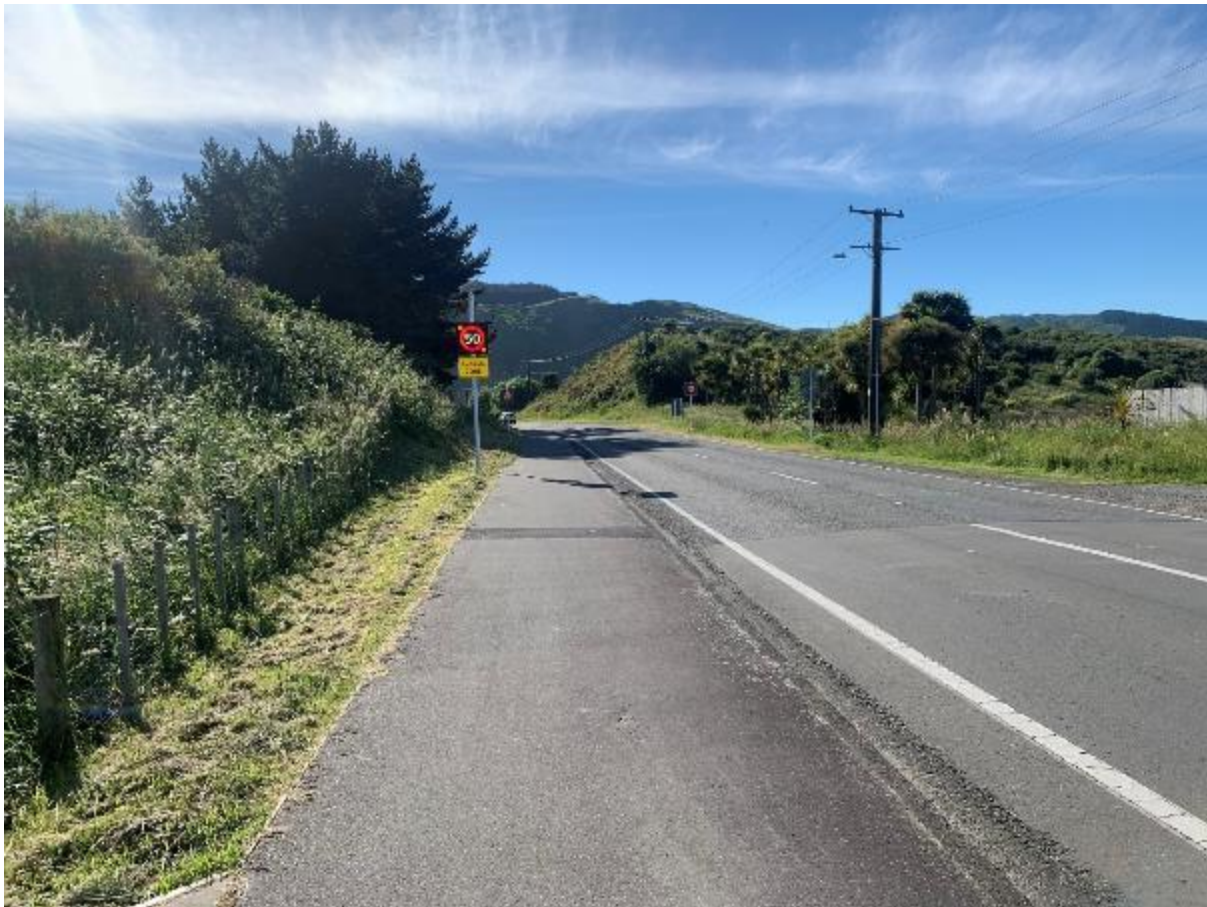
Image 5 – Westbound approach to school zone

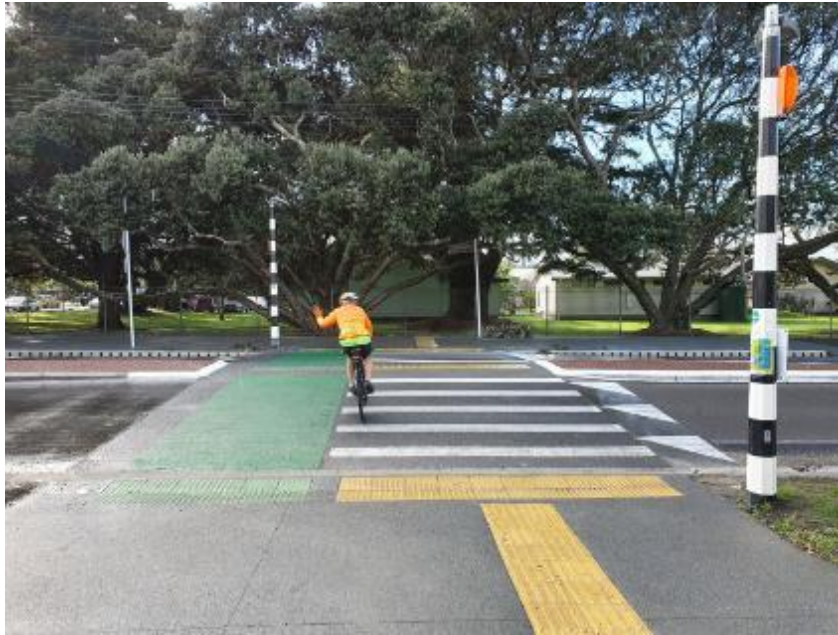
Image 6 –raised dual cycle/zebra crossing example - Carrington Road/Sutherland Road, Mount Albert, Auckland (source [Unsignalised crossings | Waka Kotahi NZ Transport Agency \(nzta.govt.nz\)](https://www.nzta.govt.nz/unsignalised-crossings/)).

- The preferred option that has been assessed in **Table 5** is a raised (dual/paired cycle) Zebra Crossing (see example in **Image 6** below) - this would give clear pedestrian and cyclist priority when crossing Poplar Avenue, would increase conspicuity of the crossing, would provide a level access crossing facility and would slow vehicle speeds through the crossing. Additional street lighting would be recommended to aid conspicuity and general awareness of the crossing. The Waka Kotahi Pedestrian Planning Guide (source [Pedestrian planning and design guide | Waka Kotahi NZ Transport Agency \(nzta.govt.nz\)](#)) indicates that raised zebra crossings have by far the largest typical crash reduction factor for pedestrian crashes.

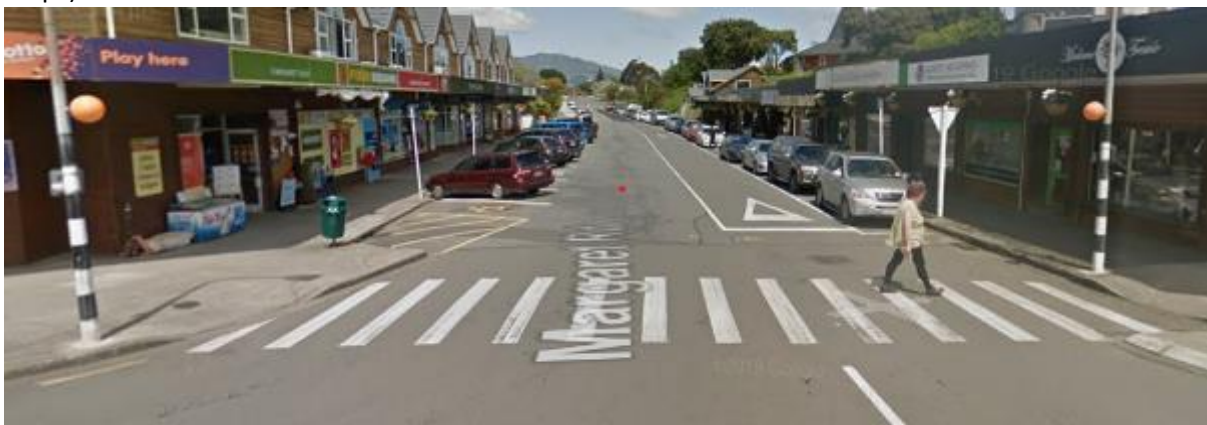
Image 7 zebra crossing (no raised table) example - Margaret Road Paraparaumu (source Google maps).

- At grade Zebra Crossing (no raised table) - see example in **Image 7** below. This would give pedestrians and cyclists priority when crossing Poplar Avenue and would increase conspicuity of the crossing. This option was rejected since vehicle approach speeds would be unchanged with an unraised zebra and the Waka Kotahi Pedestrian Planning Guide indicates that unraised zebra crossings have a negative typical crash reduction factor for pedestrian crashes and some NZ guidance indicates that new zebra crossings should not be provided unraised.

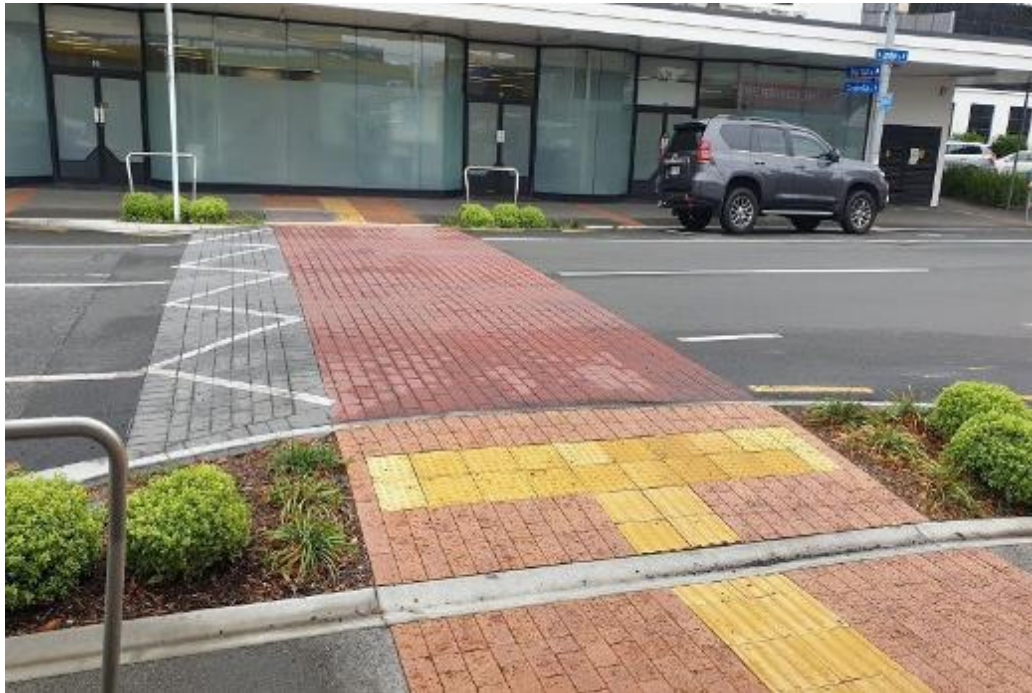
Image 8 Raised Courtesy Crossing example – London Street, Hamilton (Source NZ Herald 6/4/21).

- Provide a raised pedestrian platform (no zebra “courtesy crossing” see example in **Image 8** below). In this option pedestrians/cyclists would have to give way to vehicles. Although reducing traffic speeds and providing level access for pedestrians and cyclists, this option was rejected because it could cause confusion for drivers as well as pedestrians and cyclists as to who has right of way.

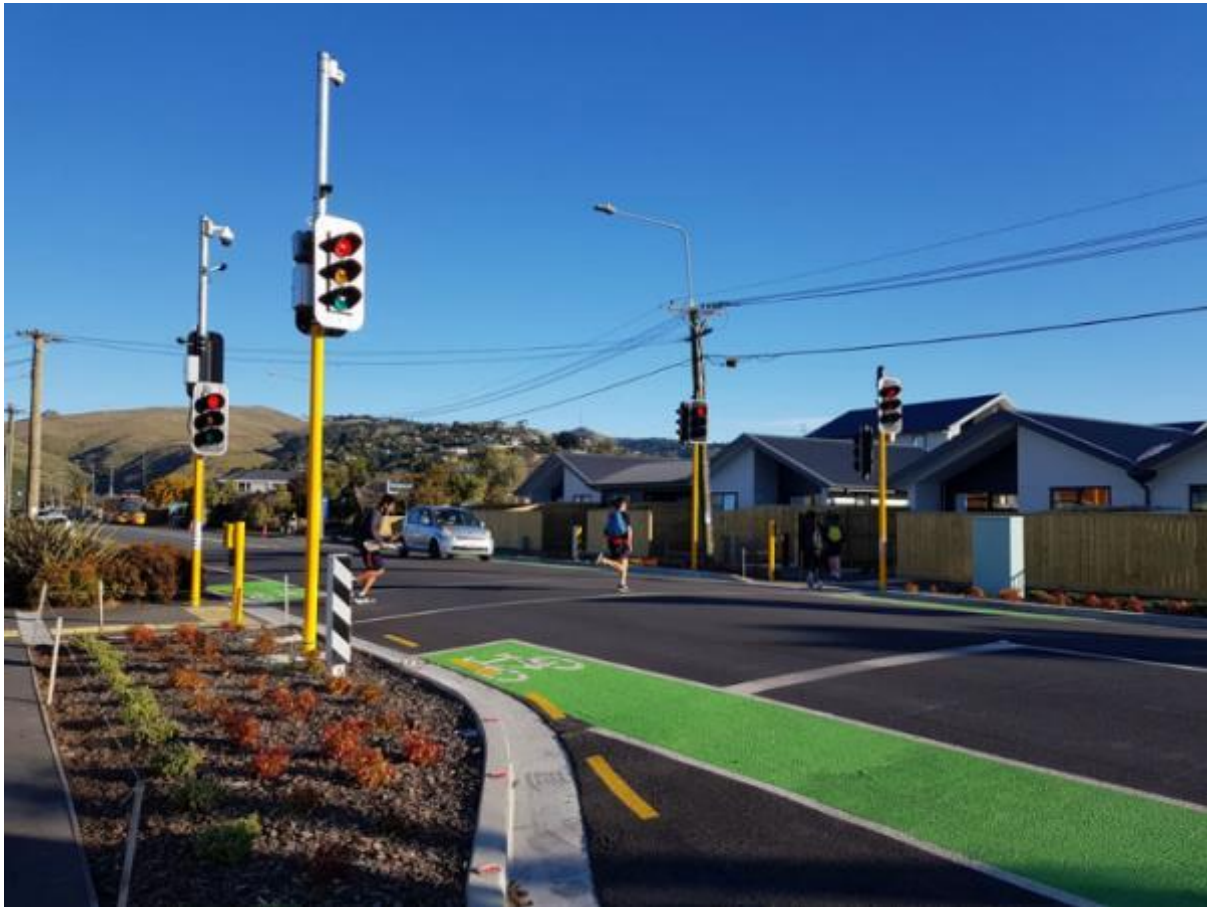
Image 9 Mid-block traffic signal controlled crossing example – Wilsons Road, Christchurch (Source [Signalised crossings | Waka Kotahi NZ Transport Agency \(nzta.govt.nz\)](https://www.nzta.govt.nz/signals/signals/crossings/))

- Mid-block traffic signal controlled dual/paired crossing (see example in **Image 9** below). This would give pedestrians and cyclists priority when crossing and would slow vehicle speeds. The signal crossing could be raised or unraised (although a raised crossing will be a more effective safe system treatment). This option was rejected since the Waka Kotahi Pedestrian Planning Guide indicates that the mid-block traffic signals typical crash reduction factor for pedestrian crashes is much lower than that of a raised zebra crossing. Furthermore, traffic signals at this location would be out of character for the surrounding area and also may introduce delays to traffic.

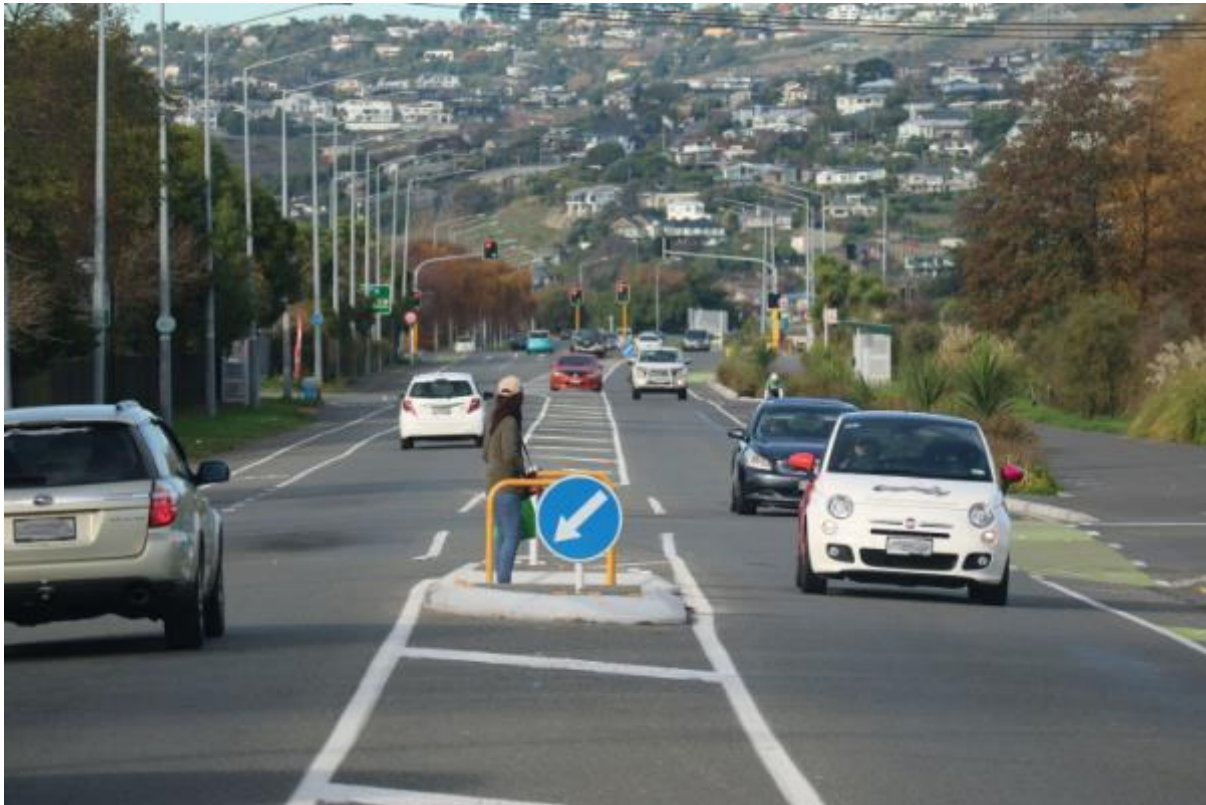
Image 10 – Pedestrian refuge example, Linwood Avenue, Christchurch (source [Pedestrian / median refuges | Waka Kotahi NZ Transport Agency \(nzta.govt.nz\)](#)).

- Provide a pedestrian refuge (1.4m to 2m width and 4m running lanes) – example in **Image 10** below. As well as providing a half way point for pedestrians/cyclists to safely stop at, this would also be a form of horizontal traffic calming by narrowing the carriageway. This option was rejected because Poplar Avenue, at circa 8.5m in width at the crossing point, is not wide enough and also this would create a pinch point for cyclists riding on Poplar Avenue. The Waka Kotahi Pedestrian Planning Guide indicates that refuges have one of the lowest typical crash reduction factors for pedestrian crashes.

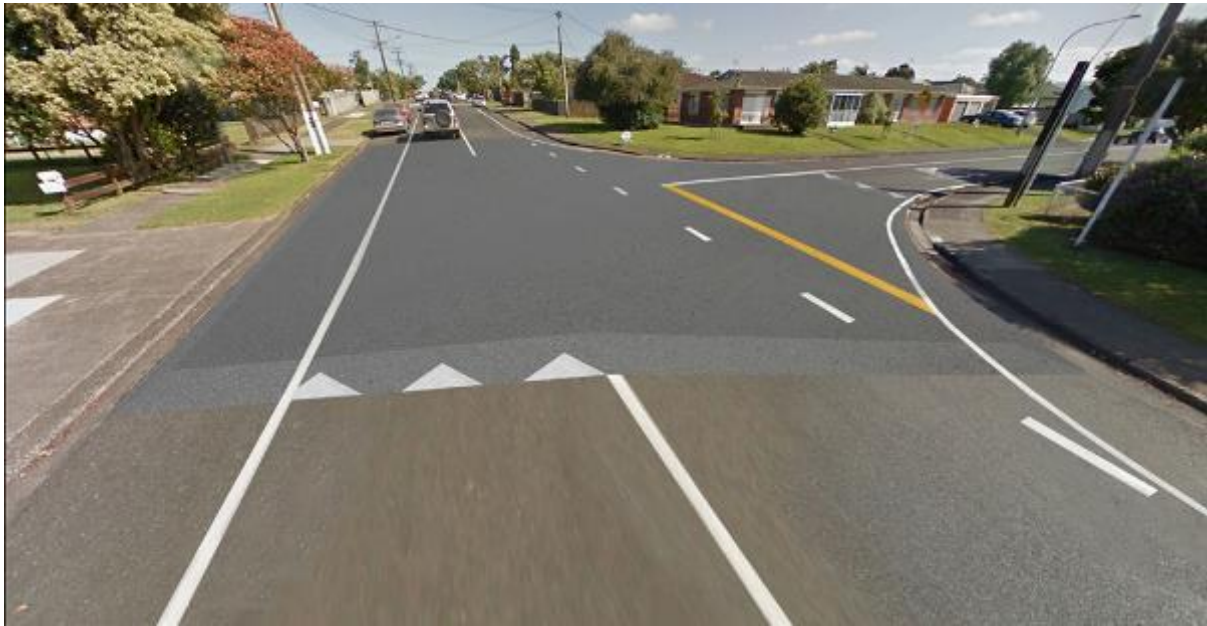
Image 11 Example raised give way intersection table, Auckland (source [Speed calming measures \(at.govt.nz\)](https://www.at.govt.nz/))

Realign the crossing point further west to Matai Road and provide a raised give way intersection table at Matai Road/Poplar Avenue with an uncontrolled/courtesy pedestrian/cycle crossing (example of raised give way intersection shown in **Image 11** below). This would simplify the crossing location and the adjacent intersection arrangement, would provide a level access crossing facility and would slow vehicle speeds through the crossing. Additional street lighting would be recommended to aid conspicuity and general awareness of the raised intersection and crossing. However, it could cause confusion for drivers as well as pedestrians and cyclists as to who has right of way and it would not increase the conspicuity of the crossing.

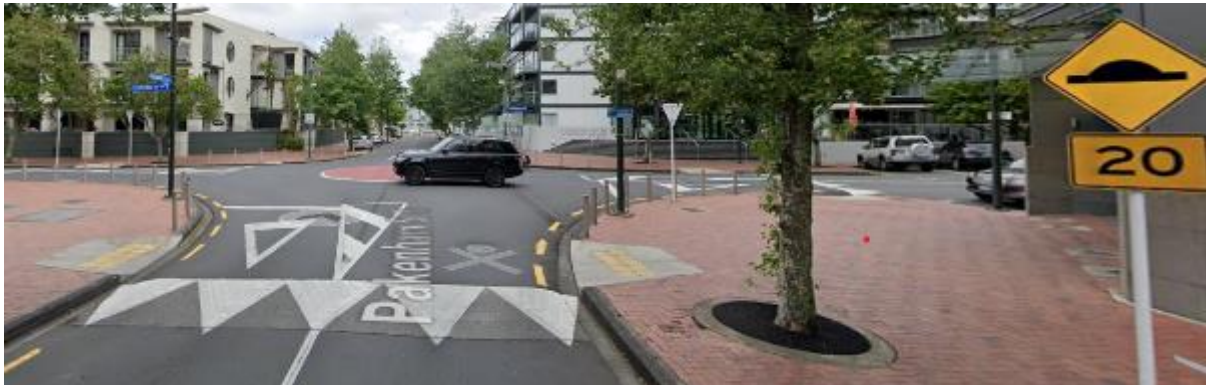
Image 12 Example raised roundabout Custom Street West/ Pakenham Street, Auckland (source google maps).

The October 2015 Poplar Avenue Shared Use Path Detailed Design Safety Audit Report recommended consideration of providing a roundabout at the Poplar Avenue/Matai Road intersection with the shared pathway “*being accommodated as a special fourth (southern) leg*”. A roundabout on its own would be a traffic calming device and could slow vehicle speeds on Poplar Avenue. Best practice guidance within the Auckland Transport Cycle Infrastructure section of the Transport Design Manual (TDM) indicates that “*the roundabout should be designed to achieve low entry and circulating speeds, not exceeding 30 km/h anywhere for cars. People on bikes should be able to claim the lane, enter and circulate safely with other traffic. Width of entry and circulating lanes should be limited, so that cars do not pass alongside people on bikes. Over-run aprons for large vehicles should be used if needed*”. **Image 12** below shows the type of roundabout design that TDM indicates would be safe to accommodate cyclists to create a slow (15 km/h to 20 km/h) speed environment. Therefore, a raised roundabout intersection would be required to achieve these safe vehicle speeds to accommodate cyclists.

- The Waka Kotahi Pedestrian Planning Guide indicates that the roundabout typical crash reduction factor for pedestrian crashes is much lower than that of a raised zebra crossing (but comparable to that of mid-block traffic signals). However, roundabouts without any formal cycle facilities have a poor safety record for cyclists.
- Furthermore, suitable crossing facilities within the roundabout (either controlled or uncontrolled) would need to be provided for pedestrians and cyclists to cross Poplar Avenue.
- It is questionable whether there is sufficient existing road reserve to accommodate both a raised roundabout and safe pedestrian and cycle crossing facilities at this location without acquisition of additional land.

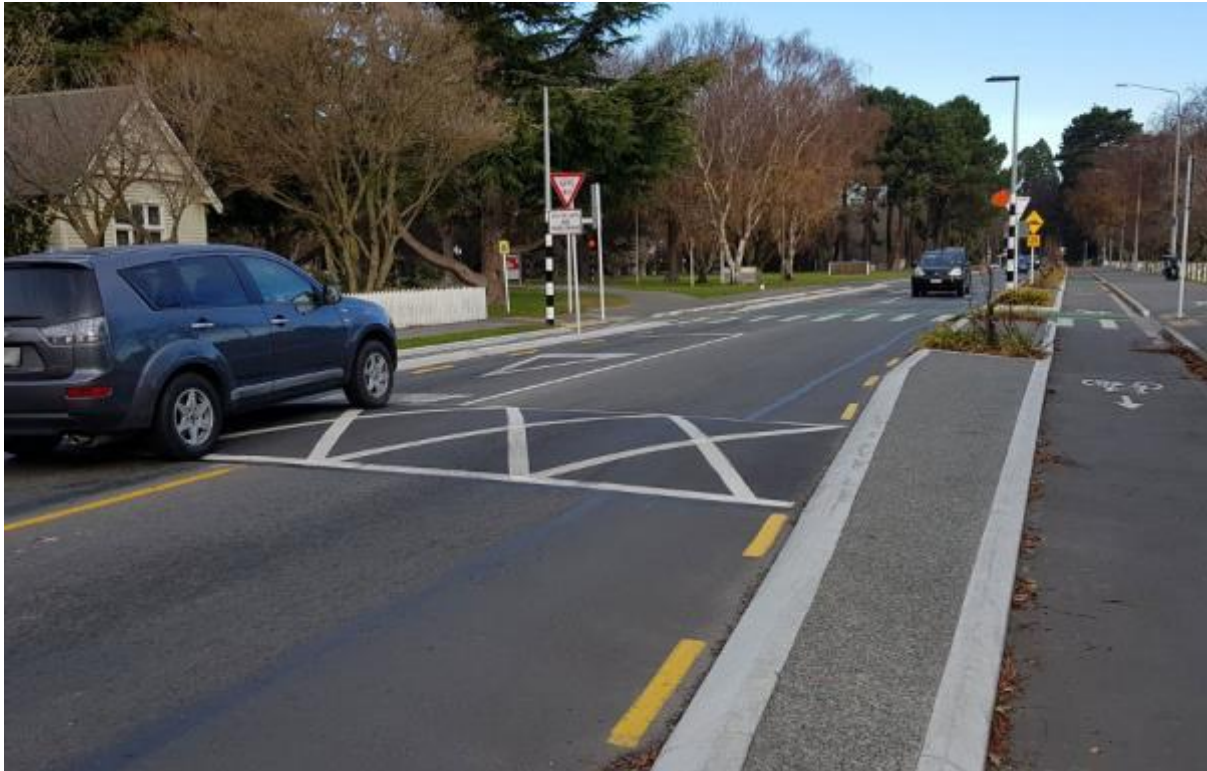
Image 13 Dual (un-raised) zebra crossing with vertical traffic calming example– Ilam Road, Christchurch (source [Unsignalised crossings | Waka Kotahi NZ Transport Agency \(nzta.govt.nz\)](https://nzta.govt.nz/unsignalised-crossings))

- Vertical traffic calming (e.g. speed tables, cushions etc) on the approaches to the crossing – there might be though an issue with comfort for bus passengers. See example in **Image 13** below.
- Horizontal traffic calming on the approaches to the crossing (e.g. kerb extensions, chicanes etc) – there might be issues with existing insufficient road reserve widths and also the desirability of having such features on Poplar Avenue.
