Paekākāriki coastal hazards

SUMMARY

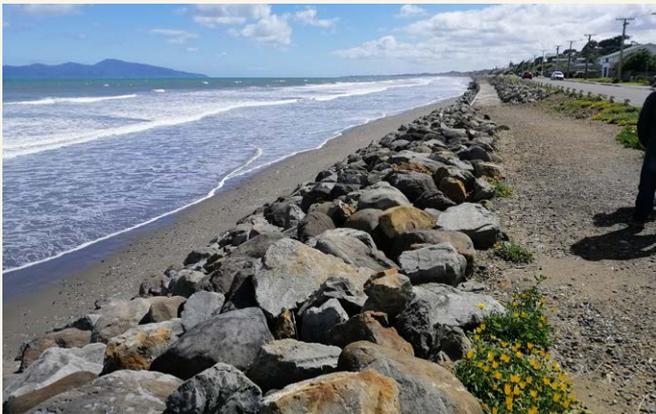
A. Rock revetment structure along The Parade.

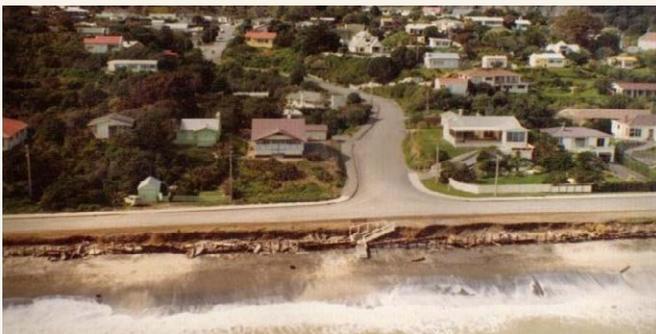
B. Structure failure and coastal erosion following September 1976 storm.

The present-day erosion hazard is what could occur in an extremely large storm (which has a 1% chance of occurring each year in the immediate/near future), and if the existing protection structures failed, as shown in photo (B). Along the Paekākāriki coast, short term erosion is 'most likely' to be 7 to 20m of erosion.

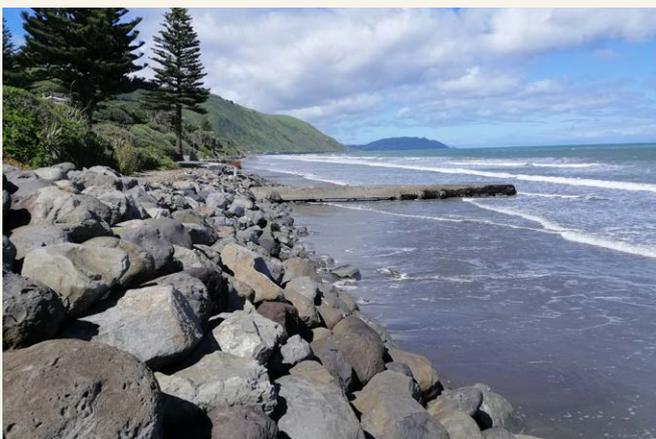
C. Paekākāriki seawall at Beach Road.

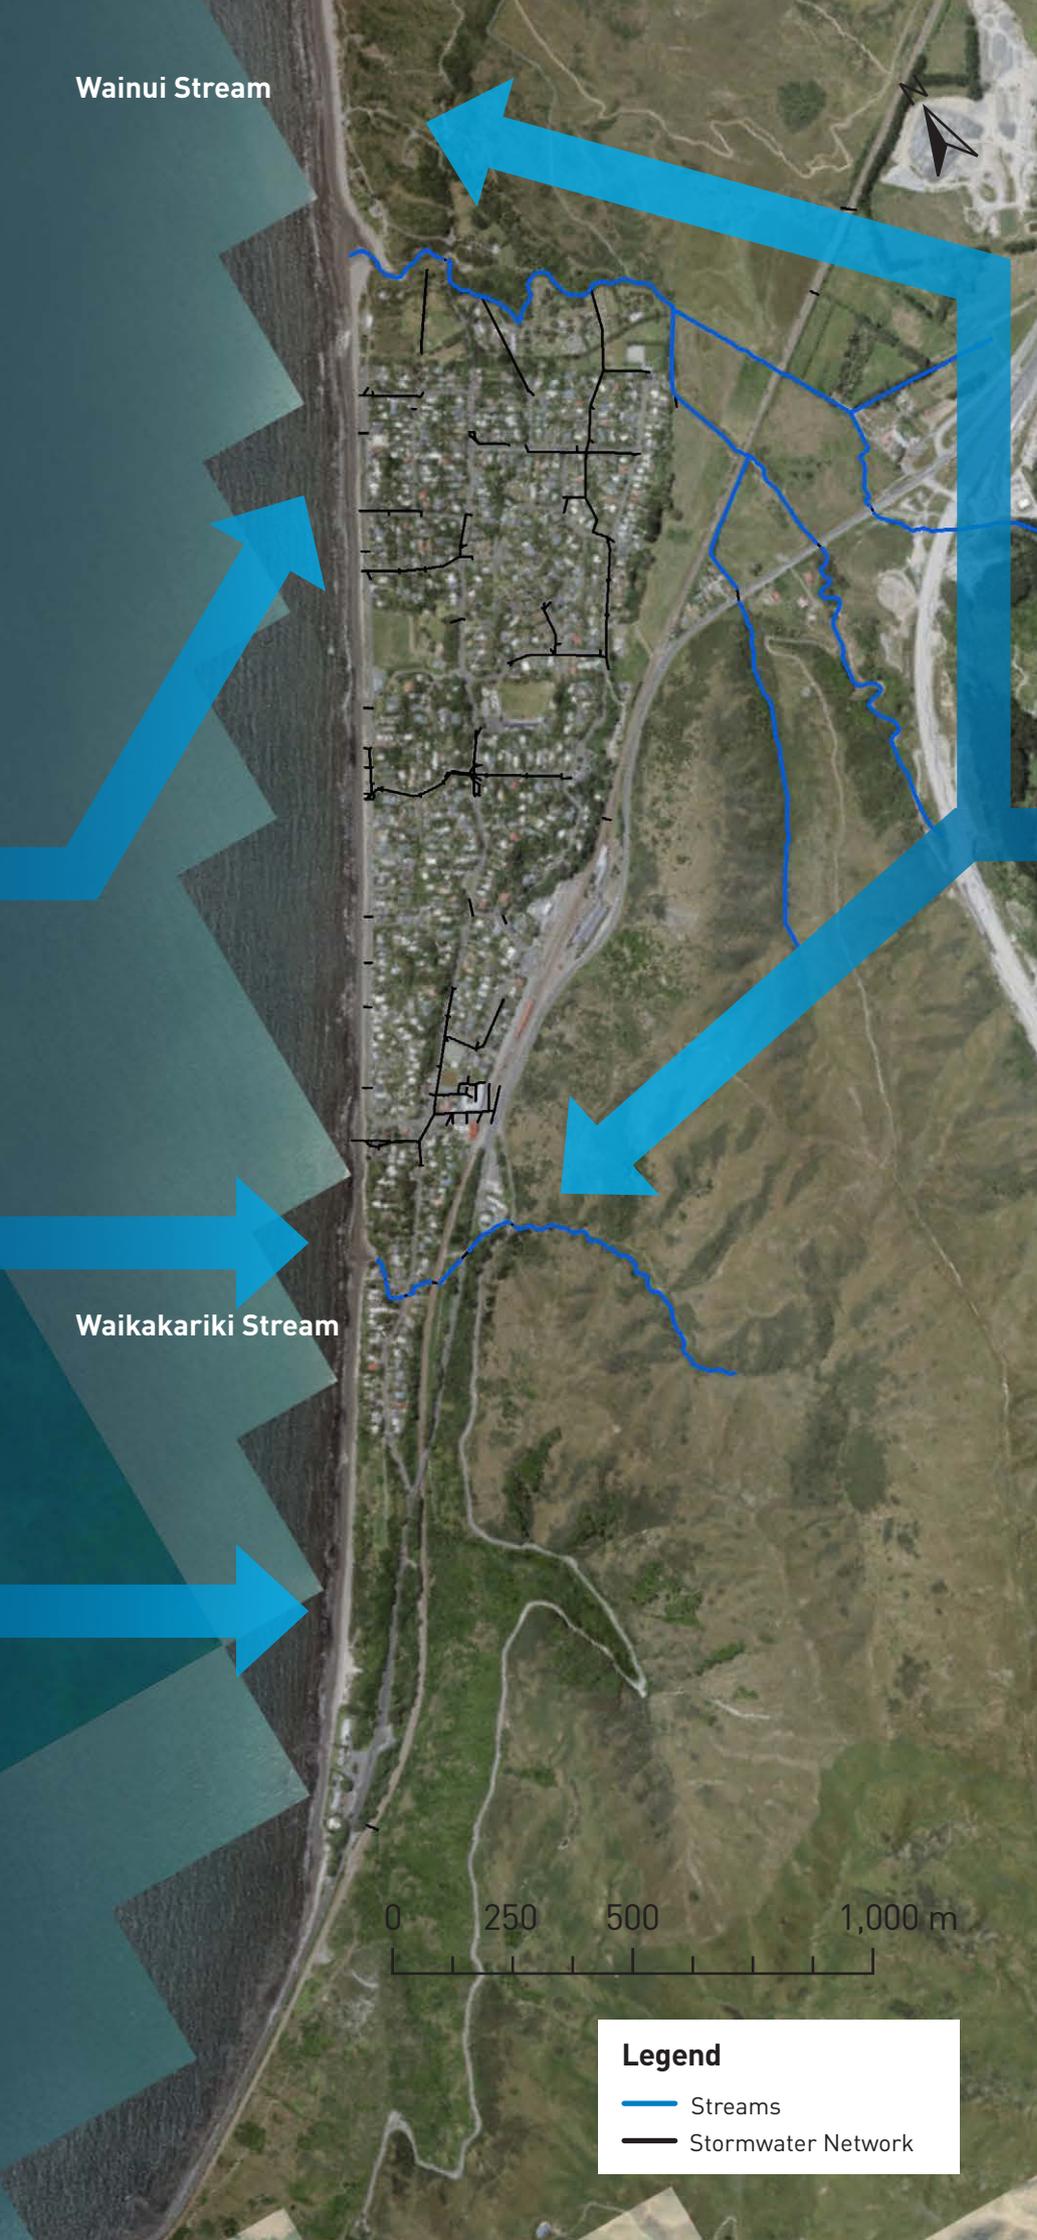
Future projections of shoreline position take into account the presence of current protection structures up to their estimated remaining life (10–50 years). After this it is assumed that the structures are not replaced, alternative protection measures are not implemented, and the beach reverts to a natural system.

Northern Paekākāriki

Paekākāriki seawall assumed to have at least a 30 year lifetime.

Projected to erode:

- 8 to 12 m by 2050
- 17 to 30 m by 2070
- 38 to 96 m by 2120

Central Paekākāriki

Seawall lifetimes vary from 10–30 years along this section.

- 23 to 31 m by 2050
- 30 to 47 m by 2070
- 50 to 100 m by 2120

Southern Paekākāriki

Seawalls are assumed to last for the next 50 years.

- 8 m by 2050
- 8 m by 2070
- 30 to 72 m by 2120
